REMEDIAL ACTION COMPLETION CERTIFICATION

RE: FAA, Building M104, MOIA, Oakland 94621

RE: Fuel Leak Site Case Closure- FAA, Building M104, MOIA Oakland CA 94621

QUALITY CONTROL BOARD CASE CLOSURE SUMMERT 2: 40 Leaking Underground Fuel Storage Tank Program

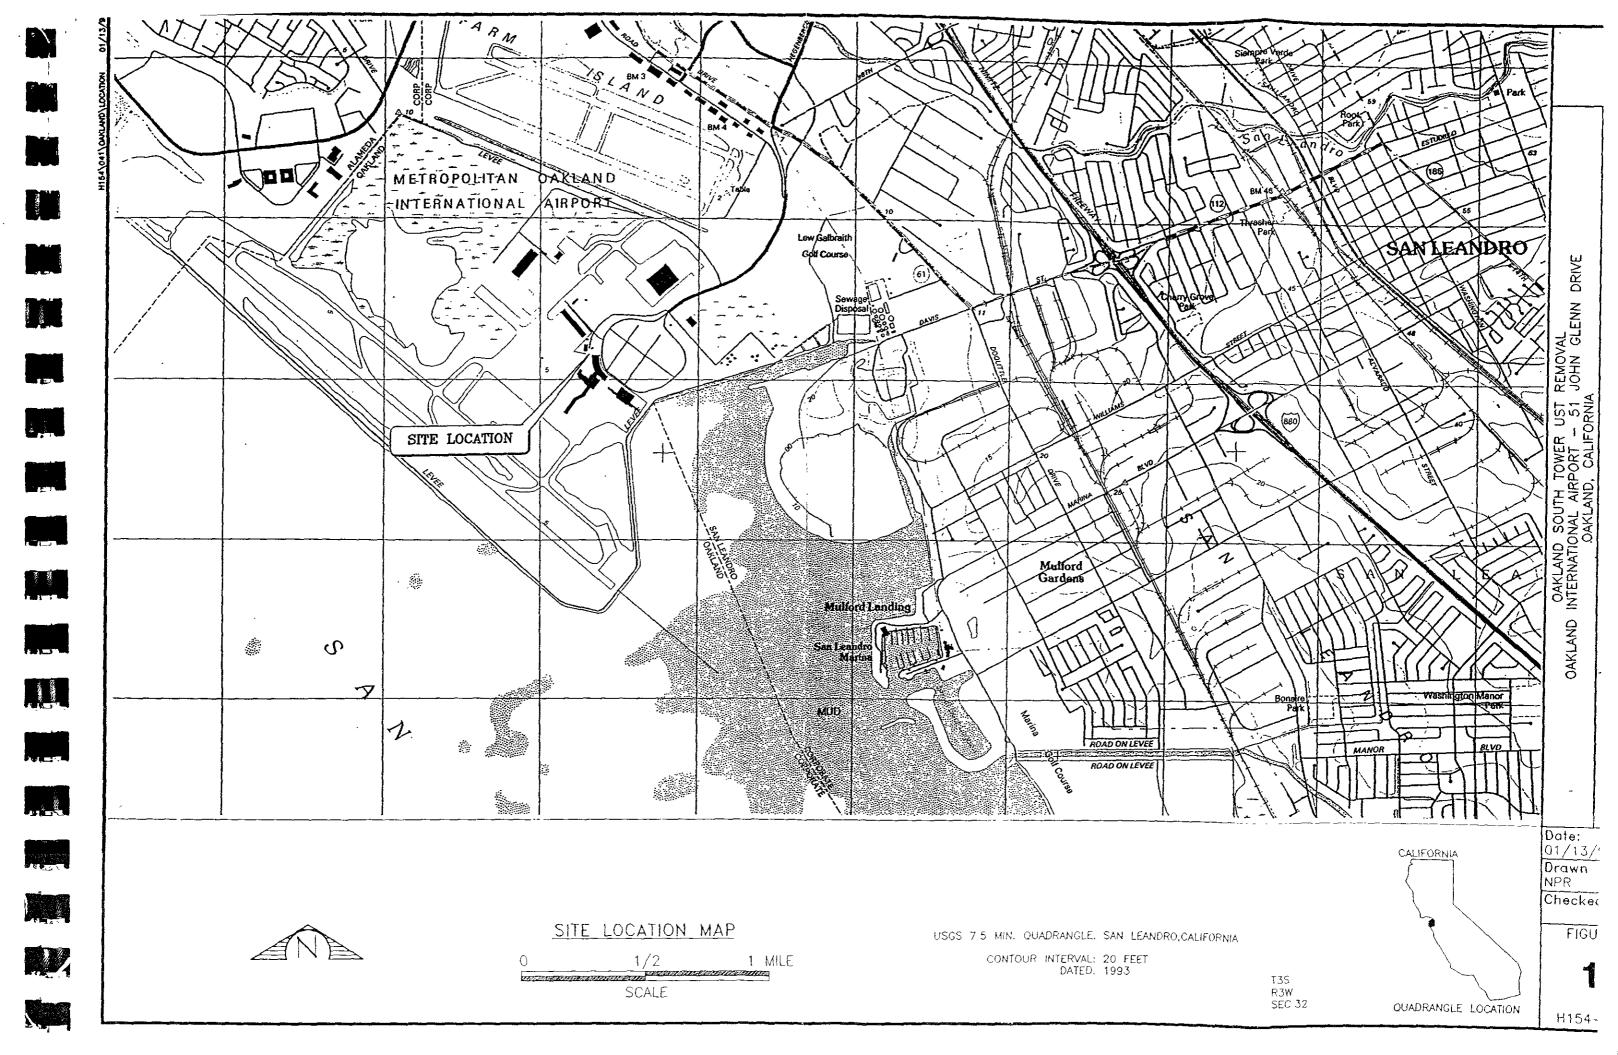
The 1000 gallon underground diesel tank, owned by the FAA and used to fuel a generator at the south Air Traffic Control Tower (ATCT) was located just south of Building M104. This location is approximately 50' southwest and down gradient of the Hertz Rental Car facility, located at 1 Airport Drive. The address of the Port of Oakland's Building M104, 51 John Glenn Drive, is used for this site. See Figure 1 for the location of this site.

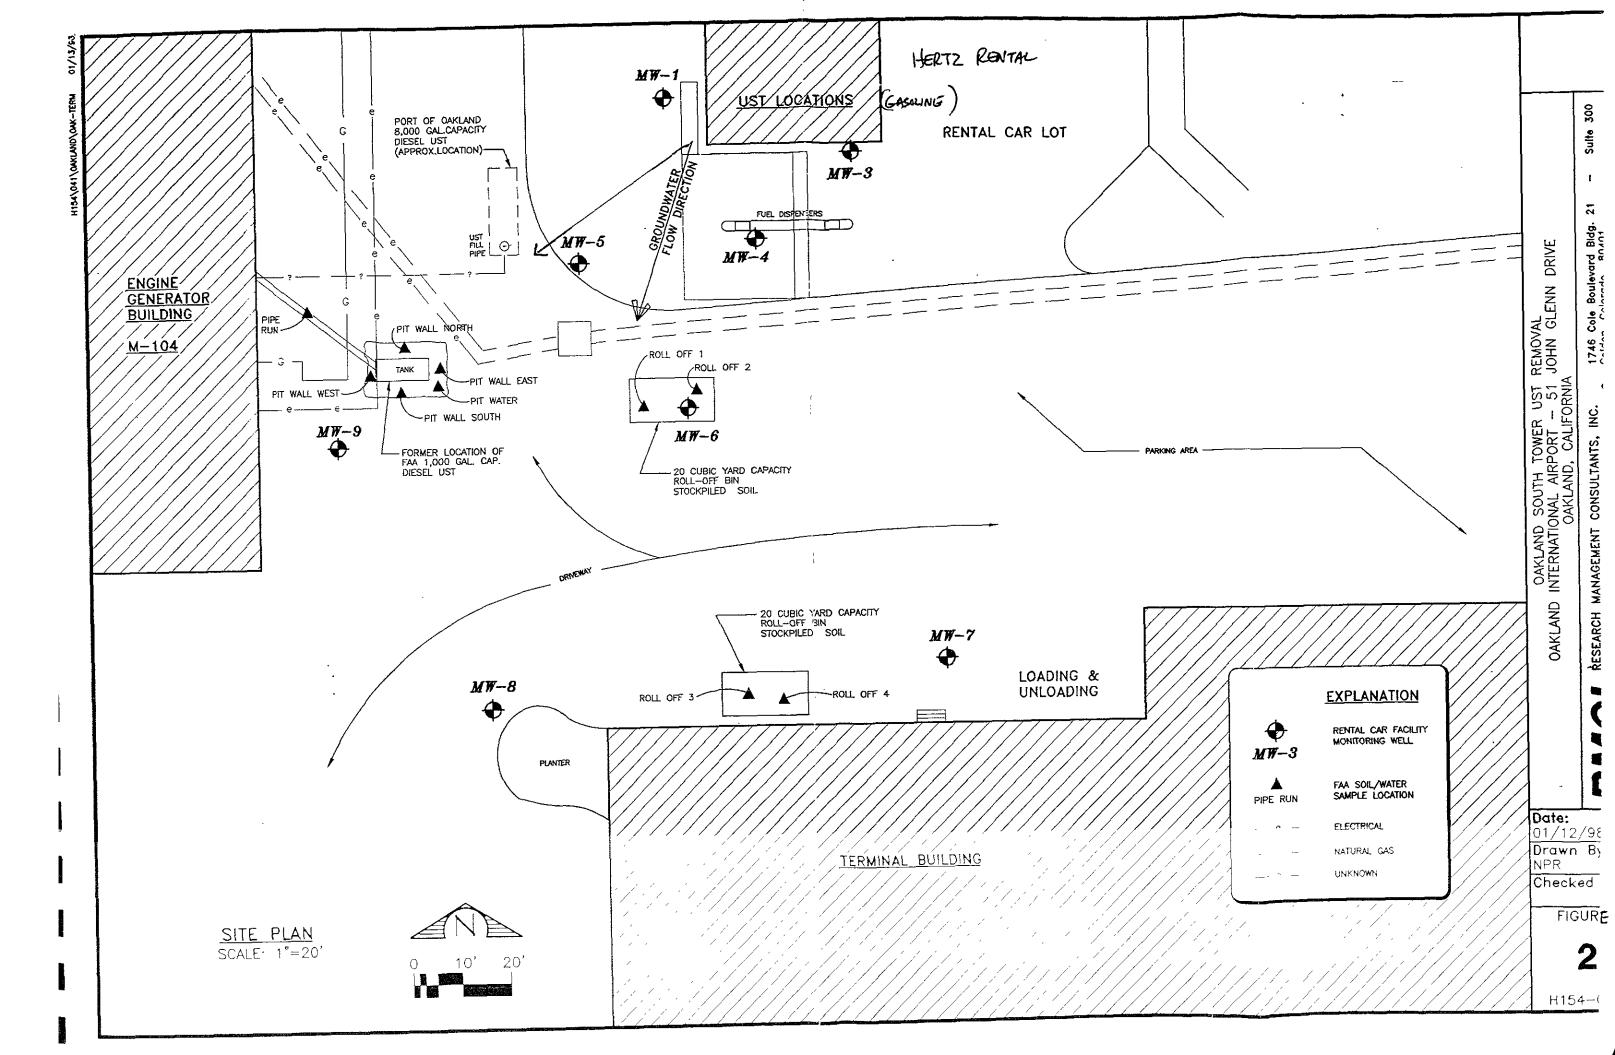
On January 8, 1998, in the presence of employees from the FAA, their contractor Kvaerner Aronson, the subcontractor, Army Corp of Engineers, the Port of Oakland, the City of Oakland Fire Services and Alameda County Environmental Health, the 1000 gallon diesel UST was removed. The Port of Oakland is the property owner and also maintains a 8000 gallon diesel tank approximately 20' north of this tank. See Figure 2 for a site plan indicating the tank, tank samples and neighboring site with wells.

Shoring was placed around the tank to prevent caving of the sidewalls. Groundwater, as anticipated, was encountered during the removal. The neighboring site, Hertz Rental, has an ongoing investigation and has installed nine monitoring wells. Groundwater gradient at that site is southwesterly and encountered at 3-5' bgs. Beneath the UST, at approximately 6' depth, was a concrete deadman. The UST had an approximately 30' piping run leading to the generator inside Building M104. Four soil sample were taken from the sidewalls at a depth of 6', just above groundwater. These samples were identified as Pit Wall N, Pit Wall S, Pit Wall E and Pit Wall W. These samples were sandy soil, typical of the native soils. A grab groundwater sample from the tank pit and a piping run sample, midway below the shallow piping run, were also taken.

All sidewall samples were ND for TPHd and BTEX. The piping run sample exhibited 160 ppm TPHd (characterized as aged diesel) and ND for BTEX. The groundwater sample exhibited 2.6 mg/l TPHd and 0.54,2.2,0.68 and 4.6 ppb BTEX, respectively. See Tables 1 and 2 for a summary of analytical results. It appears that the TPHd release from the piping run impacted groundwater. The TPHg release from the nearby Hertz site has likely impacted this site because BTEX was found in the grab groundwater sample. This is reasonable since there is a significant release near MW-4 on the Hertz site, which is up-gradient to this former tank pit. Enclosed are the recent groundwater monitoring results and gradient map for the Hertz facility. The historical monitoring of MW-9 for the Hertz site demonstrates that TPHd is not a significant problem in groundwater. The grab groundwater sample result is not representative of actual groundwater conditions.
