SITE CLOSURE REPORT
at
5787 Scarlet Court
Dublin, California 94568

June 6, 1994

REACT ENVIRONMENTAL SERVICES CORPORATION

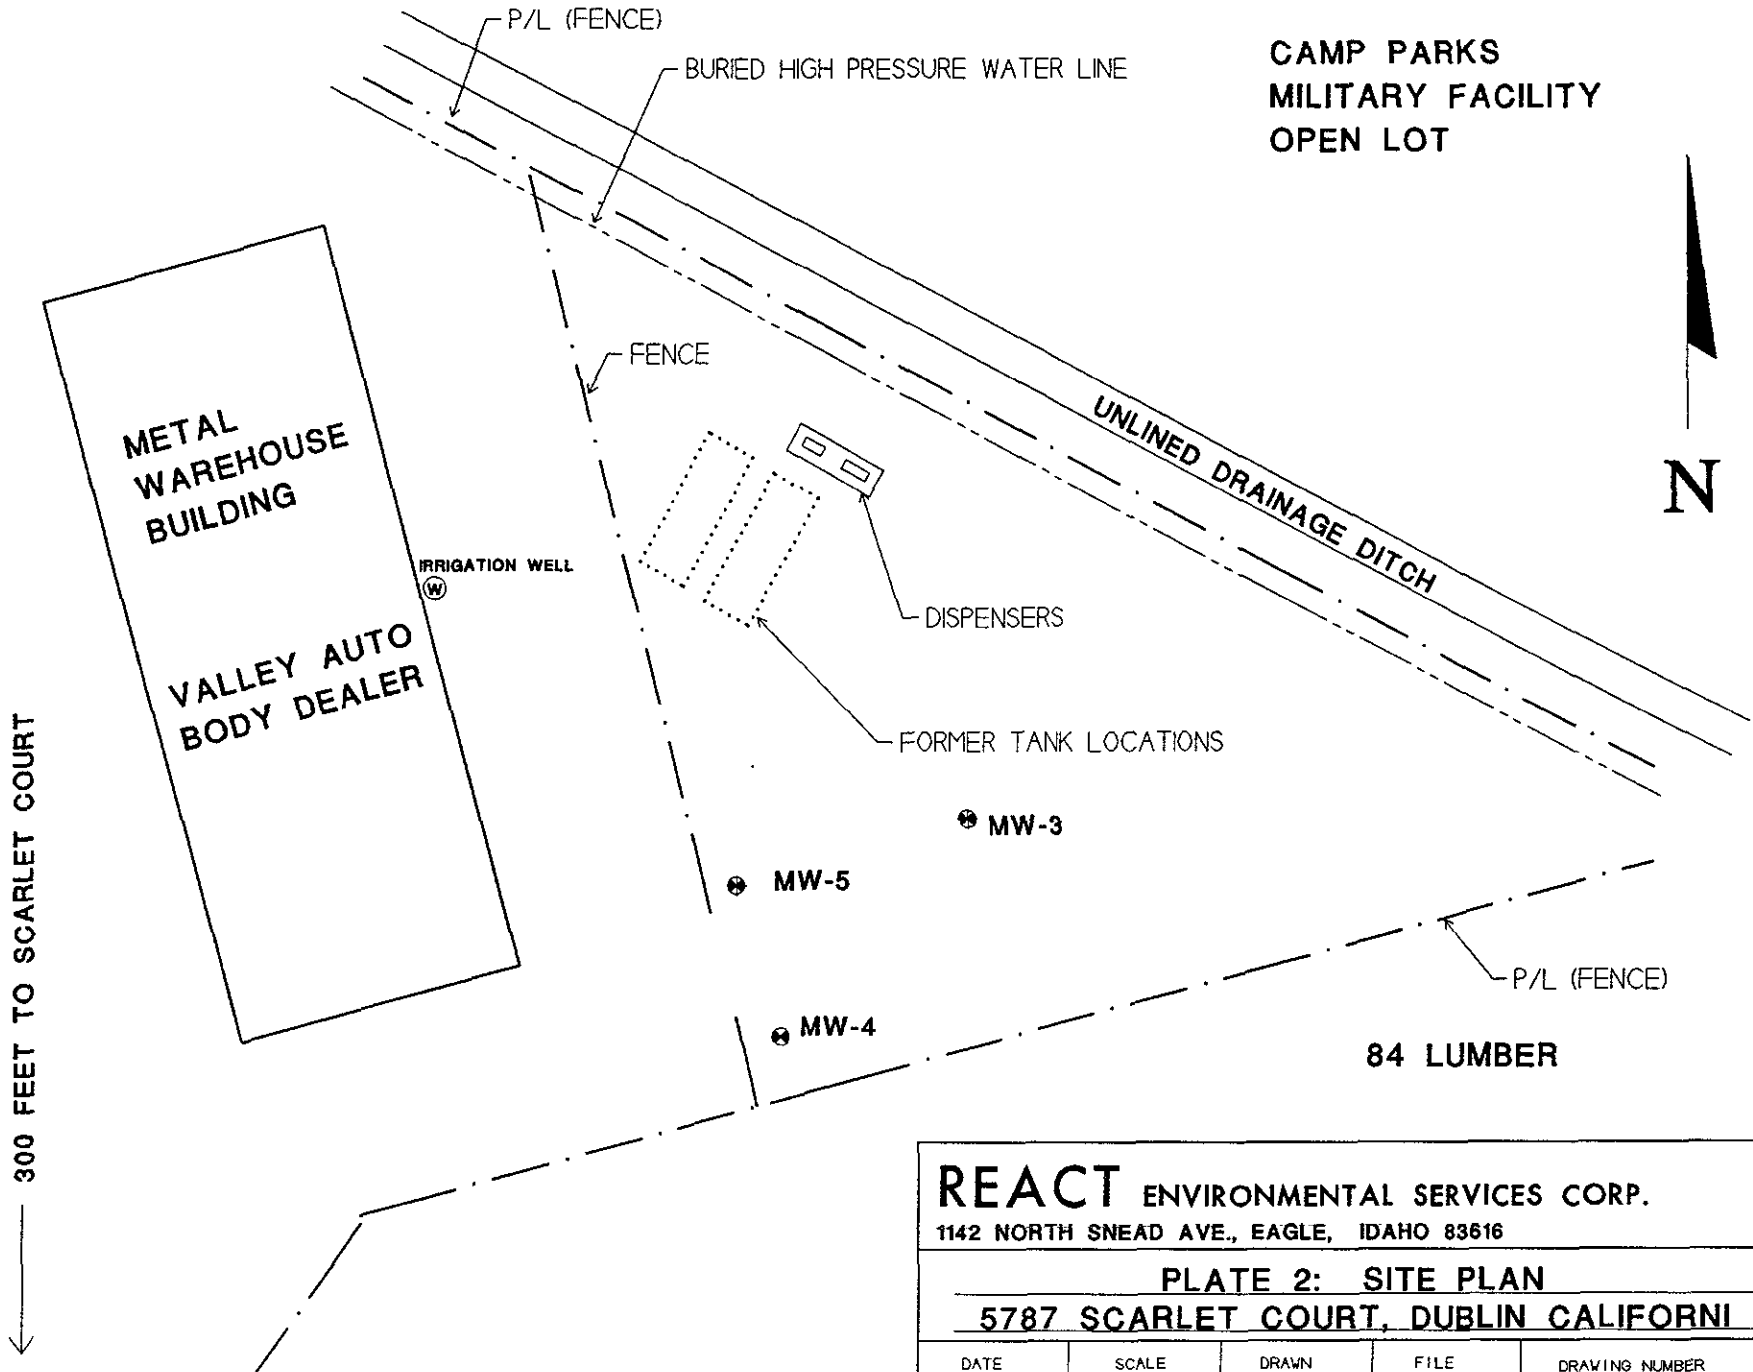
PLATE 2: SITE PLAN
5787 SCARLET COURT, DUBLIN CALIFORNIA

The subject site is located at 5787 Scarlet Court, in Dublin, California; approximately one mile east of highway 680 and 1500 feet north of Highway 580 (Plate 1). The property is a relatively flat, mostly paved, triangular-shaped parcel bounded on the north and east by an unlined drainage ditch adjacent to an old Southern Pacific Railroad grade. The unused rail-bed separates the site from vacant land at the Camp Parks military facility. The site is bounded on the south by 84 Lumber and on the west by Valley Auto Center (Plate 2).
