RE: Internal Inspection and UTG Report for
Corwood Car Wash 6973 Village Pkwy Dublin, CA

INTERNAL TANK INSPECTION AND UTG REPORT FOR:

CORWOOD CAR WASH
6973 VILLAGE PARKWAY
DUBLIN, CALIFORNIA
94568

MARCH, 1990

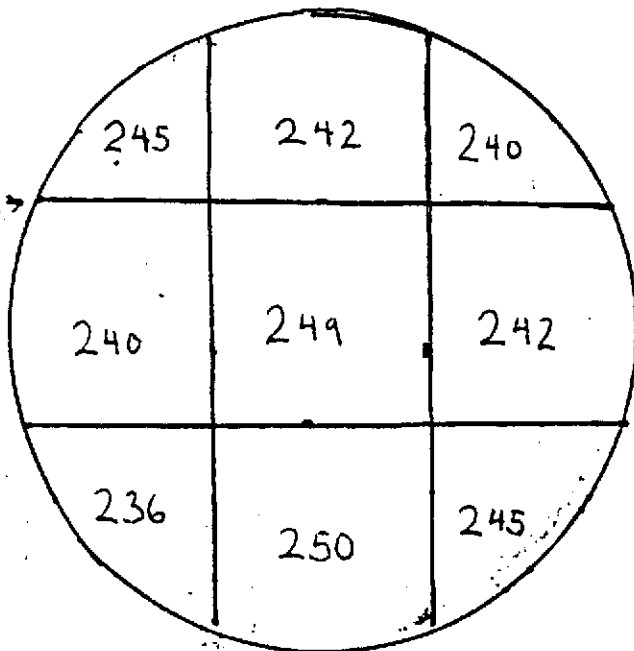
Tank # 1

- a. Seams are single welded.
- b. Negligible floor pitting
- c. Dents in tank - none

- a. 16 oz brass mallet used on 3' X 3' quadrant centers
- b. No denting, echoing or penetrating occurred as a result of this test - passed

SIDE {	226	242	254	226	216	247	260	218	236
	218	242	222	224	226	251	246	217	239
Top →	252	222	224	250	217	253	244	216	245
SIDE {	230	225	219	221	220	235	226	217	216
	226	248	246	230	264	259	218	248	215
Floor Center →	230	226	220	231	247	222	251	233	238
	250	261	255	231	253	232	254	257	240
	226	223	245	250	230	247	218	215	212

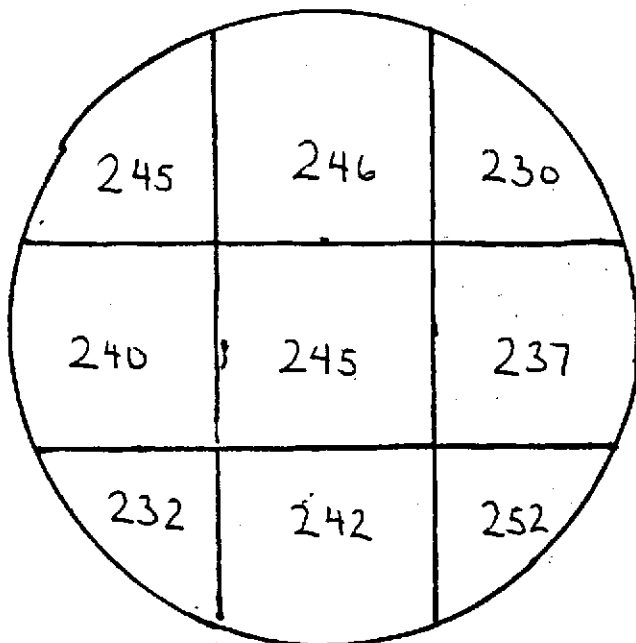
Total of Gauges	<u>21233</u>	•	<u>235.9</u>	Av. Thk.
Total No. of Gauges	<u>90</u>			
Av. Thk.	<u>235.9</u>	X 100 =	<u>94.3</u>	% of Design Thk.
Design Thk.	<u>250</u>
