GEOTECHNICAL DATA REPORT

CONCRETE ARCH CULVERT RELINING
AND CMP REPLACEMENT
GLEN ECHO CREEK
DRAINAGE IMPROVEMENT PROJECT
OAKLAND, CALIFORNIA

PROJECT NO.: 51-951273NB.00

PREPARED FOR: WINZLER & KELLY

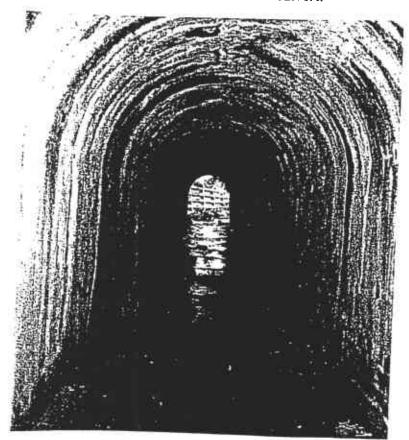
PHOTO 2: A view from inside of culvert (looking north).

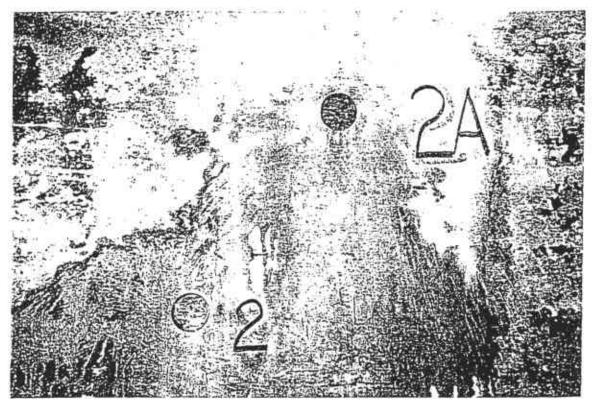
PHOTO 5: A view of cored location @ Sta.0+85 west.

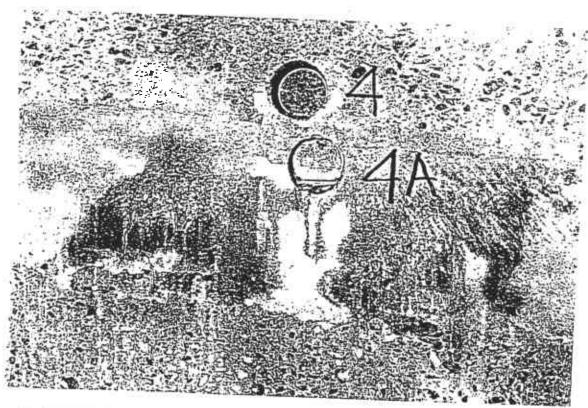
PHOTO 8: A view of cored location @ Sta. 2+05 west.

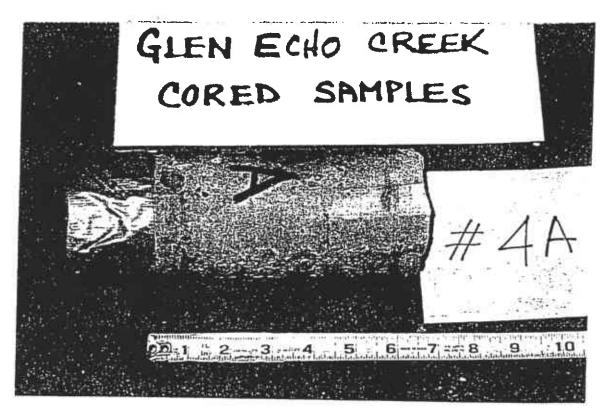
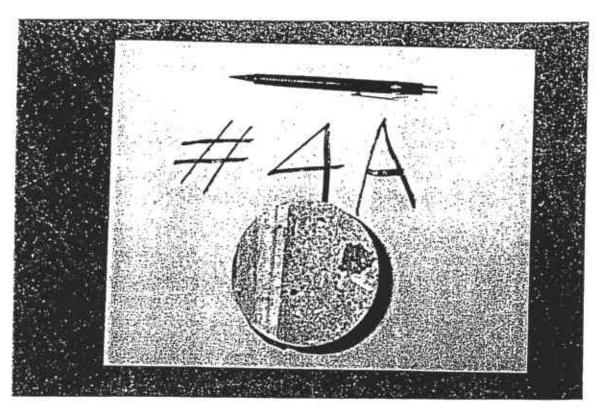
Sample 2A (Sta. 0+85) fell apart during the coring process. The concrete at this location was in very poor condition and exhibited poor strength. Upon inspection of sample 4A (Sta. 2+05), it was apparent that an inclusion was contained within the core sample. A view of the core sample is shown in Photos 14 & 15. Additional core samples were taken at these locations for compressive strength testing.

PHOTO 14: A view of core sample #4A.

PHOTO 15: A view of core sample #4A

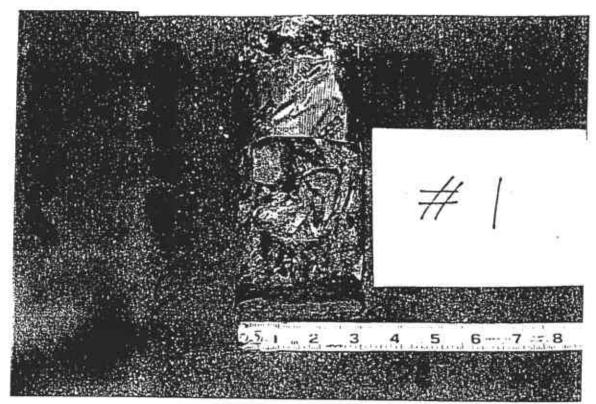
PHOTO 16: A close-up view of core sample #1.

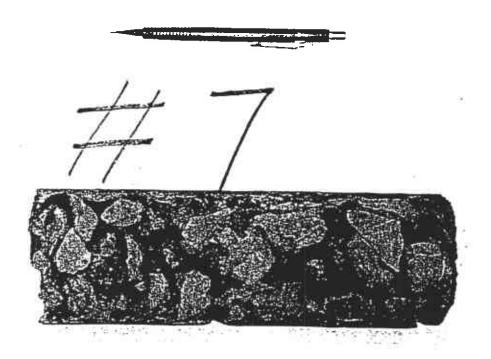
PHOTO 17: A close-up view of core sample #7.
