FACILITY CLOSURE REPORT

Grand Auto Supply
4240 East 14th Street
Oakland, California

J-6077

February 16, 1996

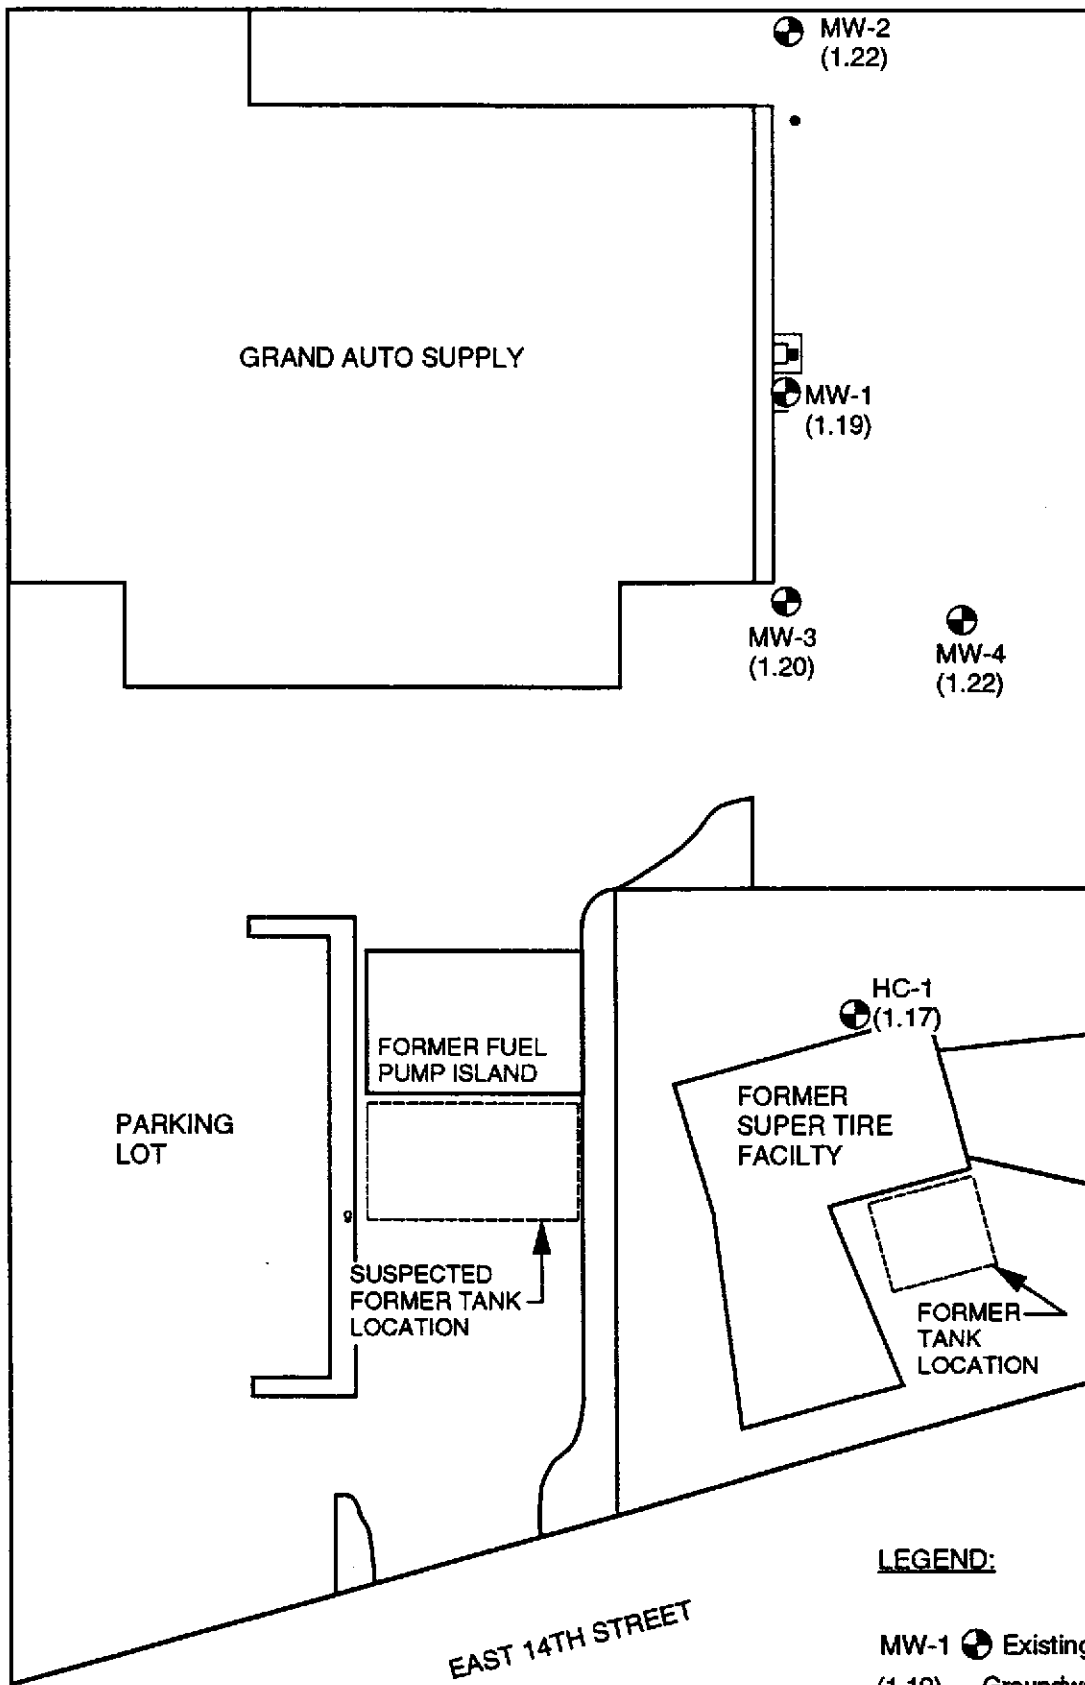
MW-4	
PCE	160
TCE	24
DCE	4.4
Clfm	<0.5
TCA	<0.5
DCA	<0.5
VC	<0.5

HC-1	
PCE	170
TCE	27
DCE	14
Clfm	<0.5
TCA	<0.5
DCA	<0.5
VC	<0.5
