Please find the attached re-sampling report for 16611 E. 14th St.

June 10, 2003

RE: Phase II Investigation – Additional Sampling
16611 East 14th Street
San Leandro, CA **94578**
San Leandro

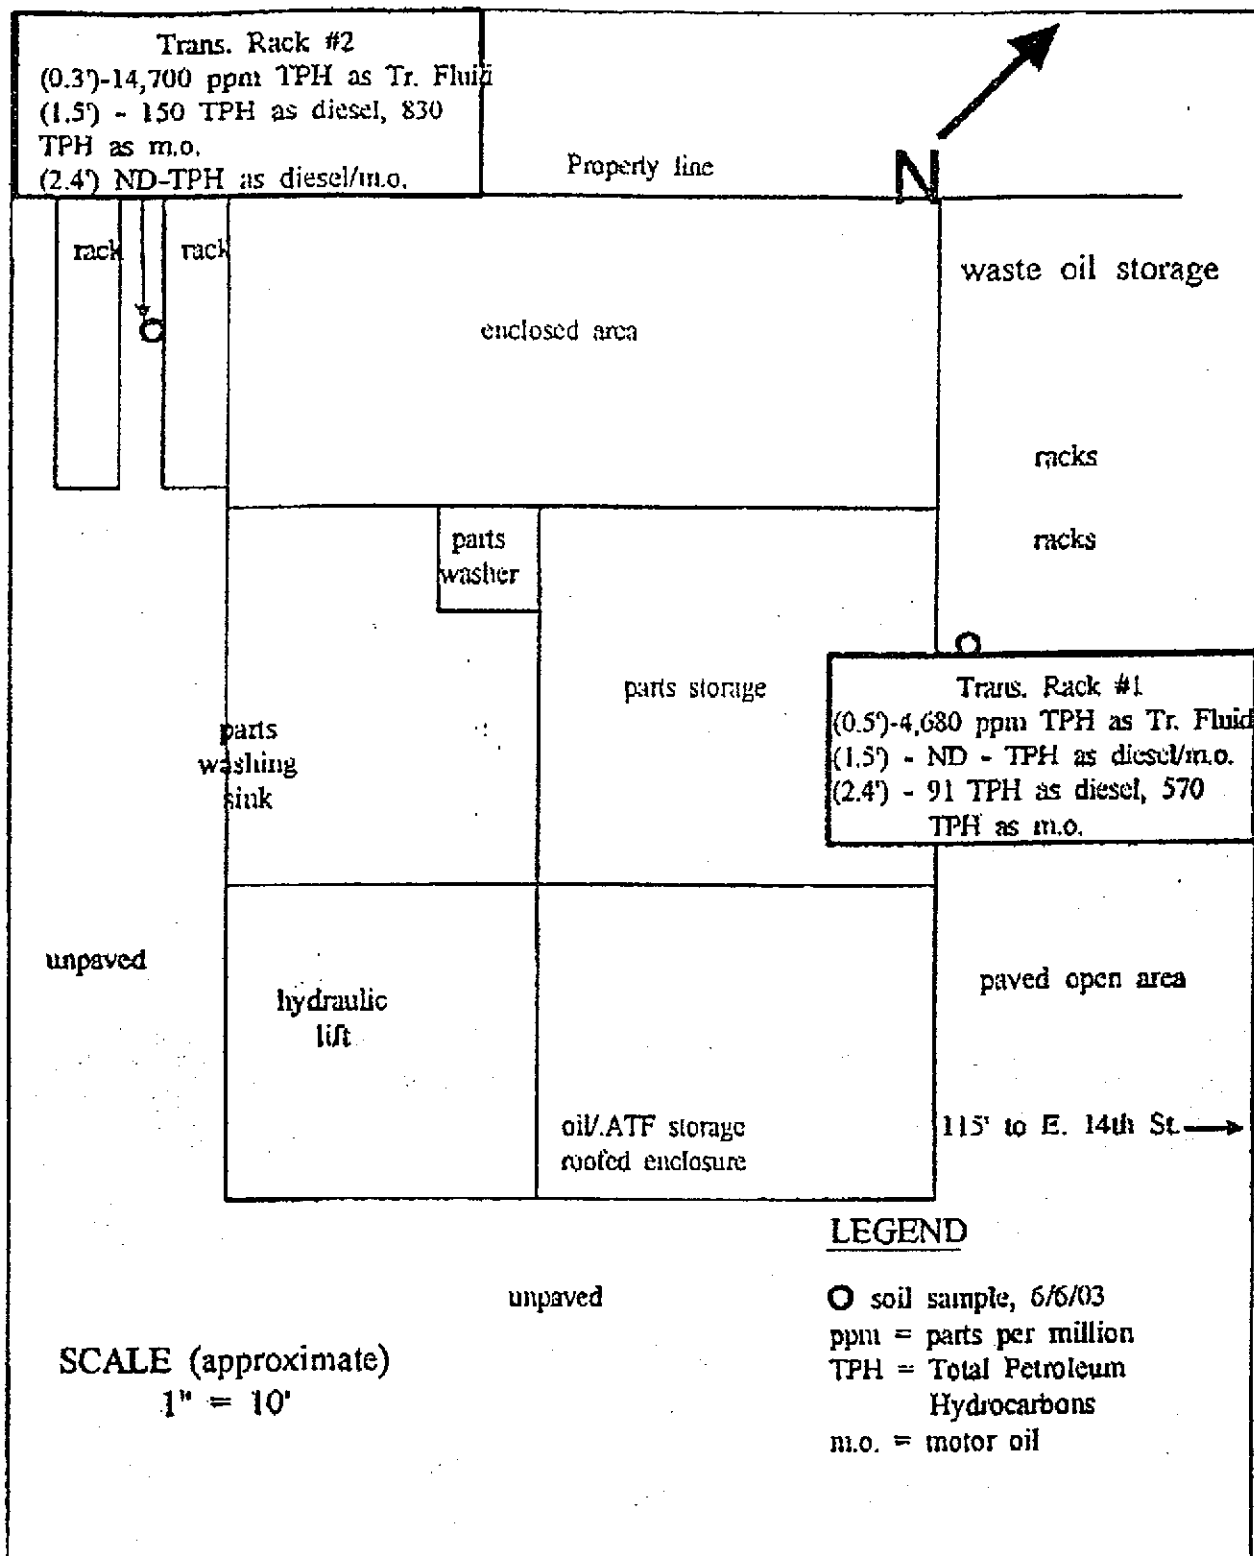
FIGURE 2
PROPERTY SITE PLAN

The soils encountered generally consisted of two or three inches of sand, silt, and gravel base material (fill) beneath the paved surface, which was underlain by dark brown clayey silt. No obvious evidence of contamination or odors was observed in these borings, except at the transmission racks in the unpaved area, where visible oil and grease was observed on the surface of the soil. No fill material was present at this location, which is entirely unpaved. The locations of the borings are shown on Figure 2.

The analytical results are summarized on Table 1 and Figure 2. Copies of the laboratory analyses and the Chain of Custody documentation are attached to this report.

The sidewall sample taken at Trans Rack #1 at 1.5 feet bgs was non-detected for TPH as transmission fluid. The sample taken from the bottom of the excavation at 2.4 feet bgs had a concentration of TPH as transmission fluid of 570 ppm. The sidewall sample for Trans Rack #2 at 1.5 feet bgs had a concentration of 830 ppm, and the bottom sample at 2.4 feet had no detected concentration.
