**JAY-PHARES CORPORATION***Commercial Real Estate Development*

**FAX MEMORANDUM**

RE: Soil Samples Laboratory Results  
Under Shoe Repair and Breezeway  
Football Square, Oakland, CA

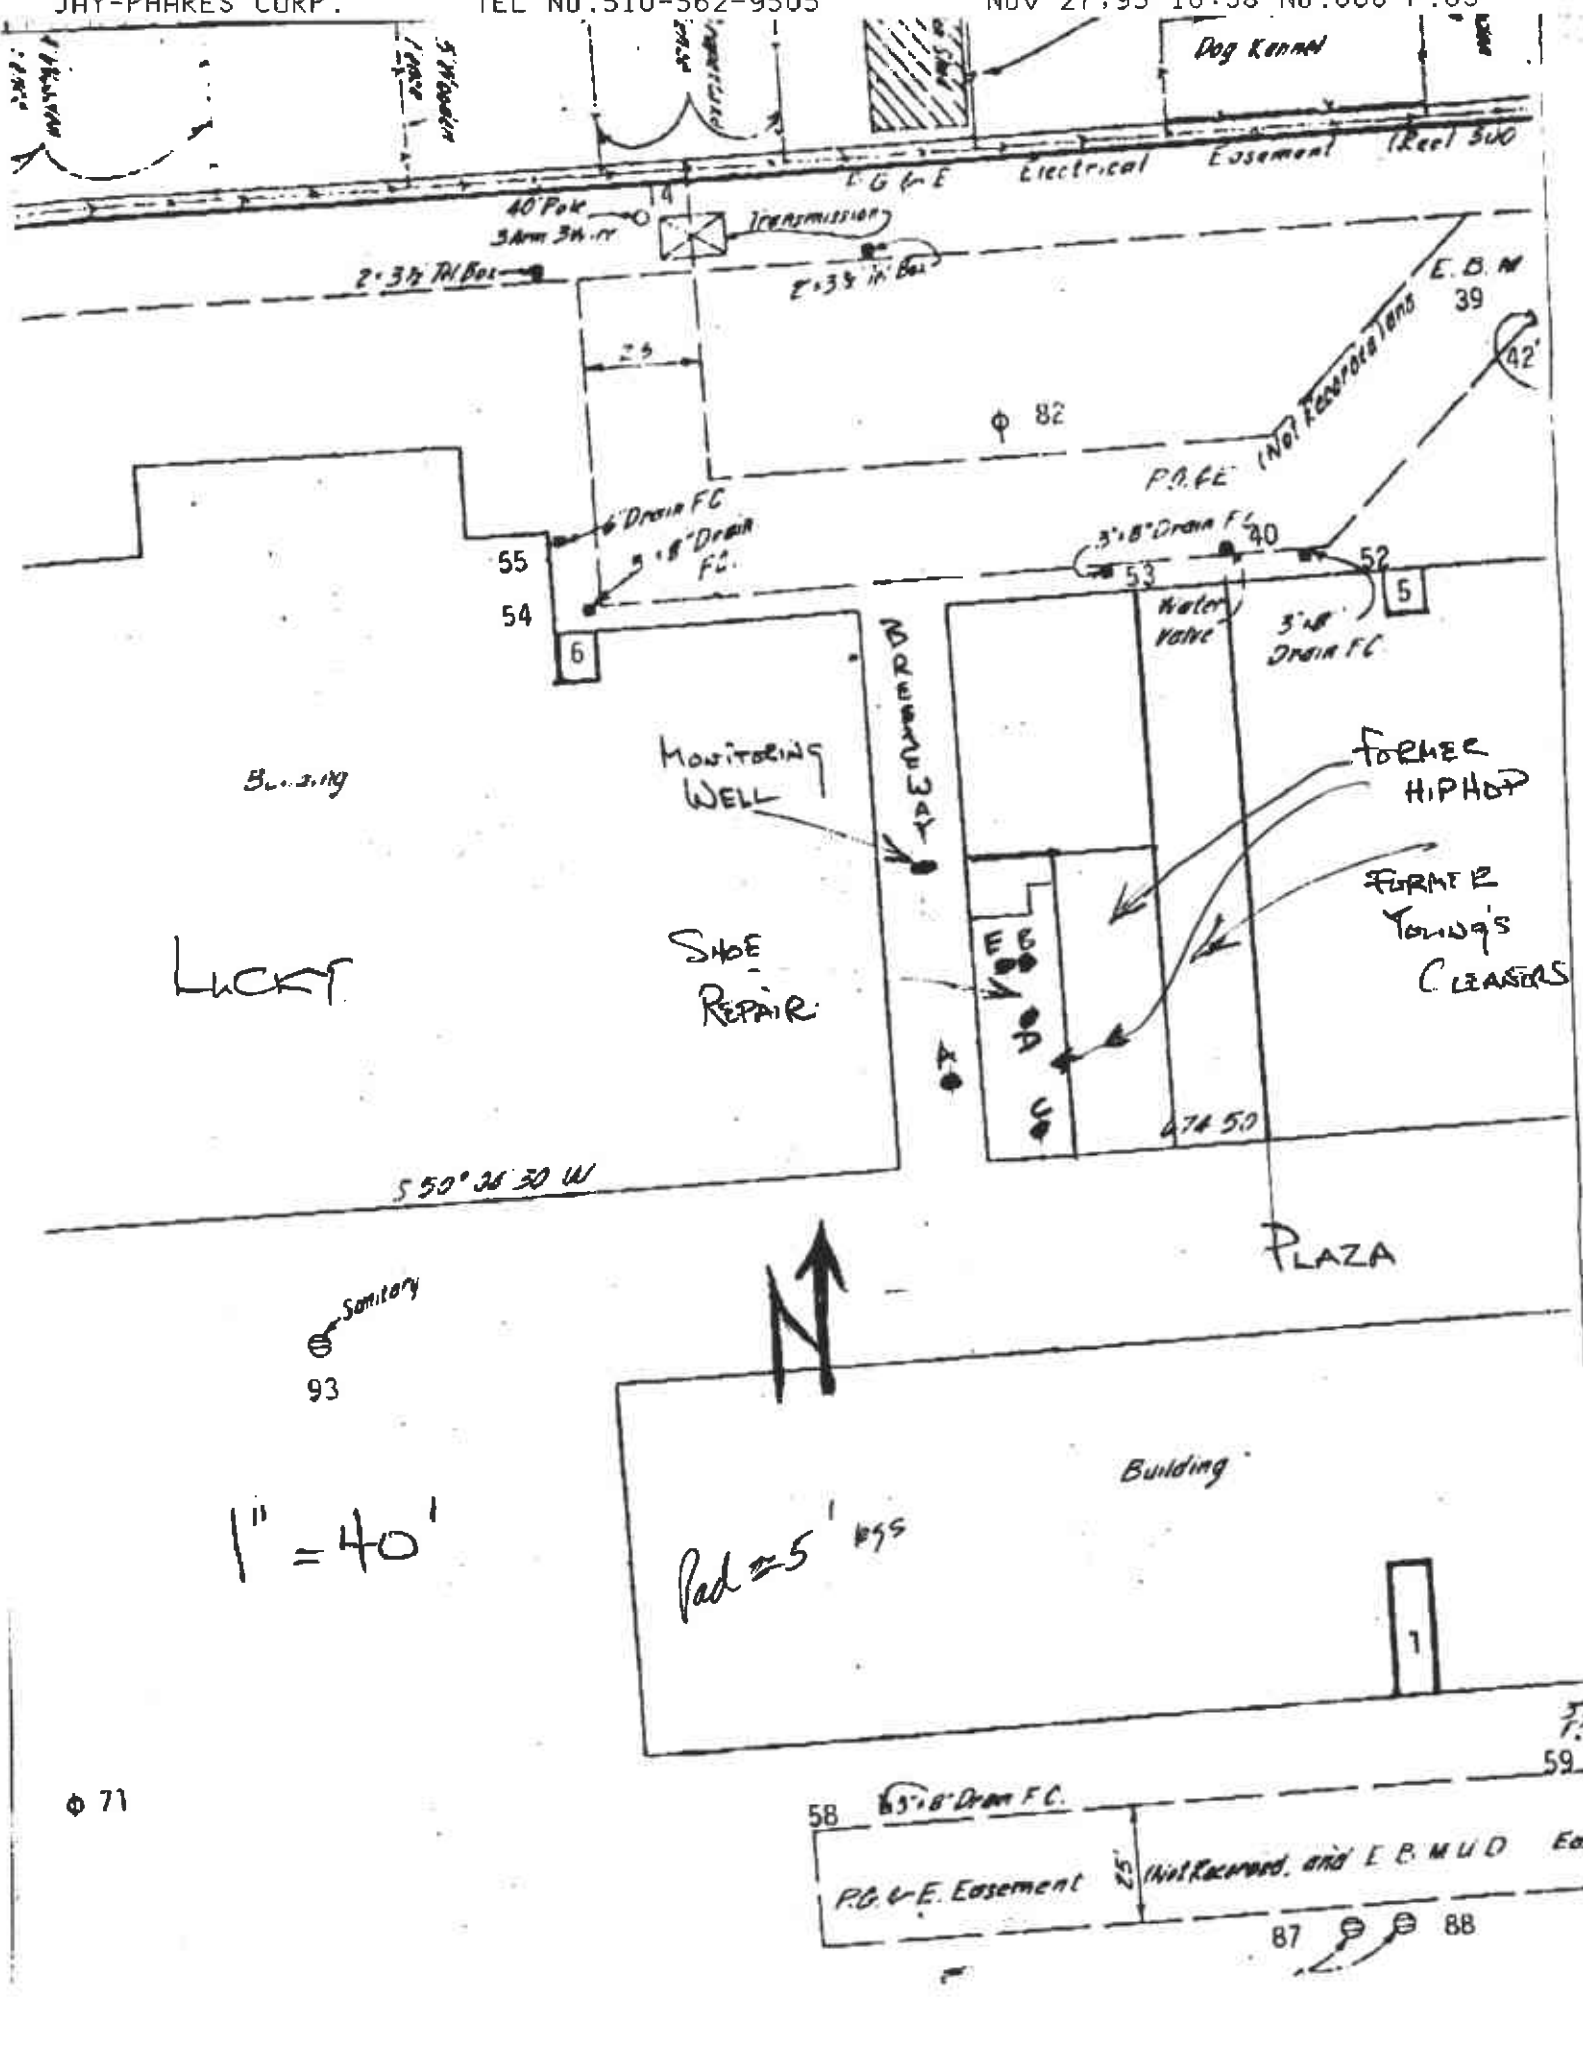
Soil Samples  
27-Nov-95

Unfortunately, however, these new test results would seem to indicate the "PERC" traveled across a subterranean slab which underlays the existing building, and as a result, soils contamination above "action levels" has extended farther west than originally anticipated. The good news is the contamination seems not to have penetrated below the slab in significant concentrations (See Sample D).

SAMPLE	LOCATION	DEPTH FROM FF	PARTS/BILLION CONTAMINATION LEVELS	
A	Breezeway 18' North of South entrance 6' West of East Wall	5'	1,2 Dichloroethene Chloroform Trichloroethene Tetrachloroethene	19 700 1500 <u>570</u> 2789
B	Under Shoe Repair 7' West of East Wall 43' No. of South (Frontwall)	5'	1,2 Dichloroethene Chloroform Trichloroethene	180 1400 1600 <u>3180</u>
C	Under Shoe Repair 7' West of East Wall 5' North of south (Frontwall)	5'	1,2 Dichloroethene Chloroform Trichloroethene Tetrachloroethene	44 2100 1600 500 <u>4244</u>
D	Under Shoe Repair 7' West of East Wall 30' North of South Wall	9'	1,2 Dichloroethene Chloroform Trichloroethene Tetrachloroethene	26 180 37 15 <u>258</u>
E	Under Shoe Repair 12' West of East Wall 43' North of South Wall	5'	1,2 Dichloroethene Chloroform Trichloroethene Tetrachloroethene	25 650 360 970 <u>2005</u>

We must now evaluate remediation alternatives. Our structural engineer is now analyzing the consequences of (i) removing the concrete floor under the shoe repair and (ii) excavating both under the shoe repair and then beyond into the breezeway. We expect going beyond the west wall of the shoe repair will result in major shoring, concrete underpinning of bearing columns along that wall, and other extraordinary expenses we are not currently able to afford economically. Nevertheless, if we continue excavating into the breezeway and reach a "below action limits" condition, we will have completed our contaminated soils remediation obligations which combined with a benign risk assessment relative to underlying ground water should create conditions conducive to redevelopment financing and the construction of a new Lucky Supermarket.

Alternatively, we believe a more practical approach may be to excavate only under the shoe repair and wait until construction of the new Lucky Store until excavating in the breezeway area, or even farther westerly under areas upon which other existing buildings are now located. A preliminary redevelopment site plan follows. Please note we propose to locate the new Lucky over a portion of what is now the breezeway and that the buildings west of the breezeway will be demolished to accommodate construction of the new Lucky. Given the apparent shallow depth of the contamination, its known northerly limit (please note the monitoring well previously dug in the breezeway found no soil or water contamination in any significant concentrations), and the likely limited additional contamination westerly from the breezeway, awaiting construction of the new Lucky for "final" clean up would certainly be our most economic approach and one likely to satisfy our lenders - if it is satisfactory to American Stores and its consultants.
