Reporting Unauthorized Release

1713 Webster Street Results (Former Auto Repair Facility)

649 Pacific Avenue Results (Former Dry Cleaners)

March 2003 Soil and Groundwater Analytical Results Petroleum and Aromatic Hydrocarbons 649 Pacific Avenue (Former Dry Cleaner Tenant Space), Alameda, California

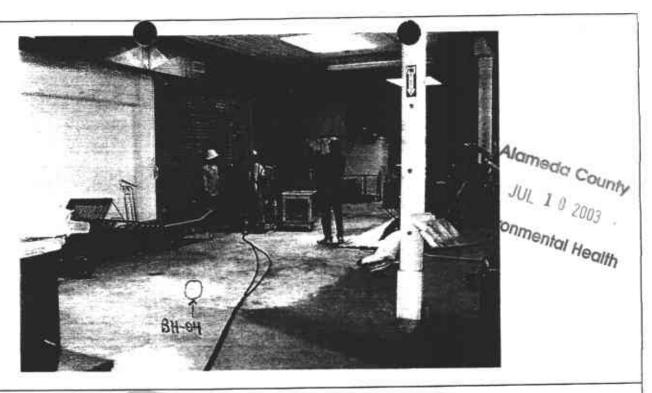
Photographer: Bruce Rucker Photo No.: 03

Subject: Drilling rig at BH-03 location (BH-04 location is shown in foreground).

Site: 649 Pacific Avenue, Alameda, California

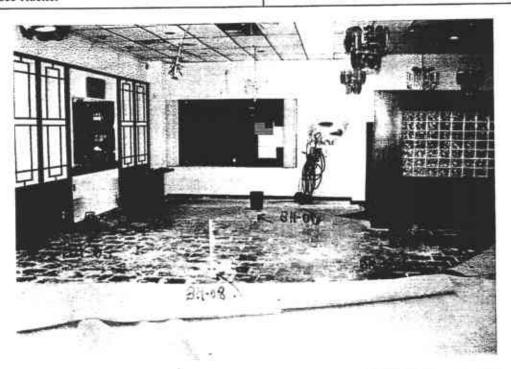
Photographer: Bruce Rucker Photo No.: 04

Subject: Interior of tenant space showing borehole locations.

Site: 1713 Webster Street, Alameda, California

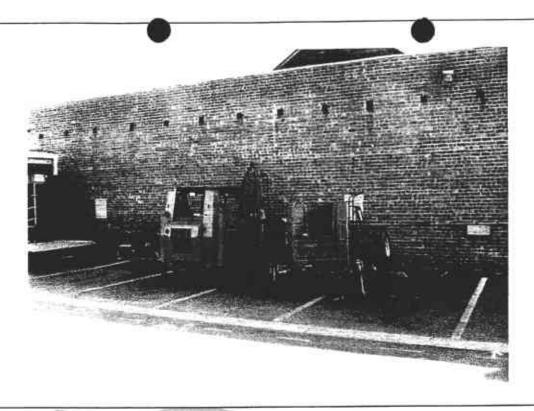
Photographer: Bruce Rucker Photo No.: 01

Subject: Drilling rig at BH-01 location, exterior parking lot.

Site: 649 Pacific Avenue, Alameda, California

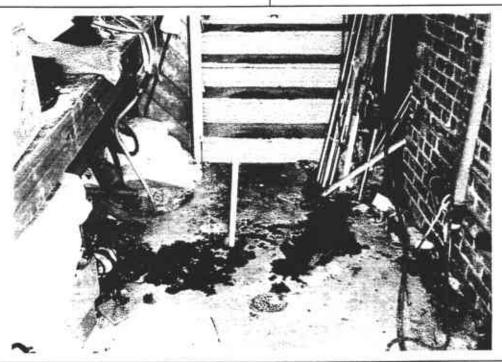
Photographer: Bruce Rucker Photo No.: 02

Subject: Temporary well casing at BH-02 in hallway leading to second-floor tenant space.

Site: 647 Pacific Avenue, Alameda, California
