A Report Prepared For:

PRELIMINARY SITE ASSESSMENT HARBOR BAY LANDING SHOPPING CENTER ALAMEDA, CALIFORNIA

October 18, 1993

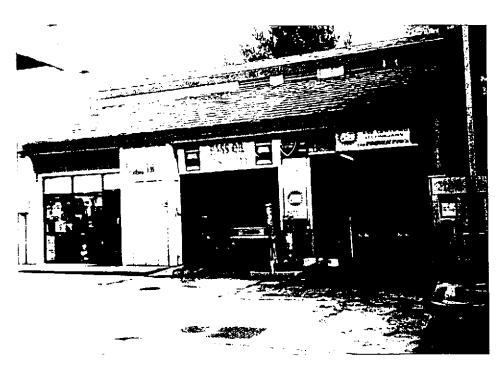
Photo 3. BP service bays

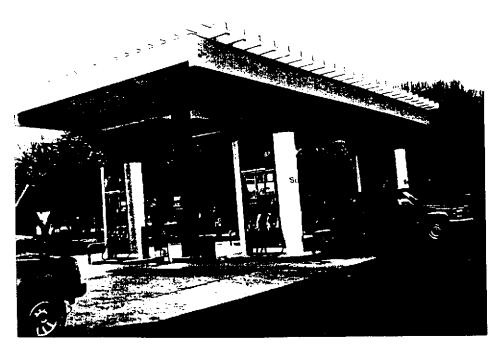
Photo 4. BP fueling islands

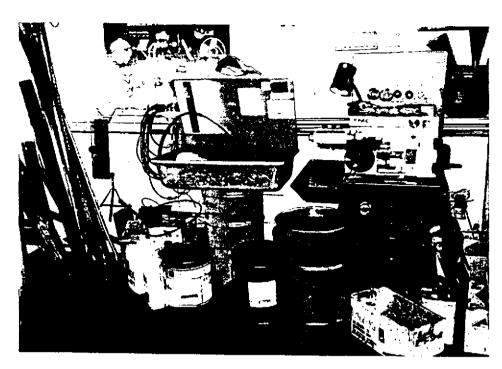
Other hazardous waste and hazardous materials present at the site include 5 gallons of waste coolant, a 55-gallon drum containing used oil filters, a Safety Kleen degreasing machine, approximately 20 gallons of gear lubricant, used batteries, brake fluid, and assorted oils and greases (Refer to Plate 6, Photo 5). According to Mr. Kim, waste oil is removed from the site approximately every five months by Artesian Oil Recovery, located in Oakland. A 55-gallon drum of waste oil filters is reportedly removed periodically by Big Sky Enterprises of Benecia. Used batteries are reportedly picked up and transported off-site by The Parts House, located in Oakland.

Photo 5. Safety Kleen degreaser located in BP service bay

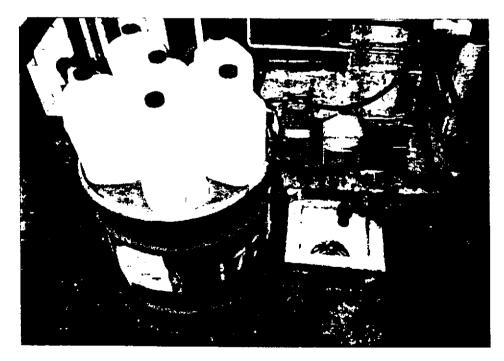
The dry cleaning equipment is located on a concrete slab floor and adjacent to a floor sink (Refer to Plate 6, Photo 6). A 20-gallon drum used for storing waste sludge material and a 55-gallon drum containing approximately 30 gallons of raw PCE are also located adjacent to the floor sink. The 55-gallon drum is elevated on a metal support and has tubing connected to a spigot for dispensing purposes (Refer to Plate 7, Photo 7). Two filters are located adjacent to the dry cleaner (Refer to Plate 7, Photo 8). The floor surface in the vicinity of the dry cleaner and hazardous materials storage is moderately stained and has minor cracks.

Waste cooling water is discharged to the sanitary sewer via the floor sink. No direct evidence of PCE releases to the floor sink were found, however a potential exists for leaks in subsurface piping to provide a conduit for PCE to be released to shallow soils and/or groundwater beneath the site. Section 9.0 provides recommendations for a Phase II investigation to evaluate whether significant releases of PCE to the sites' subsurface have occurred from this facility.

Photo 6. Floor sink and hazardous material storage located adjacent to drycleaning machine in Red Hanger Kleaners

In order to address the potential releases of dry cleaning chemicals from Red Hanger Kleaners, PES recommends a Phase II Environmental Assessment (Phase II) be performed. The proposed scope of work for the Phase II includes soil boring and hydropunch groundwater sampling at three locations adjacent to the sanitary sewer line outside the dry cleaning establishment. We recommend that groundwater samples be analyzed for halogenated Volatile Organic Compounds by EPA Test Method 8010. This scope of work is adequate to evaluate whether a significant release of PCE has occurred to the shallow groundwater as a result of operations at the dry cleaners. This recommendation is based on:

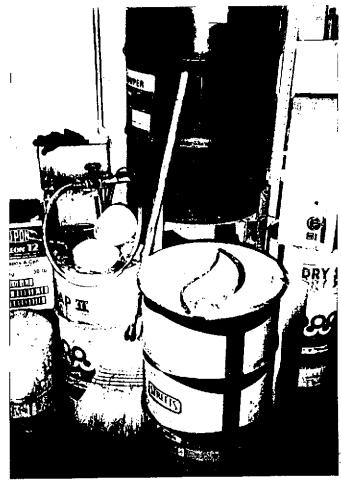
Fuller Supply Company (Fuller) provides raw PCE to the site and pumps the material directly into the dry cleaner. Additionally, Fuller occasionally supplies the facility with an extra 55-gallon drum of raw PCE which Red Hanger Kleaners personnel periodically use to replenish dry cleaner tanks. Approximately every two months. Technichem removes hazardous waste including used filters, wastewater, and waste sludge from this facility. According to file information at ACDEH, this facility has been cited for failure to label hazardous waste drums with the start accumulation date and for failure to submit a Hazardous Materials Management Plan-Part II.

Photo 7. 55-gallon drum containing raw PCE (in green drum) in drycleaning facility

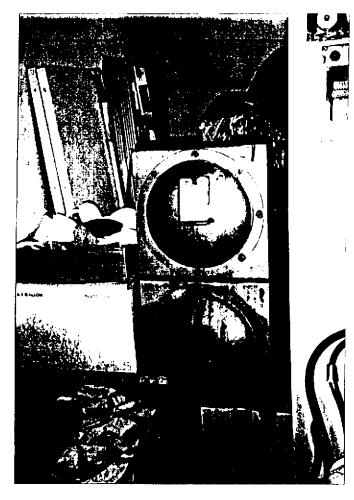
Photo 8. Filters located adjacent to drycleaning machine
