**PHASE I
ENVIRONMENTAL ASSESSMENT
REPORT
ISLAND CITY GUN CLUB
500 MAITLAND DRIVE
ALAMEDA, CALIFORNIA**

May 17, 1990

Kleinfelder Job No. 10-2081-01

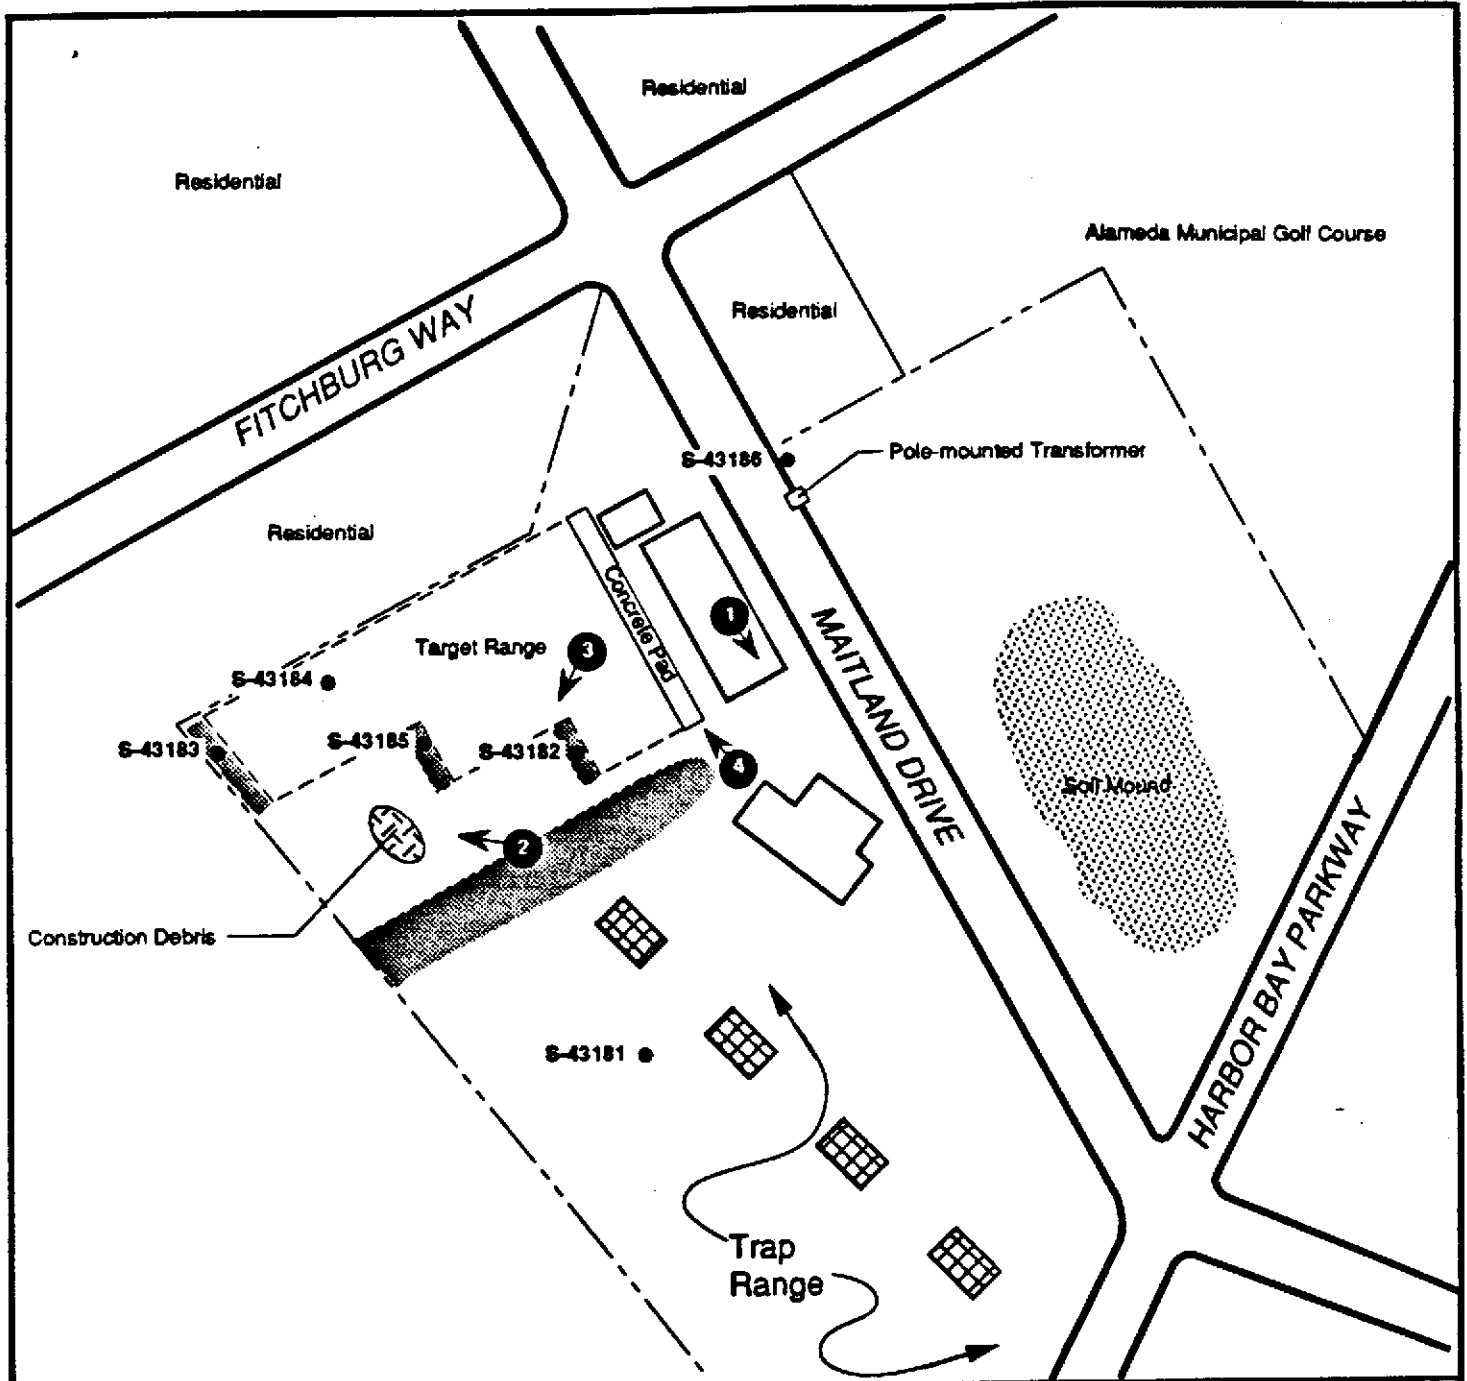
KLEINFELDER	SITE PLAN HARBOR BAY ASSOCIATES MAITLAND DRIVE AT HARBOR BAY PARKWAY, ALAMEDA, CALIFORNIA	PLATE 2
DRAFTED BY: L. Sue DATE: 5-21-90		
CHECKED BY: J. Friedman DATE: 5-21-90	PROJECT NO. 10-2081-01

The results of the six soil samples analyzed for CAM-17 metals can be found in Table 1. In two of the samples analyzed, 43182 and 43183, the levels of lead exceeded the Total Threshold Limit Concentration (TTLC) value. In one of the two samples, 43183, the level of copper also exceeded the TTLC value. The TTLC value is defined as the concentration at which a substance is classified as hazardous by Title 22 of the California Administrative Code. See Appendix B for the laboratory analyses and chain-of-custody documents for the soil sample analyses. It should be noted that both of the samples that tested high for lead were taken from berms in the pistol/rifle target range (Plate 2).

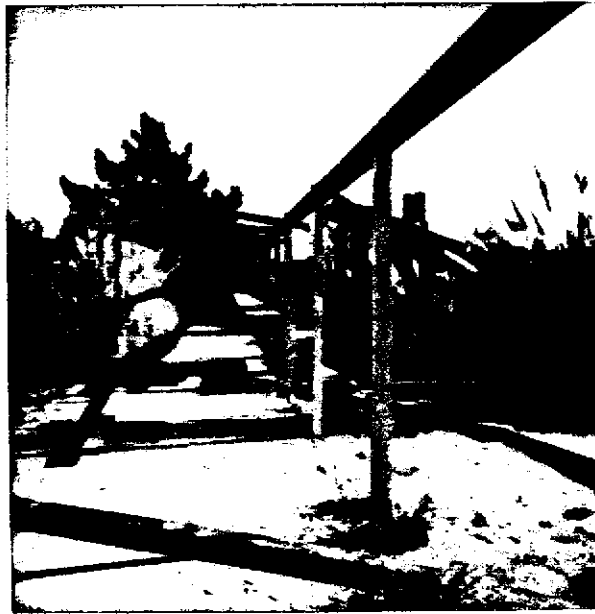
The site reconnaissance revealed numerous lead slugs in the target range berms during the collection of the soil samples. Casings for ammunition were also noted to be plentiful in the gravel located east of the concrete covered walkway.

Photo 4. View of concrete walkway facing the rifle range.
