October 25, 2000  
RGA Job # HSHI5835  
Report 0164.R6

**RE: MONITORING WELL REPLACEMENT REPORT**  
Hardage Construction Corporation Site  
5800 Shellmound Street  
Emeryville, CA 94608

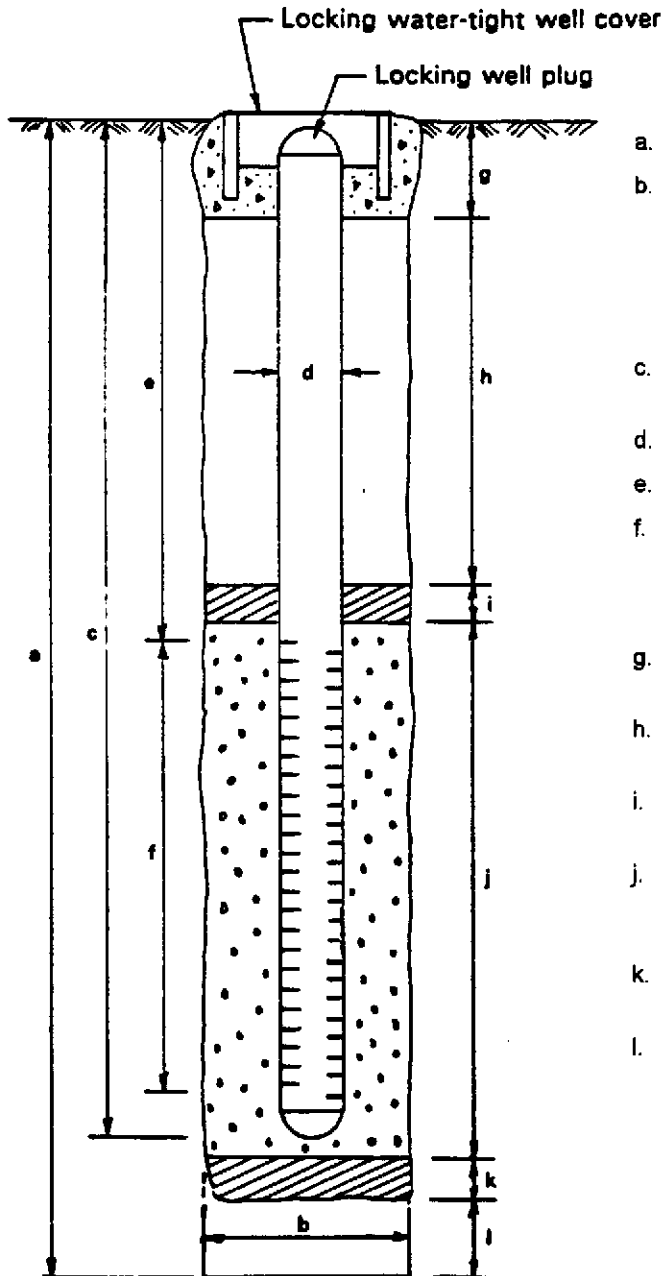
## WELL CONSTRUCTION DETAILS

BORING/WELL NO. ATD1B  
TOP OF CASING ELEVATION TBD  
GROUND SURFACE ELEVATION TBD  
DATUM TBD

a. Total Depth 10 ft.  
b. Diameter 8 in.  
Drilling Method Hollow Stem Auger

c. Casing Length 10 ft.  
Material Schedule 40 PVC  
d. Diameter 2 in.  
e. Depth to top perforations 5 ft.  
f. Perforated length 5 ft.  
Perforated interval from 5 to 10 ft.  
Perforation type Factory Slot  
Perforation size 0.010 inch  
g. Surface sanitary seal 2.5 ft.  
Seal material Neat cement grout  
h. Sanitary seal 0 ft.  
Seal material \_\_\_\_\_  
i. Filter pack seal 1 ft.  
Seal material Bentonite chips  
j. Filter pack length 6.5 ft.  
Filter pack interval from 3.5 to 10 ft.  
Pack material #2/16 Lonestar sand  
k. Bottom seal 0 ft.  
Seal material \_\_\_\_\_  
l. Slough in bottom of borehole 0 ft.
