BROWN AND CALDWELL

May 23, 1985

Subject: Western Forge & Flange Company  
Albany Site Project

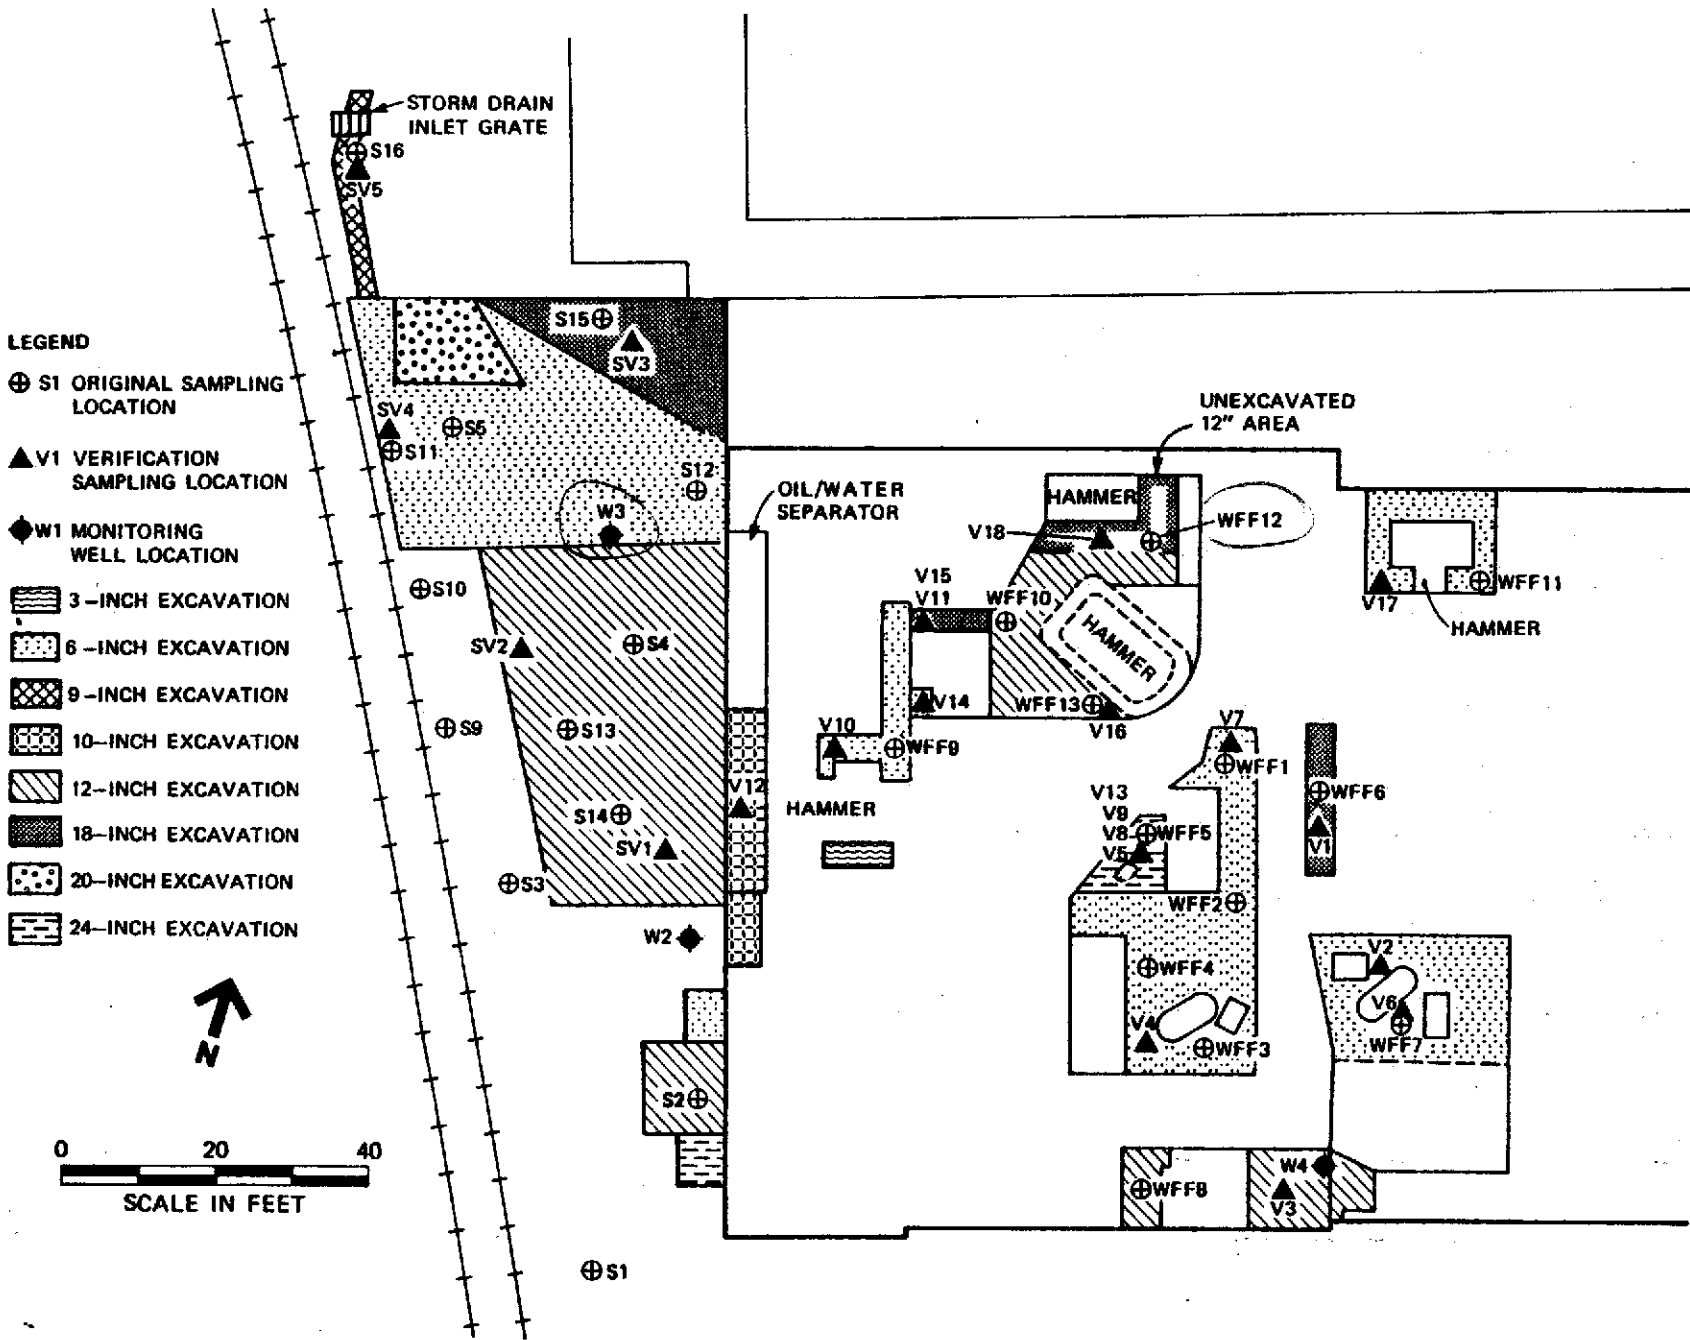
Figure 2 Sampling Locations

Soils were excavated to a 12-inch depth around the base of the 14,000-pound hammer (near WFF 12 on Figure 2). Verification sample V18 (location shown on Figure 2) was taken on May 10, 1985, at a 12- to 18-inch depth. The sample was analyzed for copper, lead, nickel, and oil and grease. Attached is the analytical report. All analyses show contaminant concentrations below the cleanup levels established for the project except for nickel. The nickel concentration of 1,000 mg/kg is at the cleanup level of one-half total threshold limit concentrations in 22 CAC 66699.

1. Removal of drum solids and soils excavated from around the 14,000-hammer to an approved disposal site.
2. Collection and analysis of an additional groundwater sample from well W3 at the end of the dry season.
3. Development and execution of a maintenance program for the facility to ensure accumulated waste oil and other hazardous materials are removed from the site in a timely manner according to the regulations.

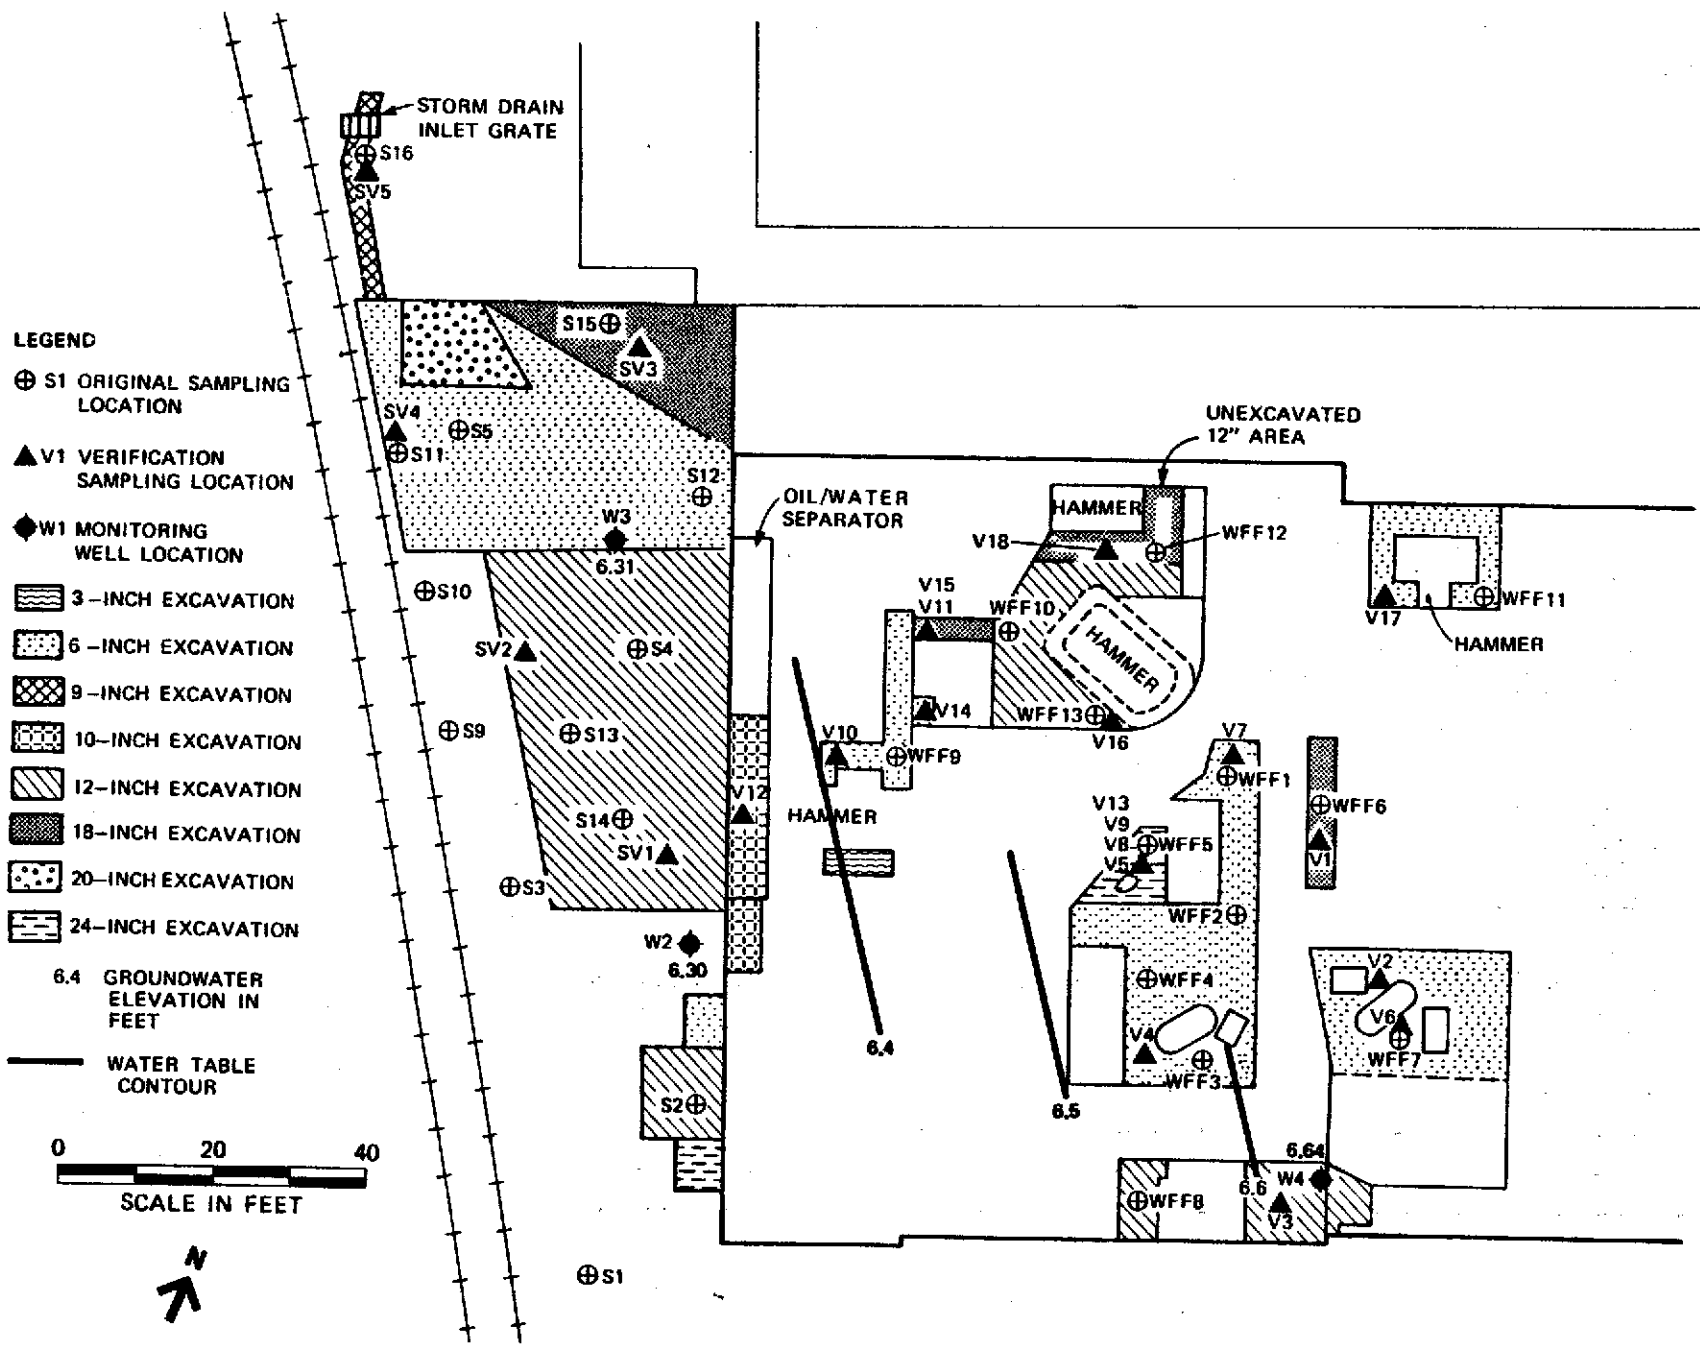
Figure 3 Water Table Configuration, May 23, 1985

Water table elevations measured in monitoring wells W2, W3, and W4 on May 23, 1985, are contoured on Figure 3. The local groundwater gradient is approximately 0.005 foot per foot to the west-southwest, toward San Francisco Bay.
