September 14, 1999

Re: 4331-39 MacArthur Blvd., Oakland, CA - Magnetometer Survey Results

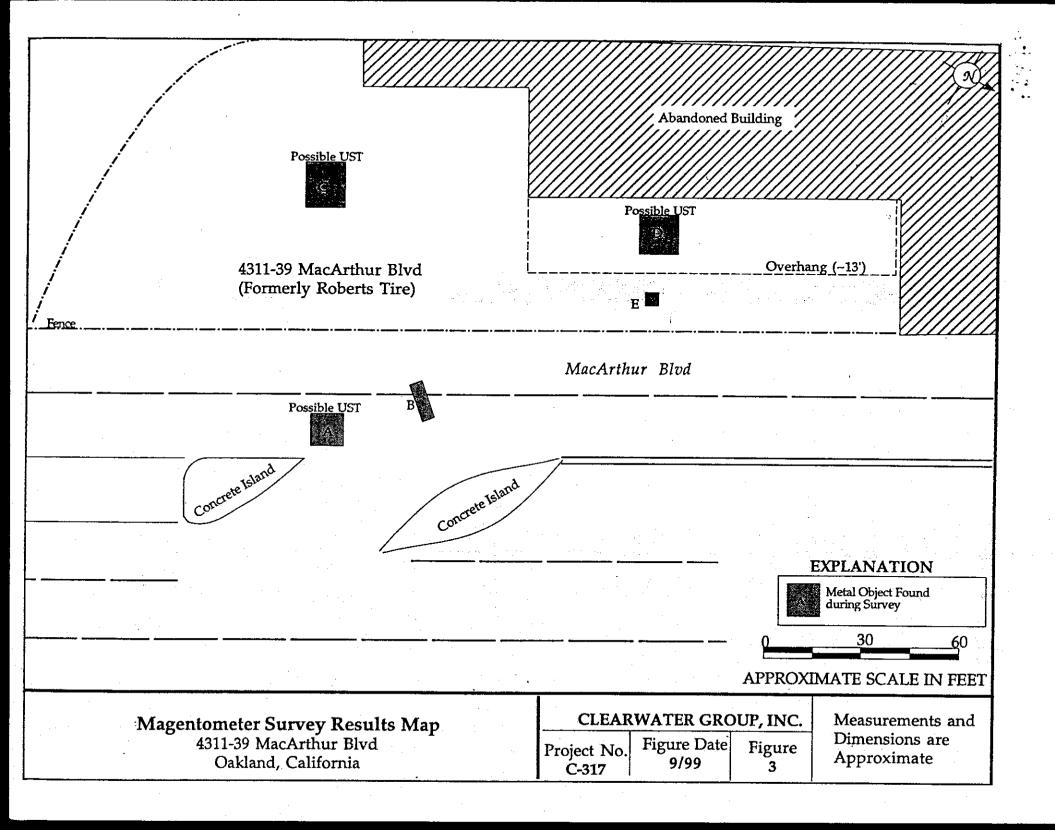
The results of the survey found five noteworthy metal-bearing objects in the survey area. Of the five objects, three could possibly be USTs. The five objects are shown on Figure 3, and are

denoted A-E. As shown on Figure 3, two of the objects were located in MacArthur Blvd., where the former UST area was suspected to be. As per CU one of the objects (B) in the street looked like an I-beam and the other (A), without certainty, could be a small 500g tank. The other three objects were located on the subject site. The object labeled E looked like it could be a buried manhole, and was definitely too small to be a UST. However, the other two objects C and D could be USTs, although the marked-out shapes are not of the size and shape typical of modern day USTs. However, irregular size and shape USTs do exist and they should not be discounted as USTs due to this. Clearwater asked CU if the approximate depths of the objects could be determined and Baul indicated that the objects in the street were at depths of about 6 feet below grade (bg) and the ones on-site were shallower at ~ 3 feet bg, but these are only educated guesses based on instrument response and the information should not be strictly relied on. Photographs of the marked-out locations were taken after the completion of the survey and are included with this report.

The results of the magnetometer survey found five noteworthy metal-bearing objects on and adjacent to the subject site, three of which could possibly be USTs. Based on the size and shape of the objects found it can not be determined conclusively if the objects are USTs or not. Historic information indicates that USTs were once located in the surveyed area and documentation does not exist regarding their removal. Hence, it is possible that the objects located are USTs from the former fuel servicestation which operated at the subject site.
