Re: Phase I Environmental Site Assessment
3701 Martin Luther King Jr. Way
Oakland, California 94609

Phase I Environmental Site Assessment
3701 Martin Luther King Jr. Way
Oakland, California

November 21, 2002

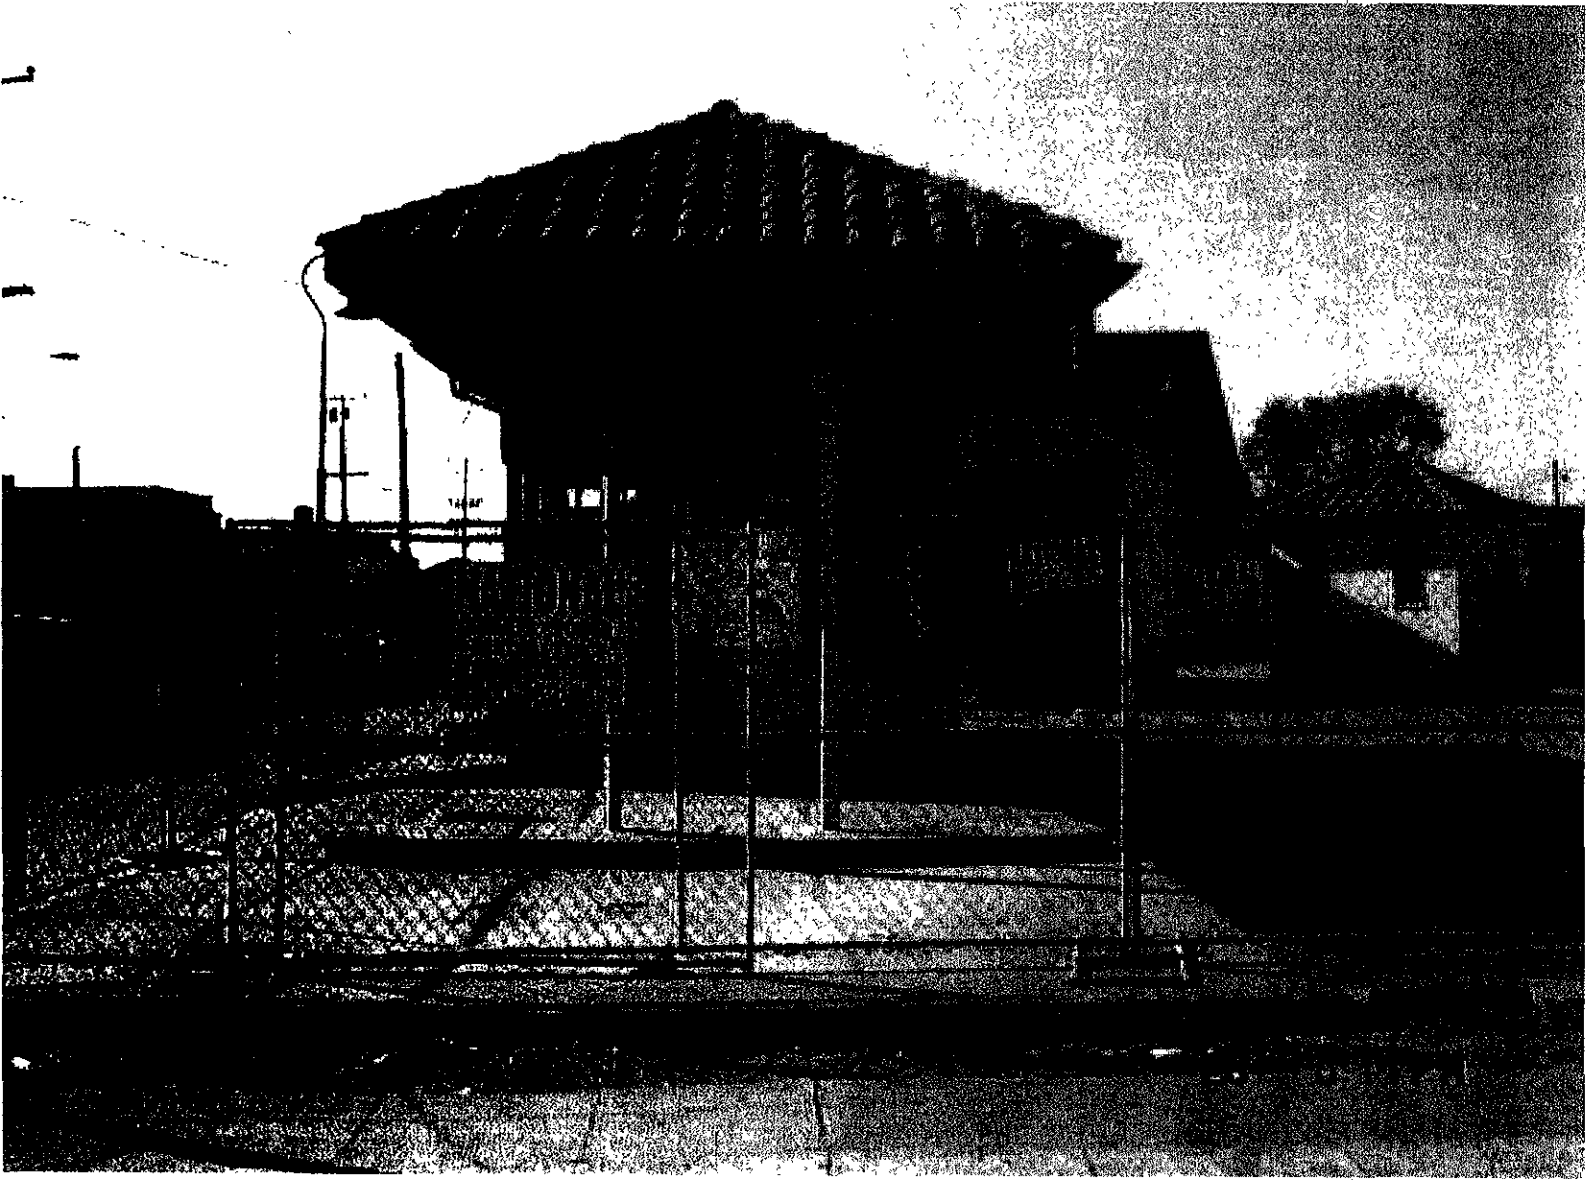
FIGURE 4

Photograph looking west from Martin Luther King Jr. Way. Photograph of the front of the Property showing kiosk, canopy, and fueling island curb. Vent pipes are seen on the roof of the canopy.

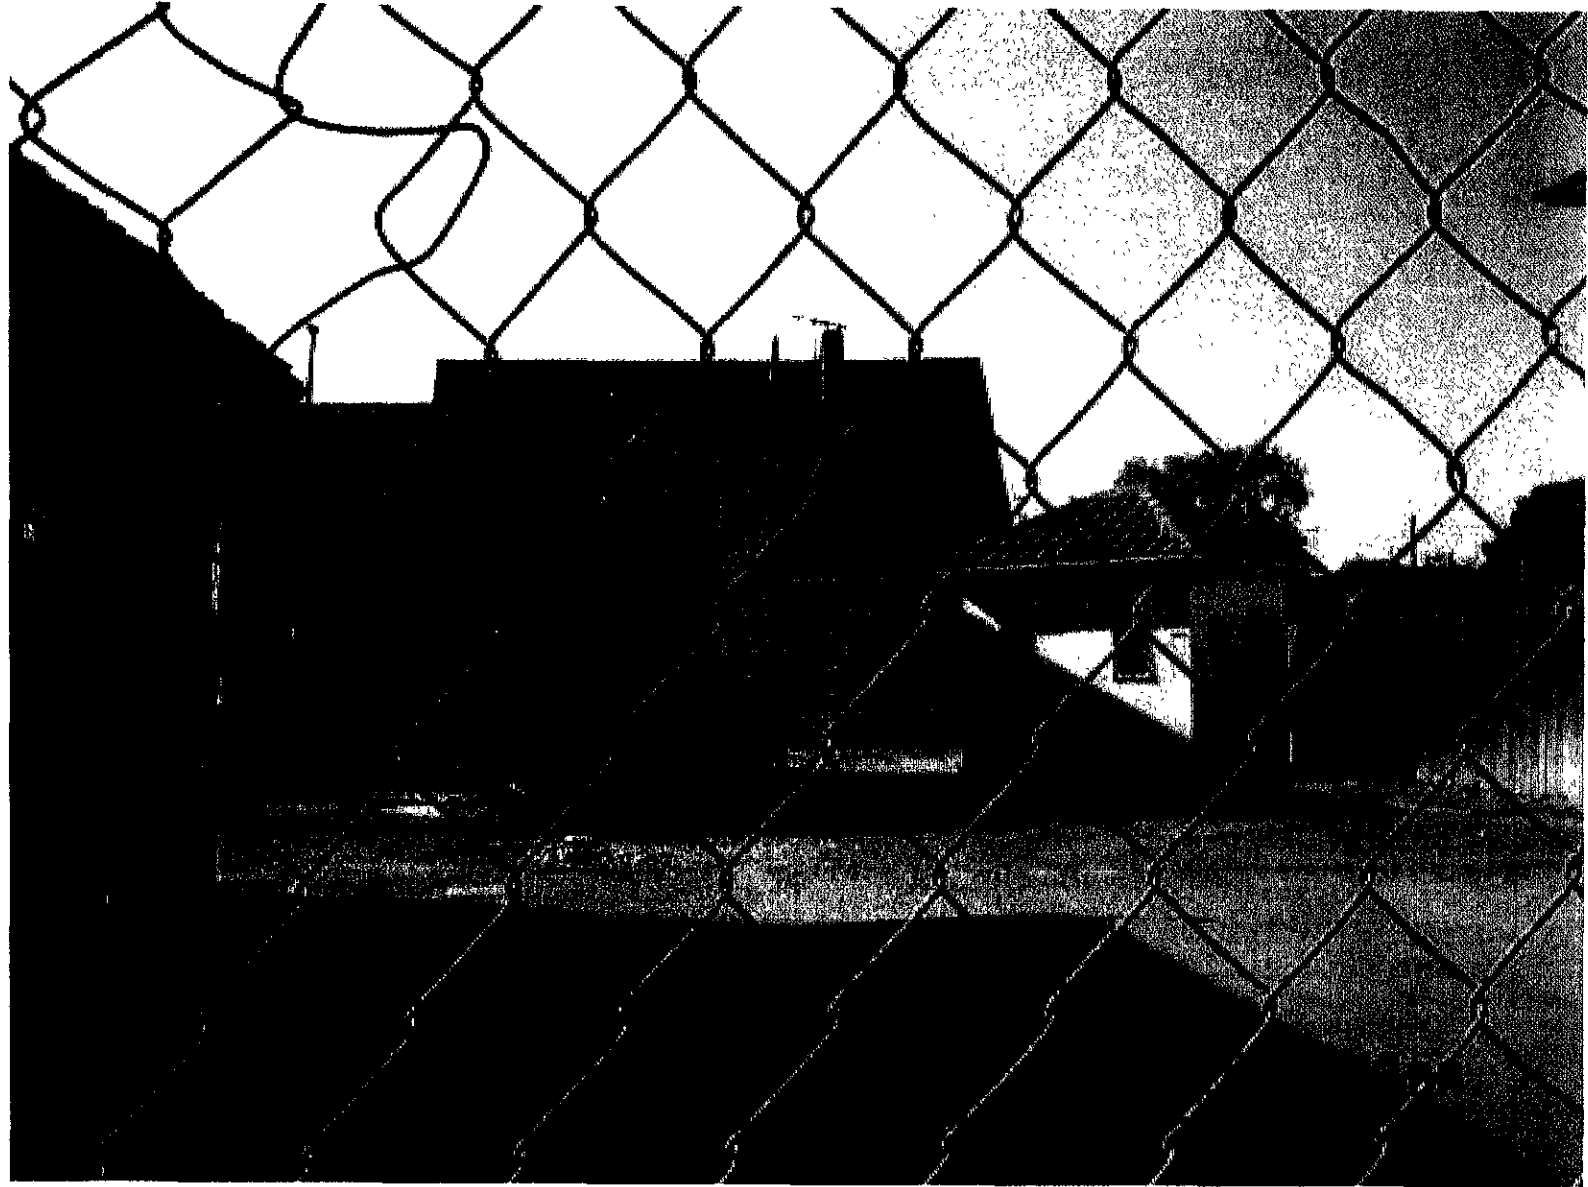
FIGURE 5

No natural surface waters were observed on the property during the site reconnaissance. No pits, ponds or lagoons were observed at the Property during the site reconnaissance. Potholes were observed in the asphalt driveway in front of the garage. It is likely that rainwater and wastewater runoff would be periodically retained in the depressions. The potholes are a result of cracking and eroding asphalt on the driveway.

Photograph looking west from Martin Luther King Jr. Way. Photograph of the front of the Property showing the garage and restroom. Notice the damaged asphalt driveway in front of garage.

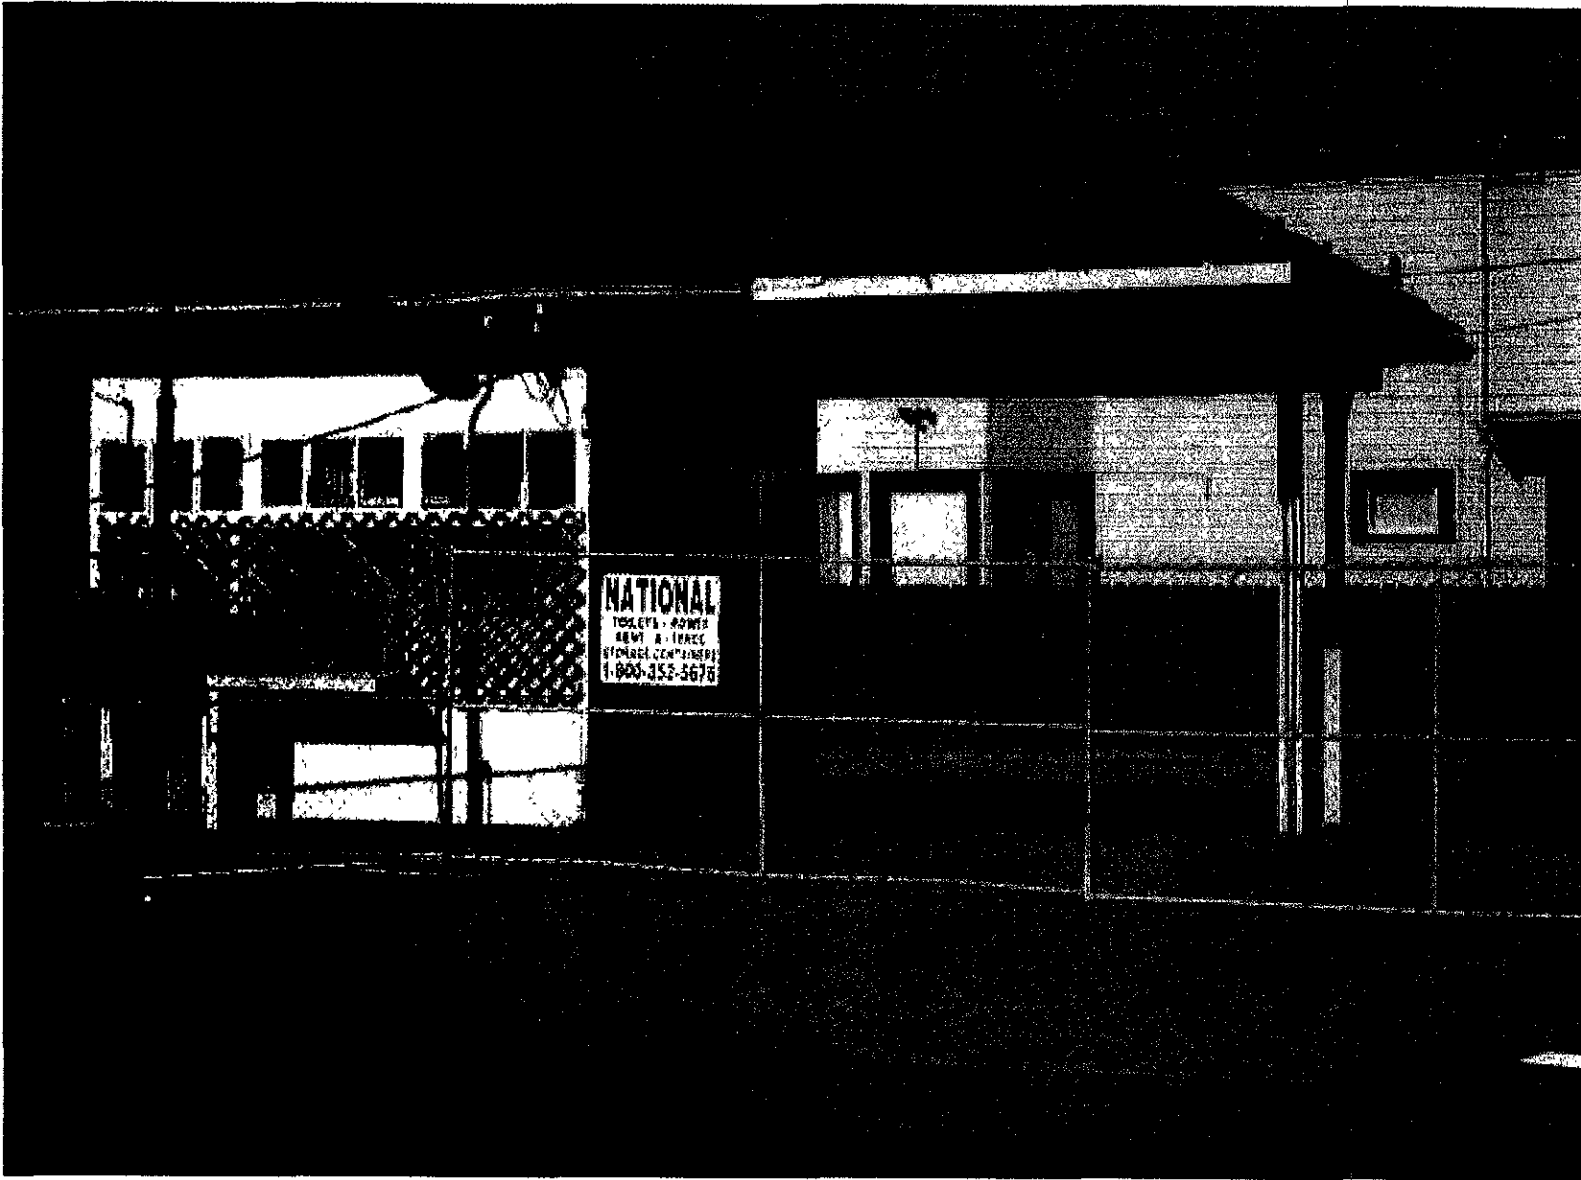
FIGURE 8

Screening sampling for lead was not included in Impact's scope of work for this Phase I ESA at the Property. Peeling and flaking paint was observed on both the inside and outside of the garage and outside of the kiosk.

Photograph looking west from 37th Street looking north. The photograph shows the south wall of the kiosk.

Impact recommends collecting an appropriate number of samples in the kiosk and repair garage to evaluate the potential presence of lead-based paint (LBP) and asbestos containing material (ACM) at the kiosk and garage.
