Report of Release  
and  
Interim Remedial Actions  
Report  
for  
Diesel Fuel Release  
located at:

**FCI DUBLIN**  
Federal Correctional Institution  
5701 8th st - Camp Parks  
Dublin, CA

by  
McElligott Consulting  
June 10, 2008

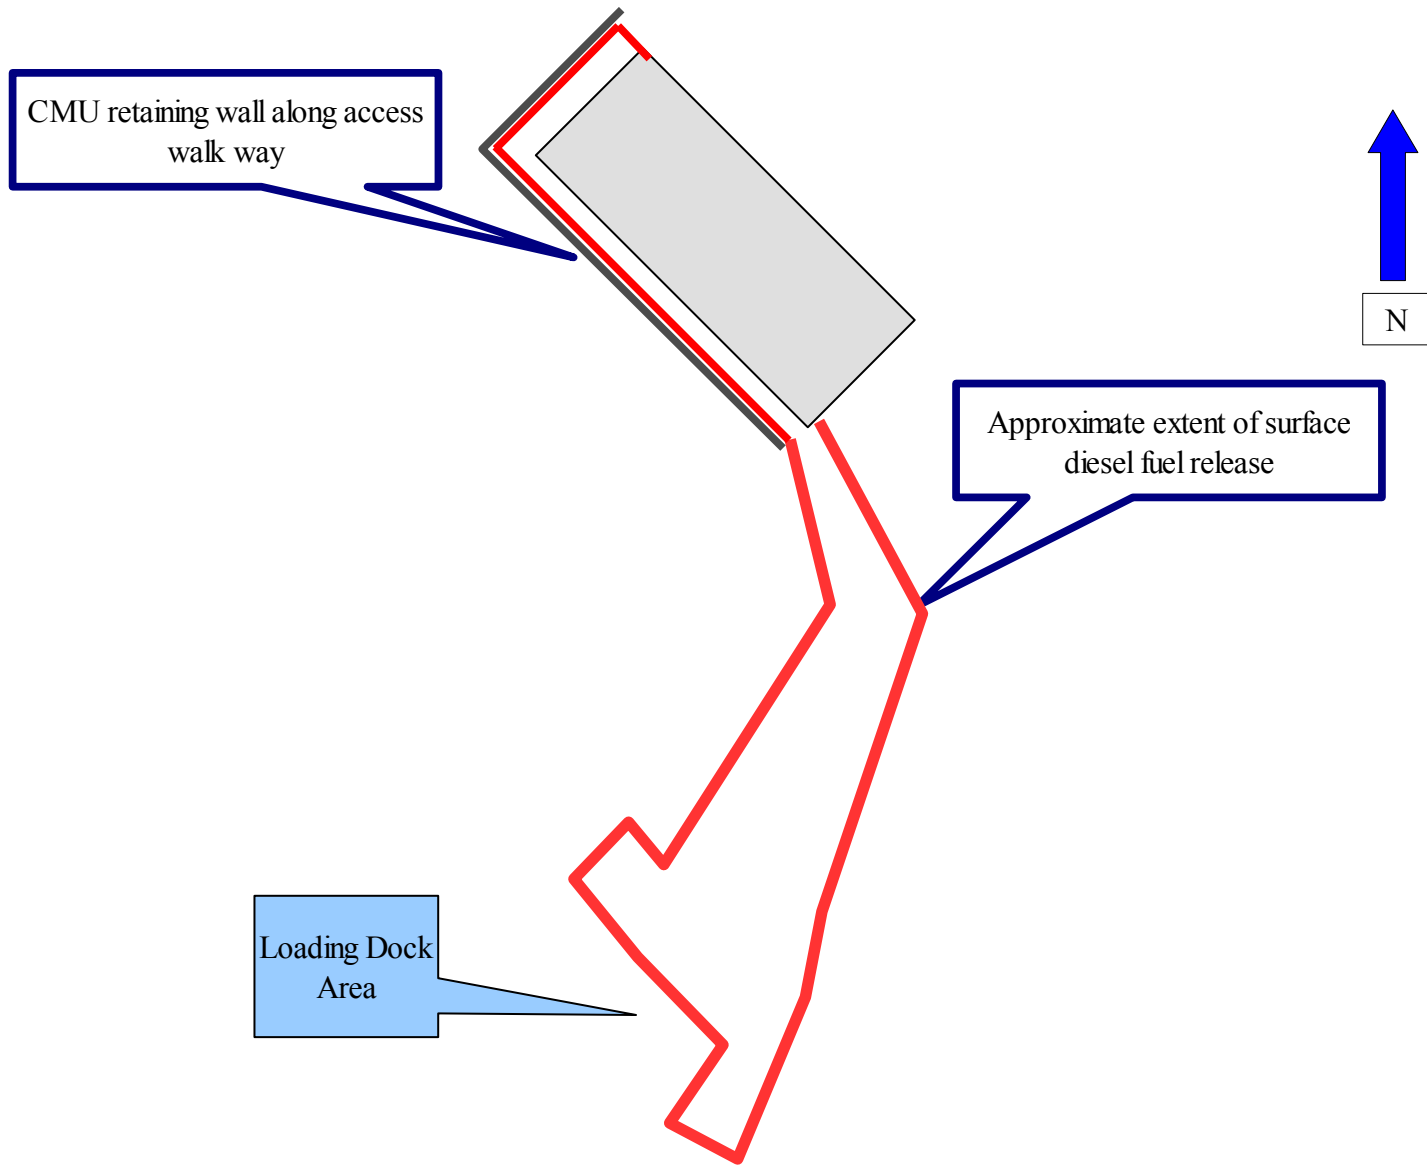
Figure 5: Detail sketch of area of release. Generator building (including storage tank) is 26 ft wide by 40 ft long  
Approximate Scale: 1" = 20'

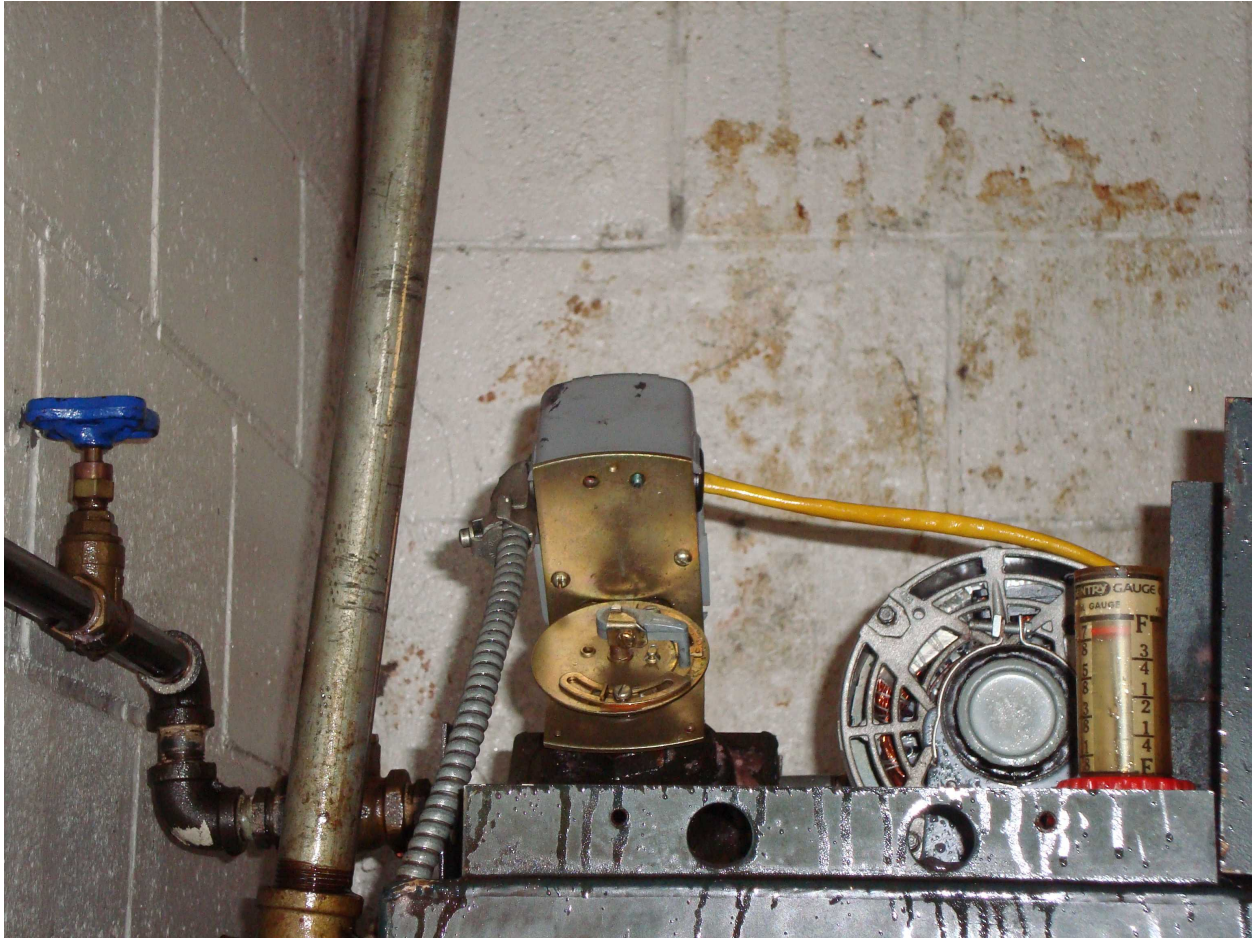
The root cause of the release is believed to be the failure of the flow switch of the emergency generator day tank to shutdown the refill pump. Due to the failure of the switch, the refill pump continued to pump diesel from the main 3,000-gallon storage tank located in the adjacent room of the emergency generator building and caused the day tank to overflow. Diesel escaped from the day tank through the cap vent hole and the tank vent pipe.

Photo 3: Day tank level sensor refill pump shutoff.

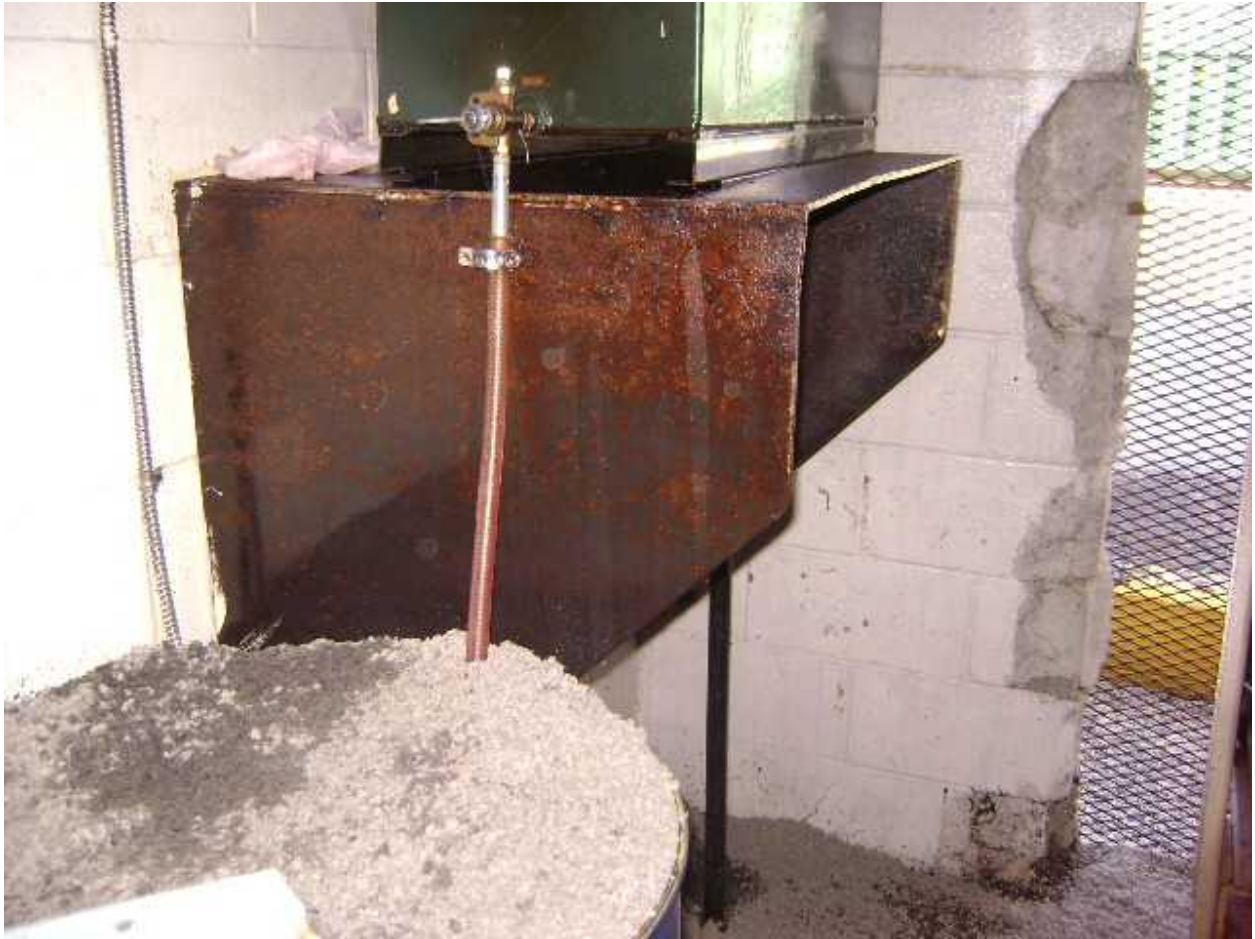
Photo 4: Day tank showing overflow to 55 gallon drum. Emergency response included deployment of absorbent.

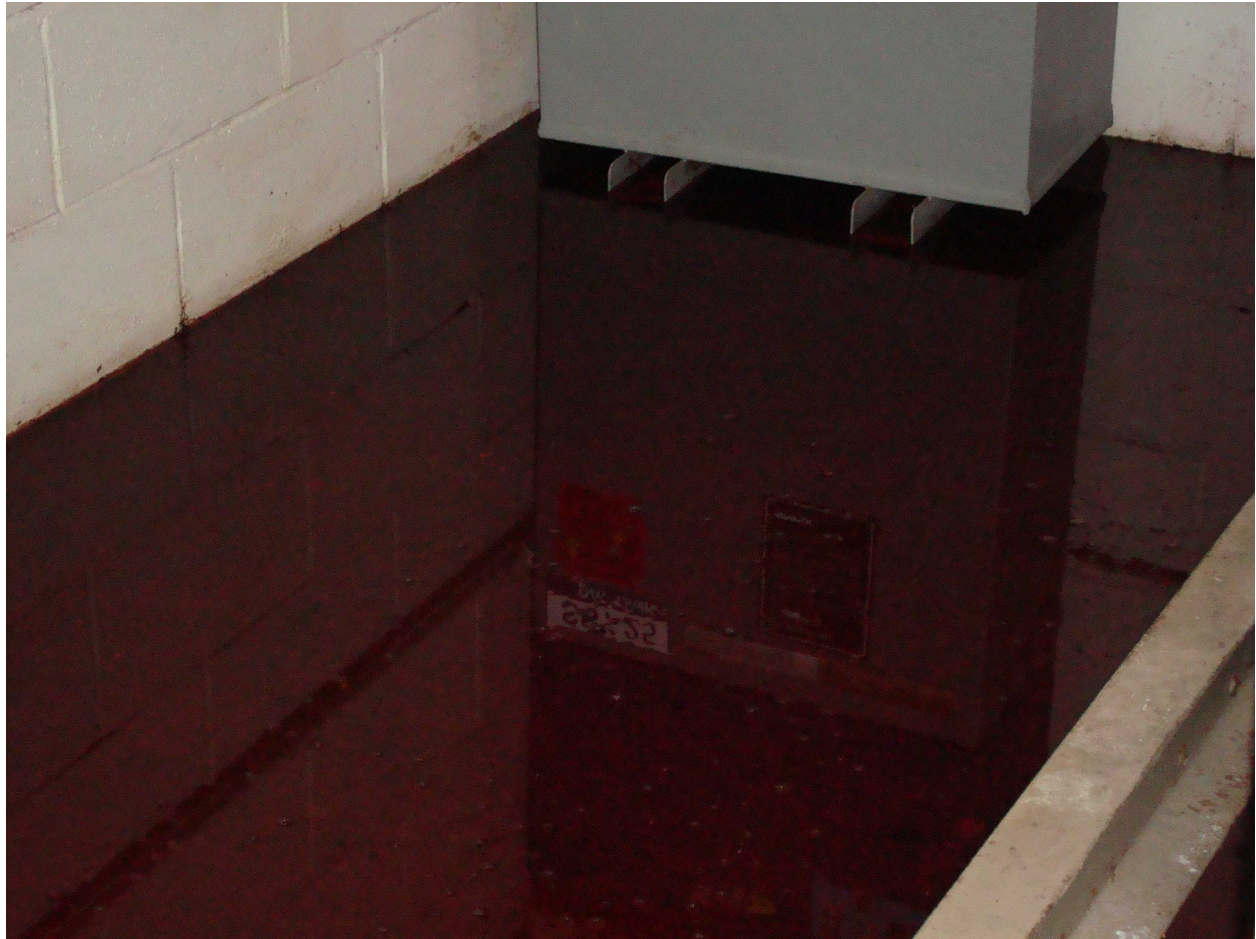
Photo 5: Generator Building floor showing shallow pool of fuel before deployment of absorbent.

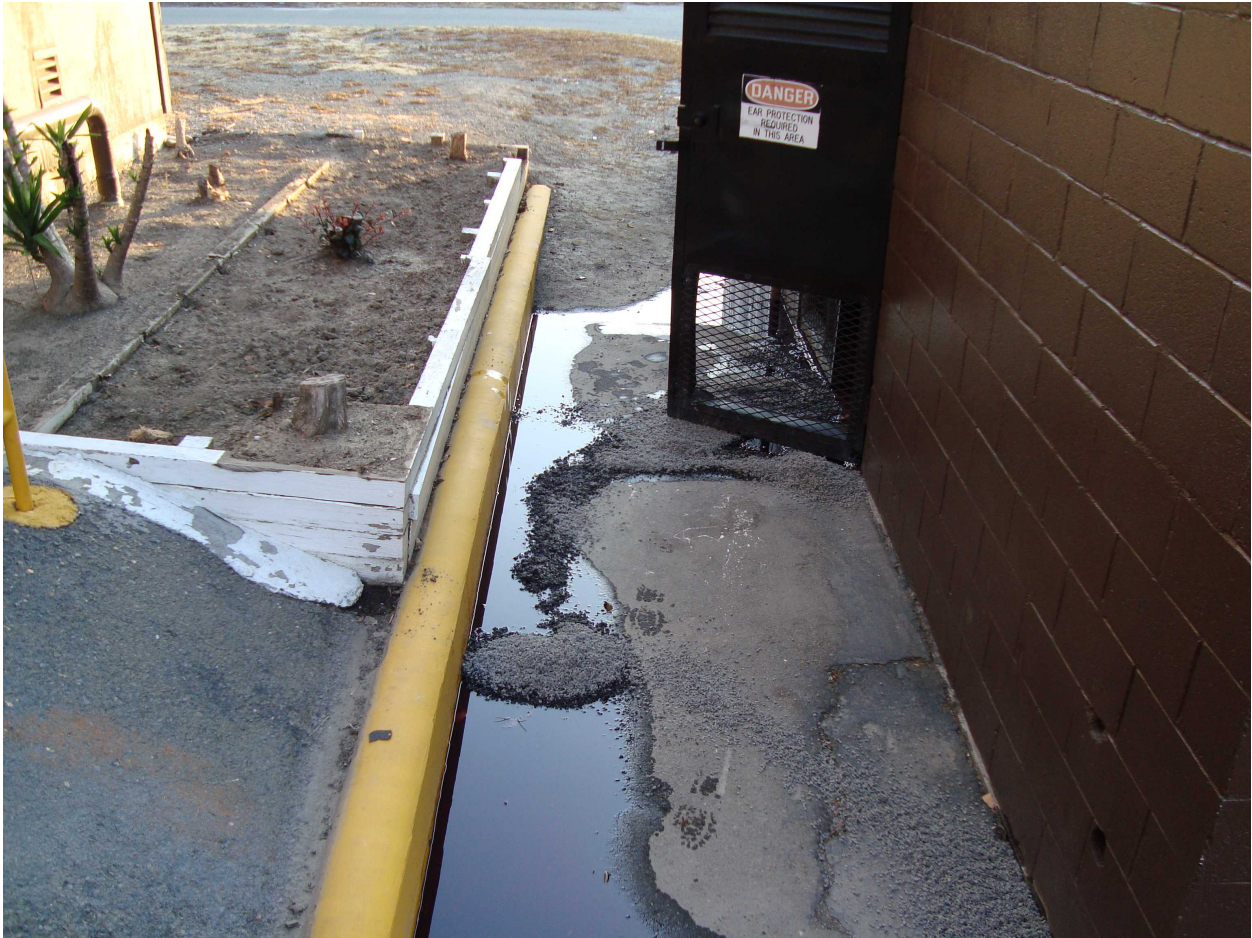
Photo 6: Generator Building, north side, access door on east end. Fuel collected against retaining wall. View is to the east.

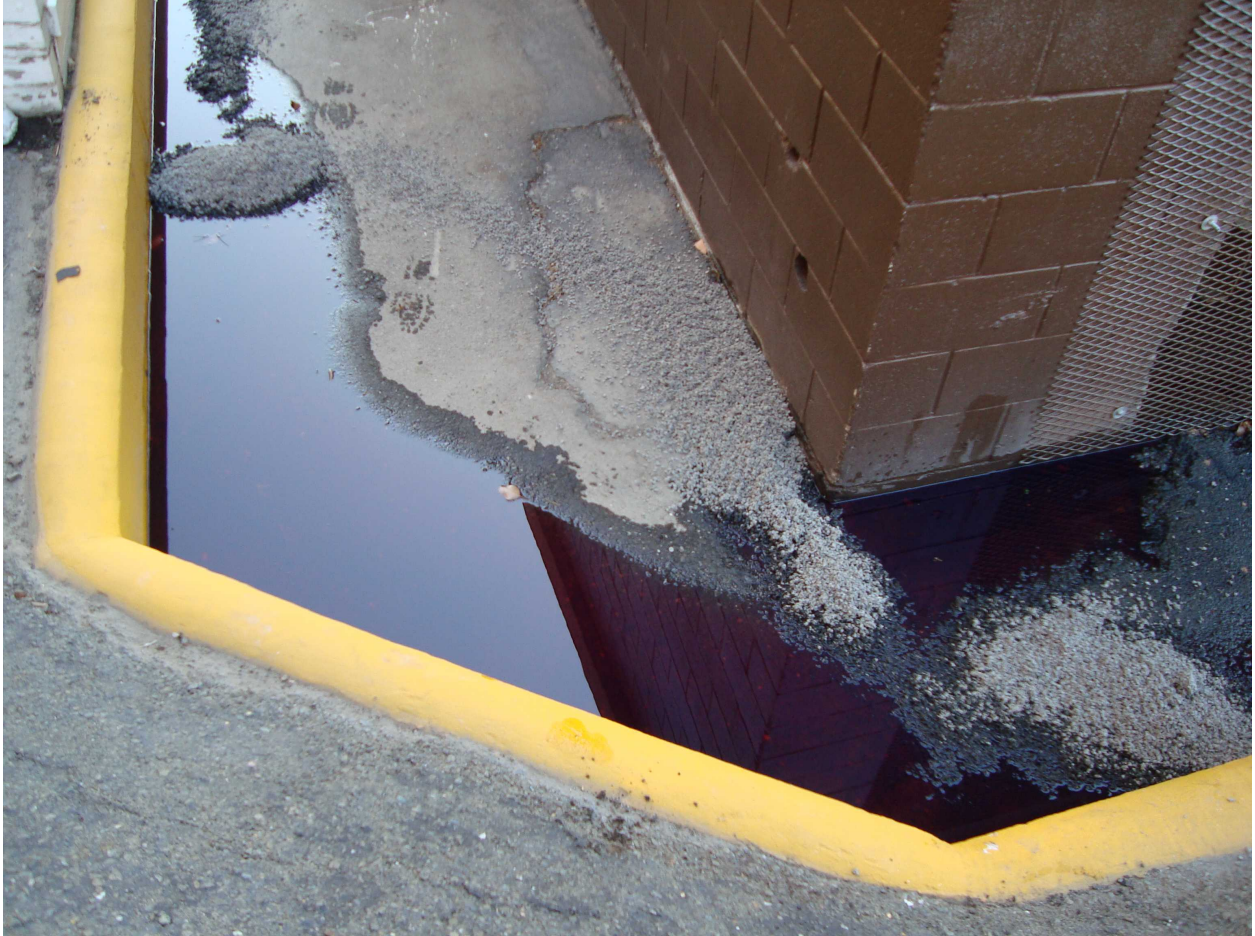
Photo 7: Generator Building, north side. Fuel collected against retaining wall. View is to the southeast.

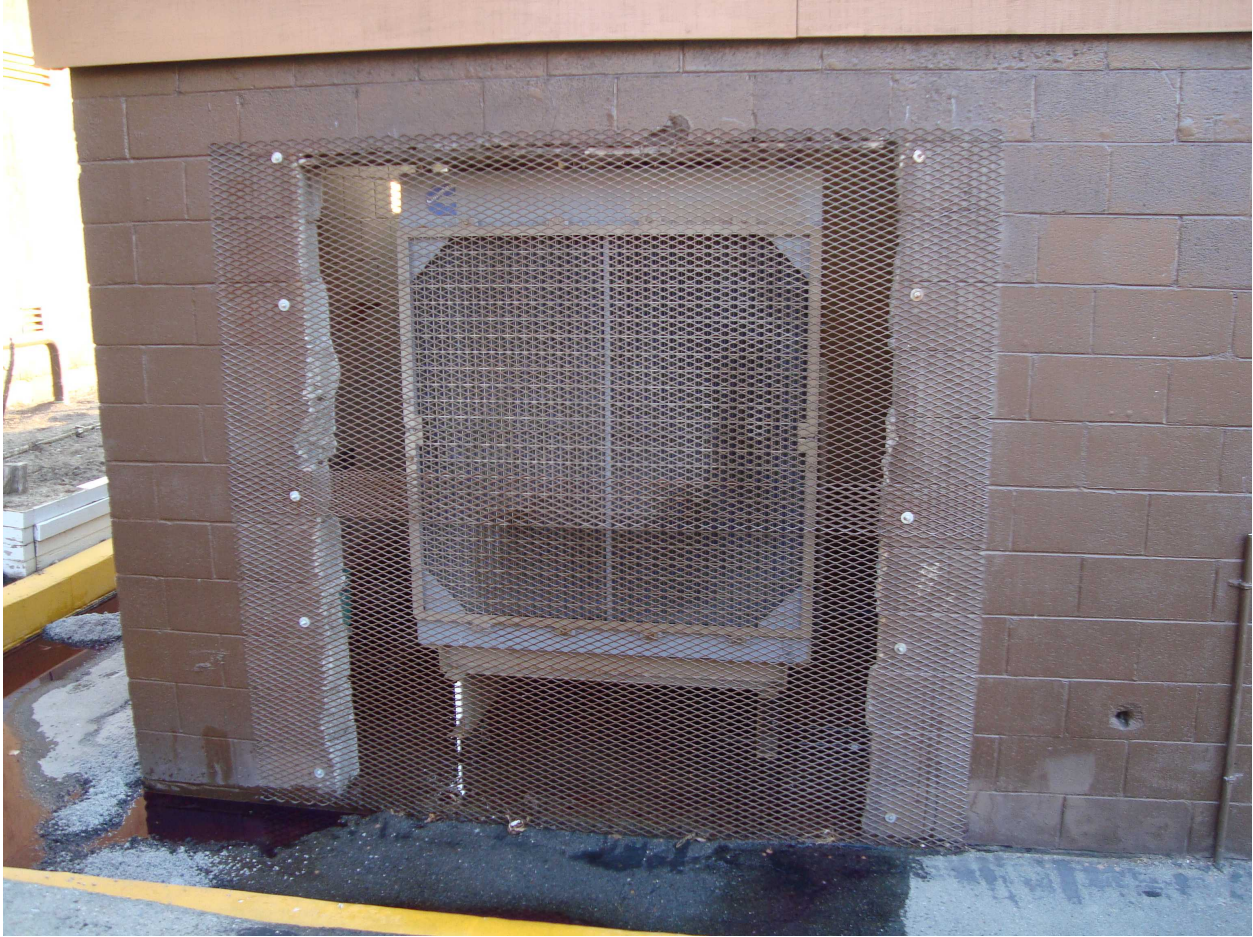
Photo 8: Generator Building, west side, fresh air ventilation wall penetration with screen in center of photo. Radiator of generator is visible through screen. View is to the east.

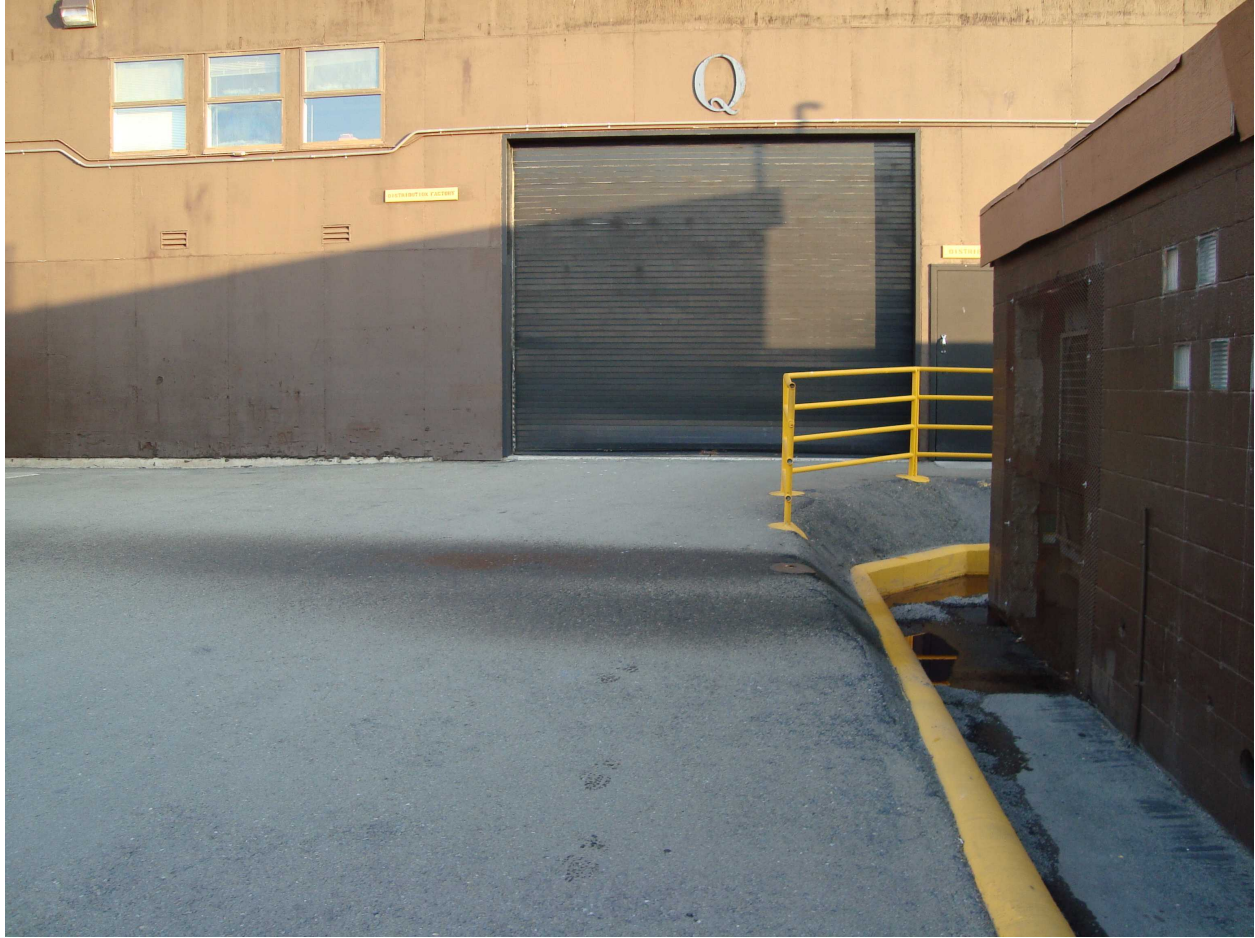
Photo 9: Building Q, south side; Generator Building is to left, showing walkway and low retaining wall. Fuel has flowed to the south along the wall. View is to the north.

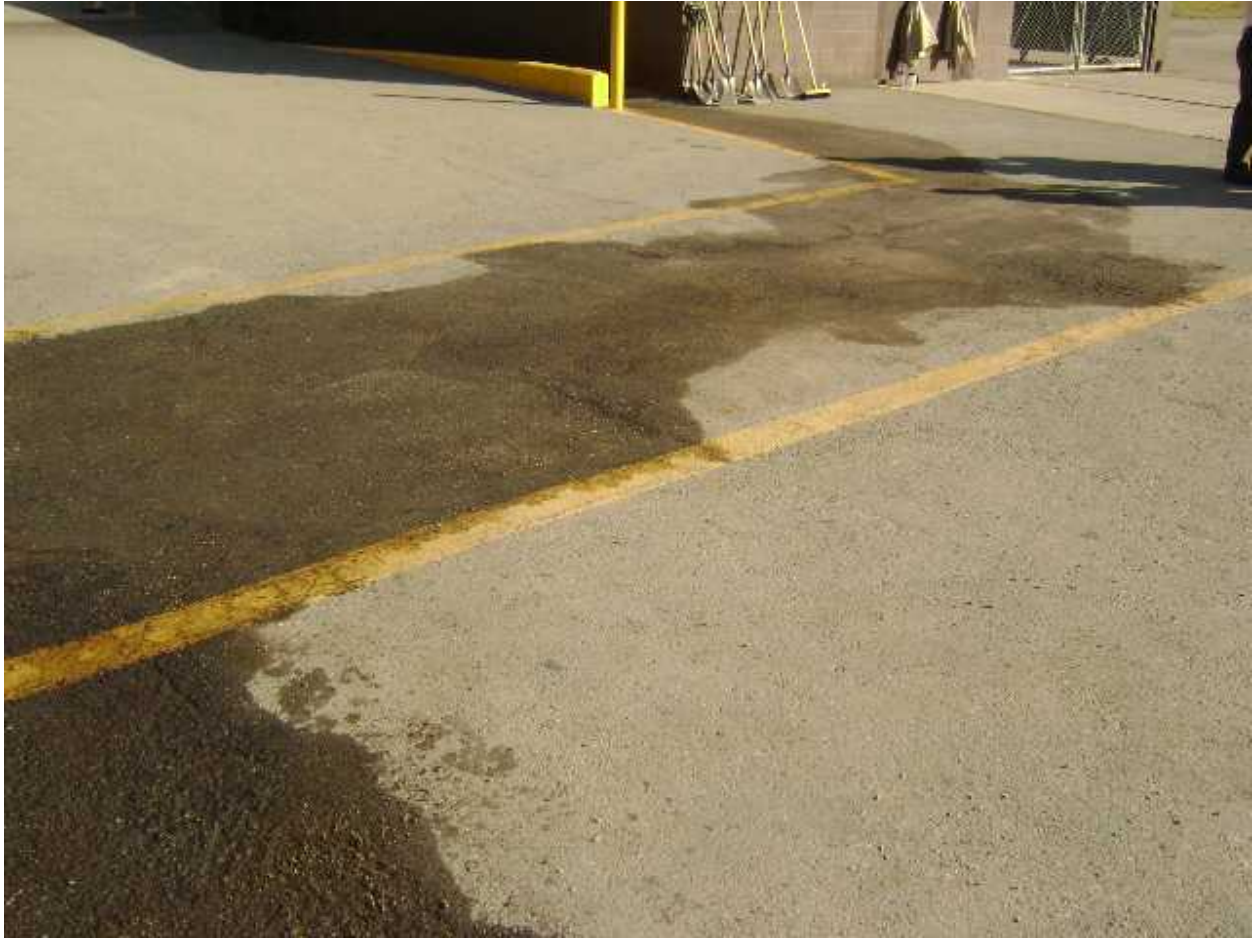
Photo 11: Generator Building, south west corner. Fuel has flowed toward dockwell to west. View is to the northeast.
