**Preliminary Site Assessment Phase
Workplan**

Diesel Fuel Release

FCI DUBLIN

McElligott Consulting
August 18, 2008

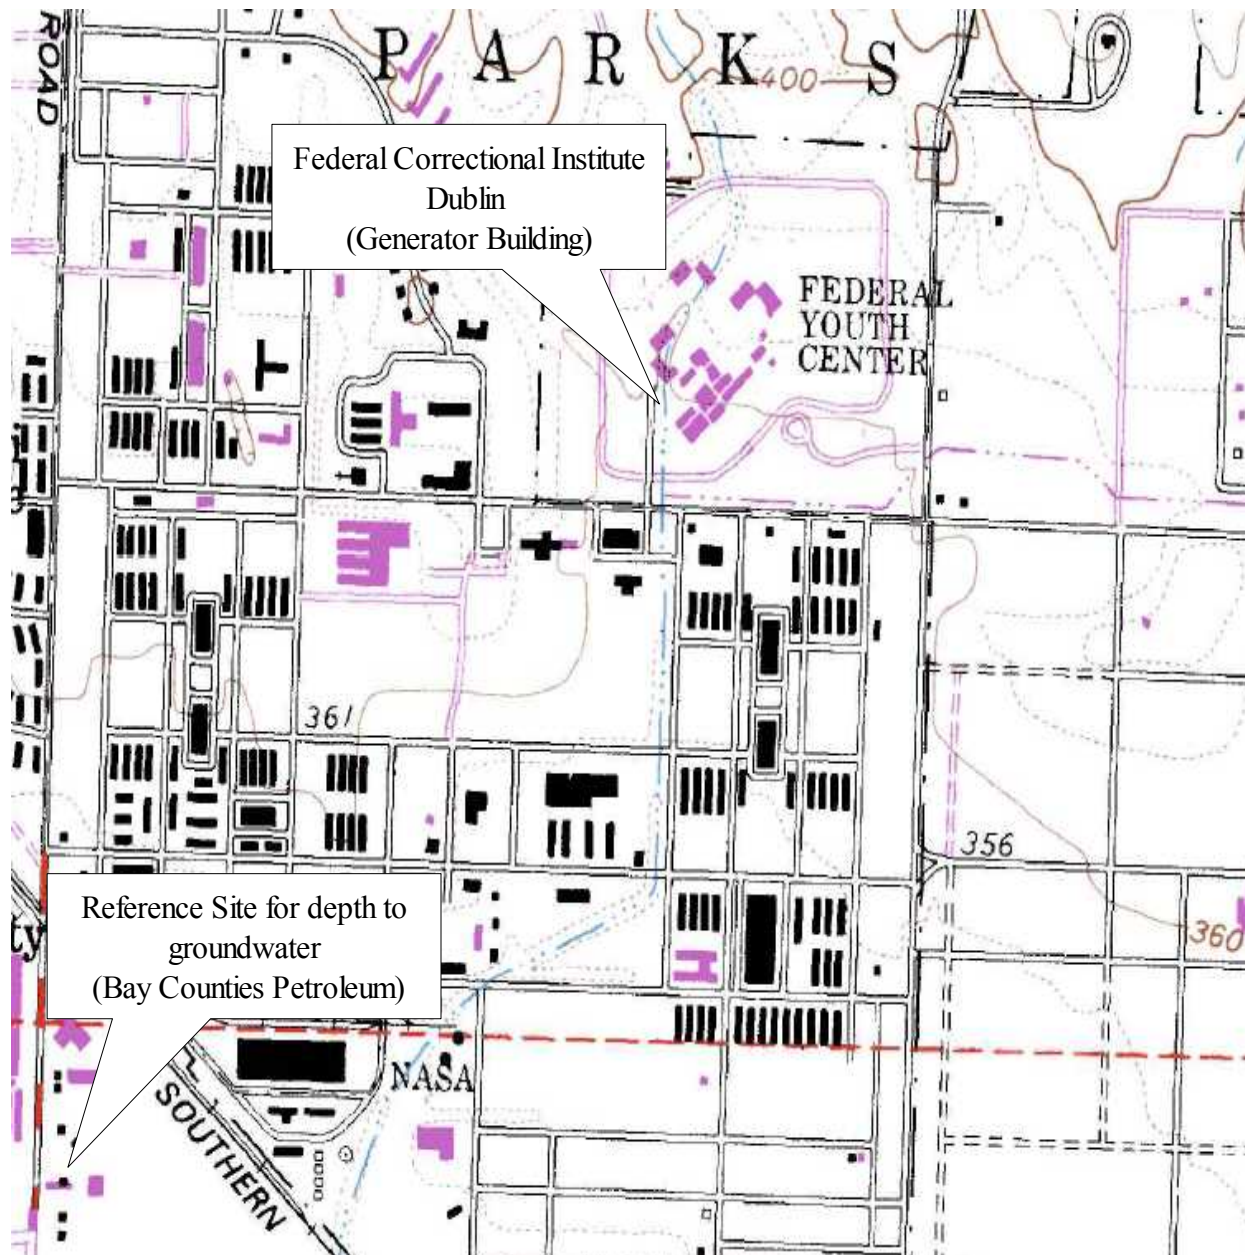
Figure 4: Topographic Map Detail, FCI Dublin and closest groundwater reference site. Release site is at approximately 360 ft amsl.

The depth to groundwater is estimated to be 21 feet below ground surface, but may be more shallow based on historic water features (a former pond upgradient and a nearby buried creek bed).

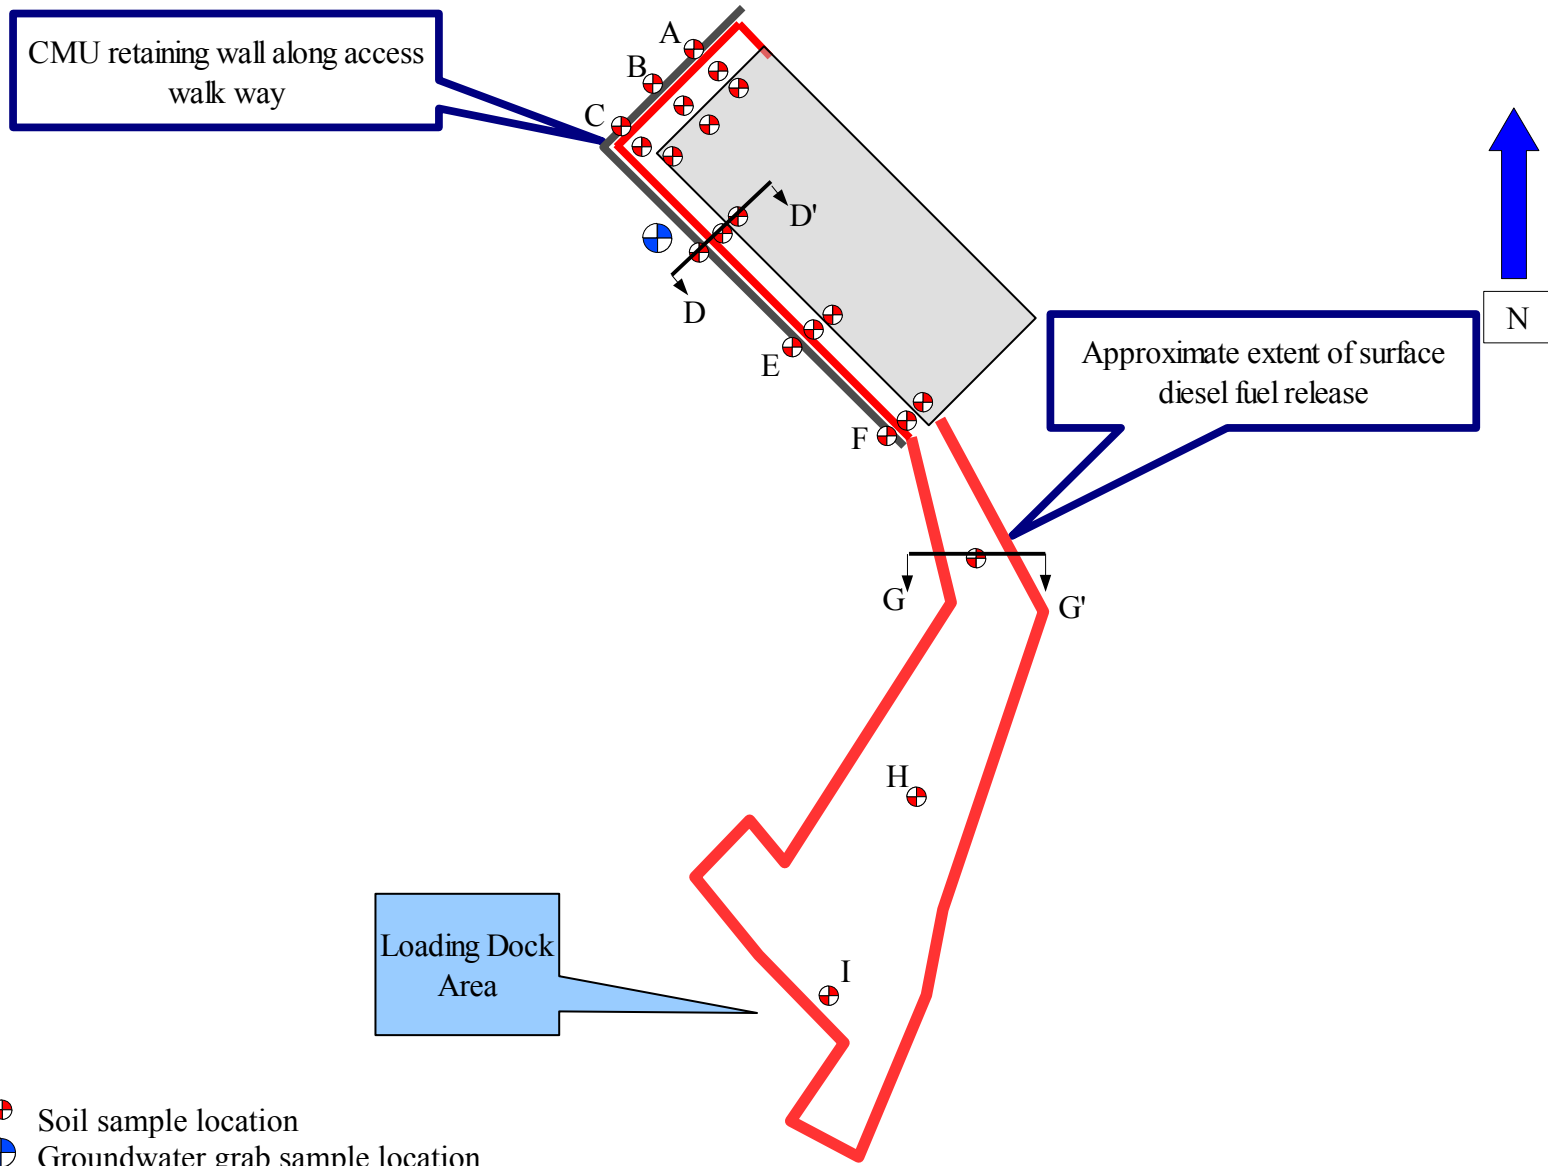
Figure 5: Detail sketch of area of release. Generator building (including storage tank) is 26 ft wide by 40 ft long
 Approximate Scale: 1" = 20'

Approximately 100 bank (in place) cubic yards of soil and asphalt cover have been removed in the interim remedial action. Residual contamination exists along the north and west sides of the generator building. Based on observation (appearance and odor only, no analytical), the area south of the building extending to the loading dock well show no residual diesel contamination. This area was not as severely affected as the walkway area on the north and west sides of the building, where free product collected until absorbed with spill clean-up materials (Pig brand Lite Dri.)

The proposed Scope of Work for this investigation consists of 30 soil samples and one groundwater grab sample. The sample locations are detailed on Figures 5 and 6. The contaminants of concern are total petroleum hydrocarbons as diesel (TPH-d) and the potential toxic constituents of diesel fuel, benzene, toluene, ethyl benzene, and xylenes (BTEX) and Naphthalene. The sample locations, sample points, and lab analyses are summarized in the table below:

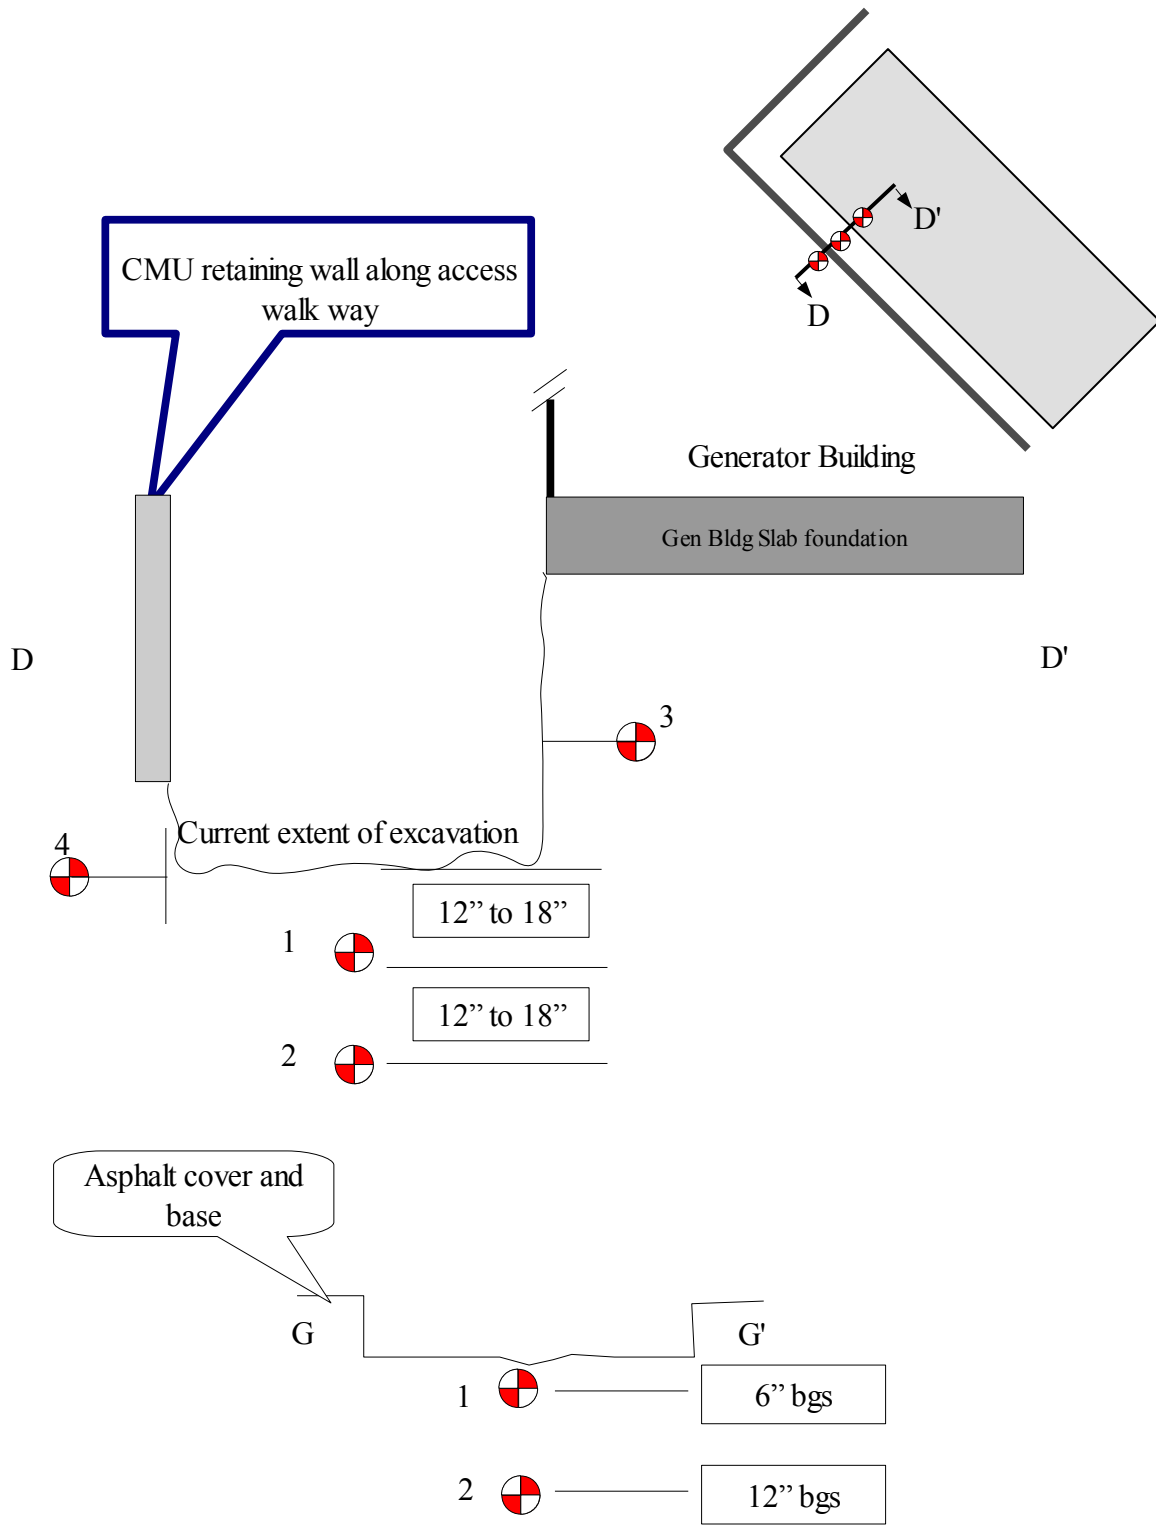
Figure 6: Detail of section A-A'. Typical cross section of sample locations.

building and concrete block of the retaining wall to the underlying soil. In the most affected area, soil has been contaminated to a depth of at least 6 feet below local ground surface. In some locations soil underneath the foundation has also been affected. The areal extent of soil contamination is believed to extend to the south west end of the generator building along the walkway, but not significantly along the driveway.

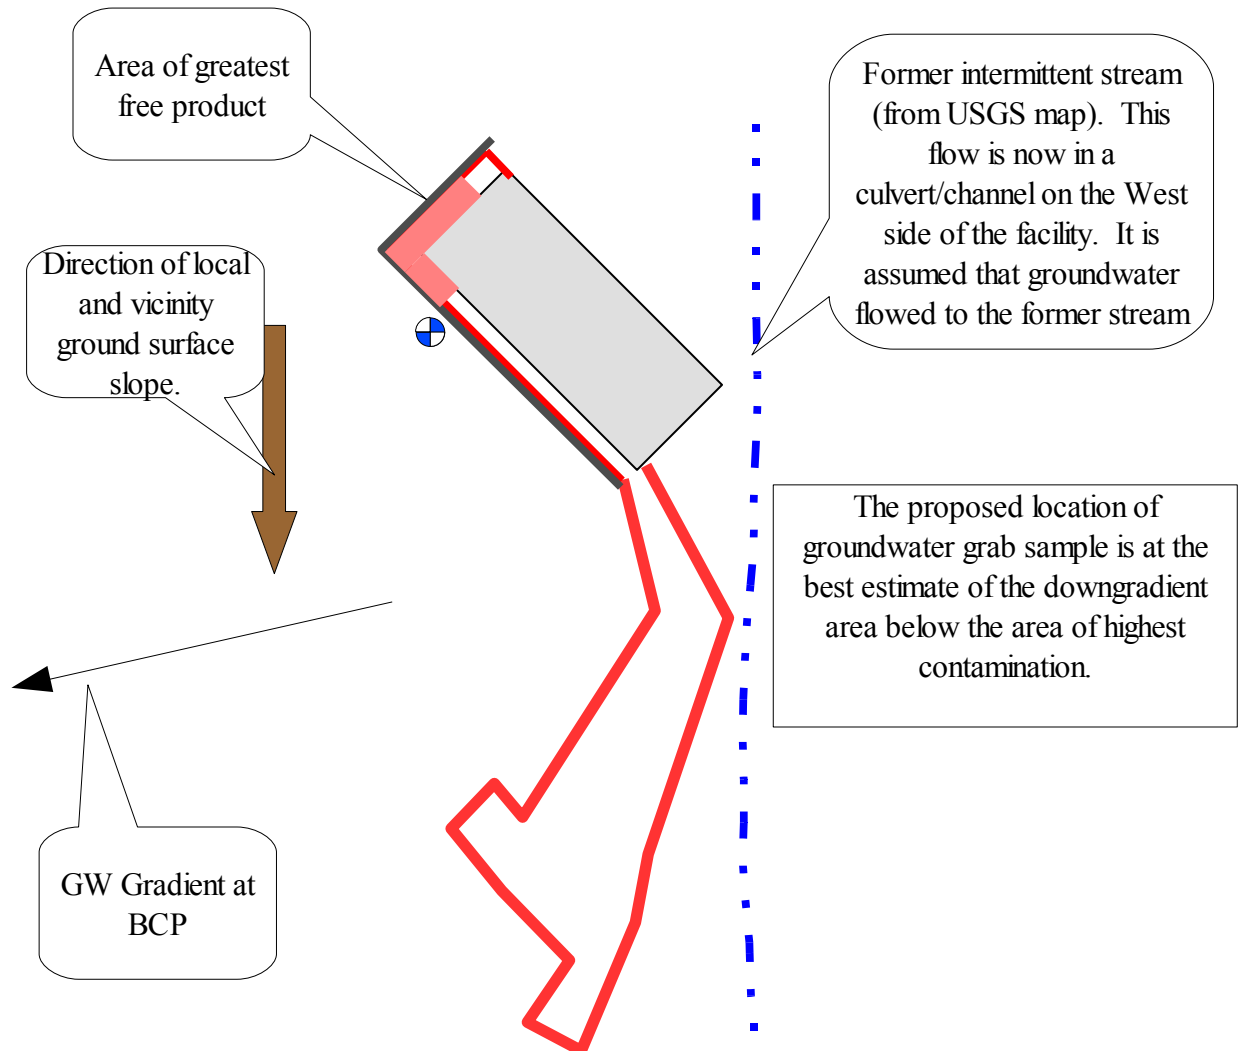
Figure 7 – Primary contamination area and groundwater sample location logic

The area most severely affected by the release was the north west corner of the walkway. Please see Figure 7.

4,907 ft away to the northeast, Groundwater flow direction is N 102.7°W, backsite from FCI Dublin to BCP is N139°W, cross gradient is then 36°.

Local gradient is 0.0024 ft/ft gradient (at Bay Counties Petroleum site), if constant between sites would put ground water elevation 11.8 ft higher, or about 339 ft. Estimated depth to gw is then 360-339 = 21 ft

The potential impact to groundwater has not been established, so a direct push groundwater grab sample has been included in the scope. The location selected is our best estimate of the downgradient location closest to the area where the soil contamination was greatest, and where the rig could be positioned.
