P&D ENVIRONMENTAL, INC.

December 14, 2015
Report 0461.R4

SUBJECT: SUB-SLAB DEPRESSURIZATION FEASIBILITY TEST REPORT
Spills Leaks, Investigation and Cleanup Leak Case No RO0002981
Geotracker Global ID T10000000416
Red Hanger Cleaners
6239 College Avenue
Oakland, CA 94618

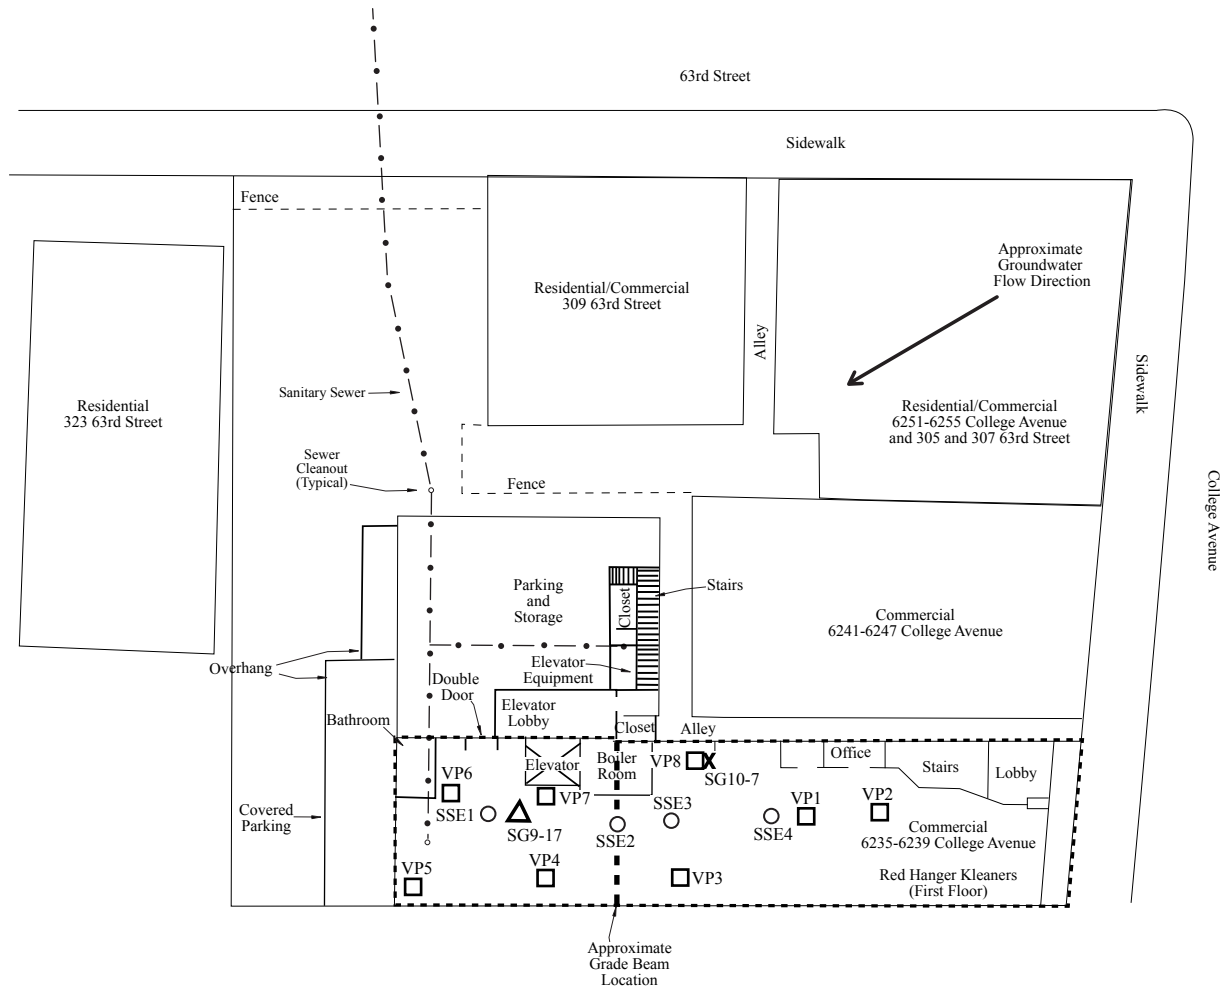
Figure 2
 Site Plan Showing Sub-Slab Soil Gas Extraction and Feasibility Test Monitoring Locations
 Red Hanger Kleaners
 6239 College Avenue
 Oakland, California

During coring in the floor slab for construction of the extraction locations, a sub-slab concrete grade beam was encountered at one of the locations, and one additional extraction location was constructed in addition to the proposed extraction locations identified in the work plan. A Site Location Map is attached as Figure 1 and a Site Plan showing the feasibility test extraction and monitoring locations is attached as Figure 2.

Review of Figure 2 shows that the first floor of 6239 College Avenue consists of the former Red Hanger Kleeners store occupying the southern portion of the building, with open parking and storage located immediately to the north of the west end of the former Red Hanger Kleeners store. The second and third floor of the building above the first floor parking and storage areas are occupied by offices, bathrooms, hallways and stairwells. The first floor tenant space (the former Red Hanger Kleeners store) is presently vacant. The former dry cleaning machines were located to the south and west of the elevator (see Figure 2).

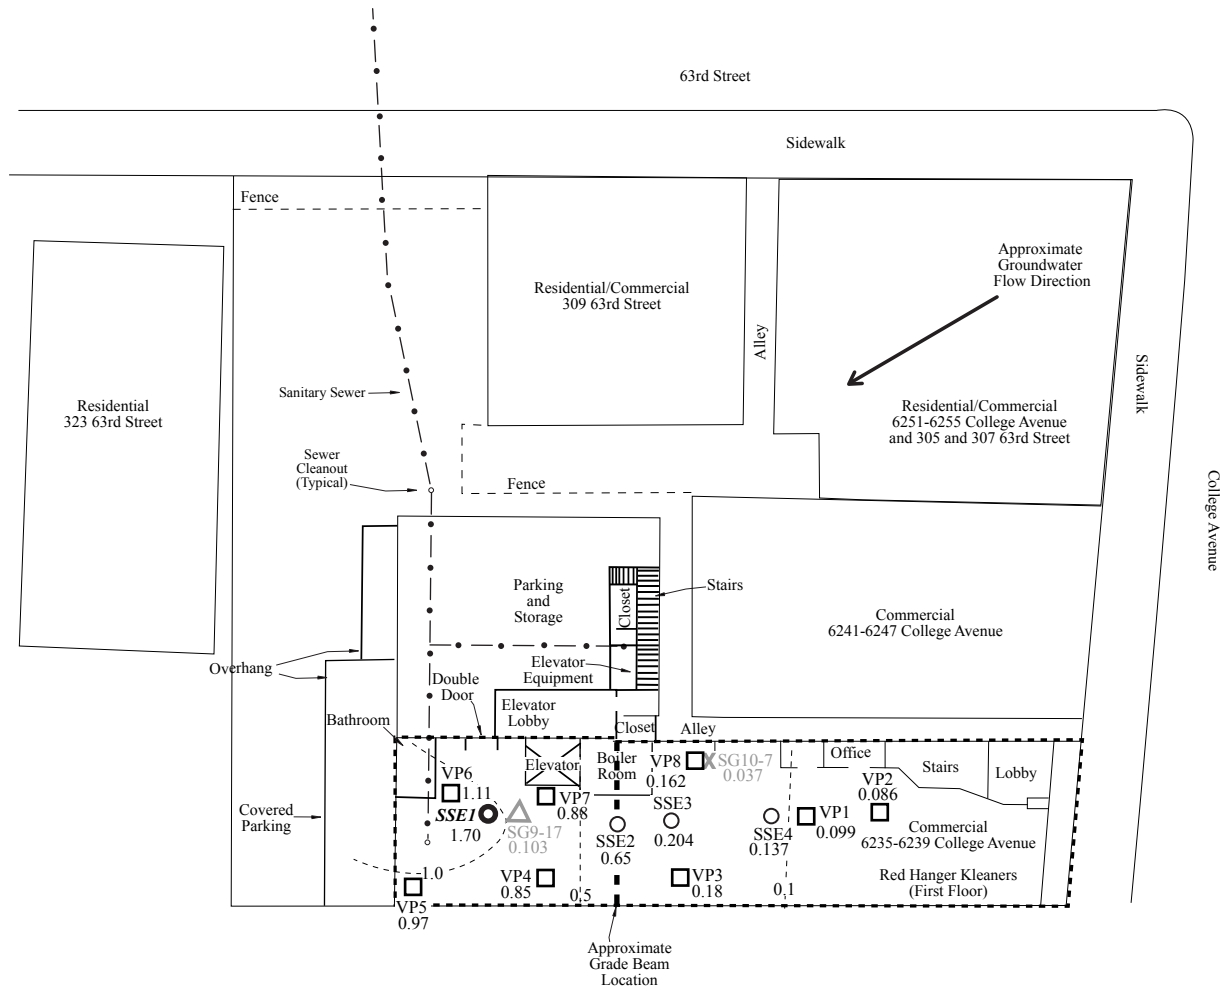
Figure 3
 Site Plan Showing Maximum Sub-Slab Vacuum During Extraction at Location SSE1
 Red Hanger Kleanners
 6239 College Avenue
 Oakland, California

maximum vacuum value recorded during extraction at each of locations SSE1 through SSE4 is shown in Figures 3 through 6, respectively. At the beginning of the application of vacuum at each location, the vacuum was observed at values near the maximum vacuum value almost instantaneously (in less than 5 seconds) for sub-slab locations, and in approximately one minute in the soil gas wells. Extraction was performed for approximately 90 minutes at the first extraction location, and based on the stable vacuums observed at monitoring locations was performed for approximately 45 to 60 minutes at each of the other extraction locations.

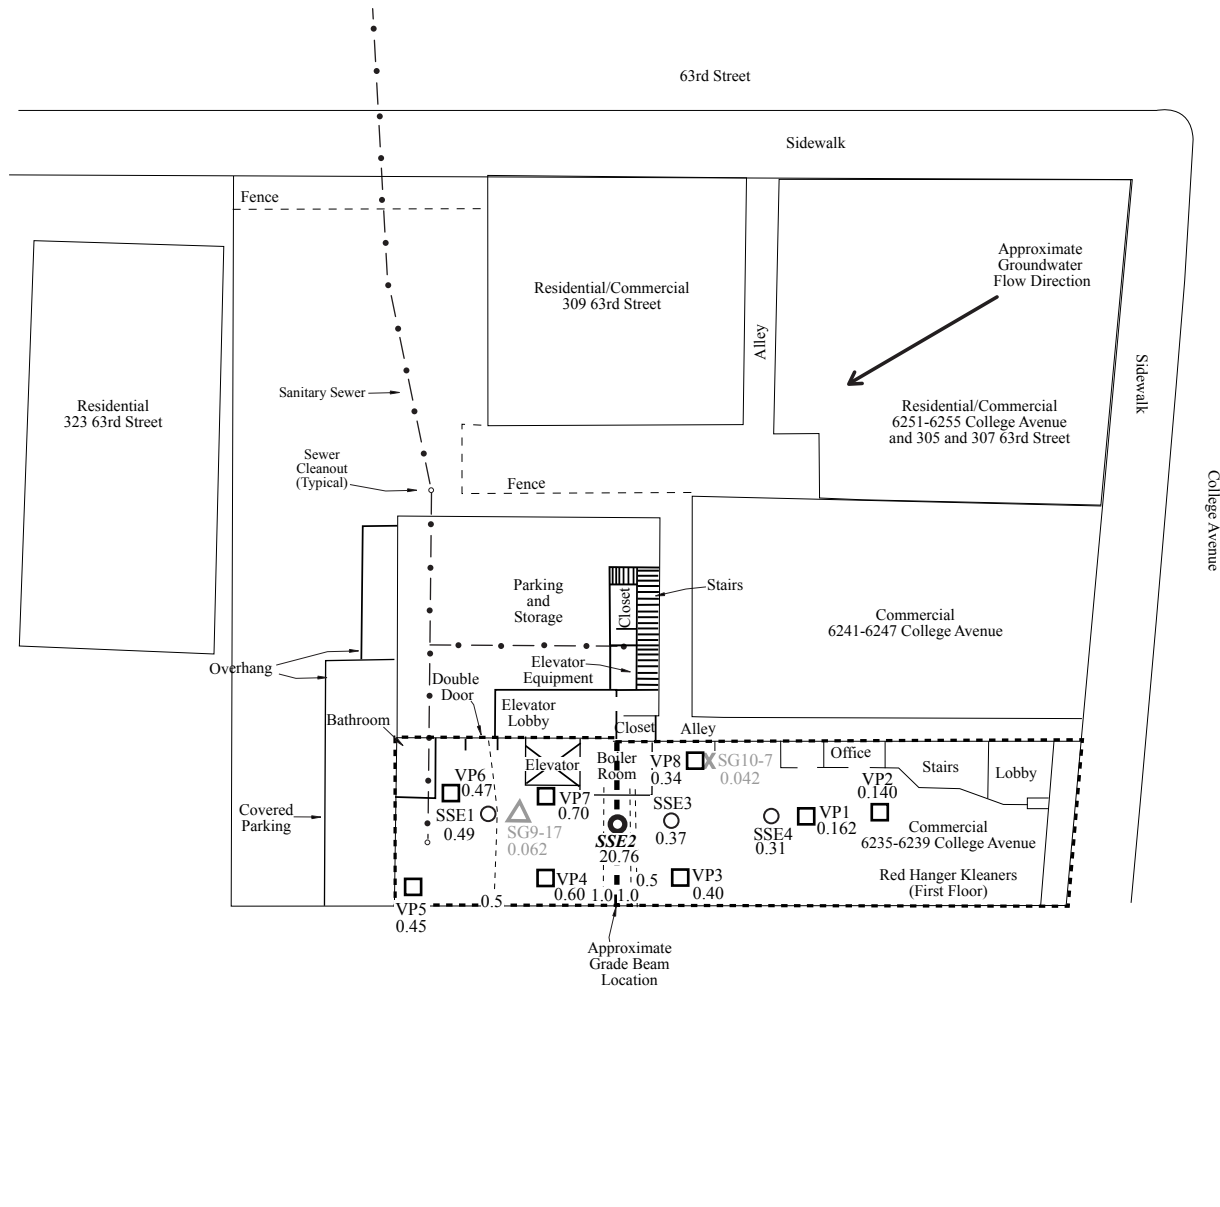
Figure 4
 Site Plan Showing Maximum Sub-Slab Vacuum During Extraction at Location SSE2
 Red Hanger Kleanners
 6239 College Avenue
 Oakland, California

A sub-slab perimeter footing is assumed to be present at the building, and the sub-slab grade beam encountered at location SSE2 is assumed to extend continuously from the south side of the building to the north side of the building. Review of Table 3 and Figures 3 through 6 shows that although the sub-slab grade beam encountered at extraction location SSE2 was a barrier to the propagation of sub-slab vacuum, that vacuum was measured at all monitoring locations during sub-slab soil gas extraction at all extraction locations. Additionally, vacuum was also measured in both of the monitored soil gas wells during sub-slab soil gas extraction at all extraction locations. At the beginning of the application of vacuum at each location, the vacuum was observed at values near the maximum vacuum value almost instantaneously (in less than 5 seconds) for sub-slab locations,

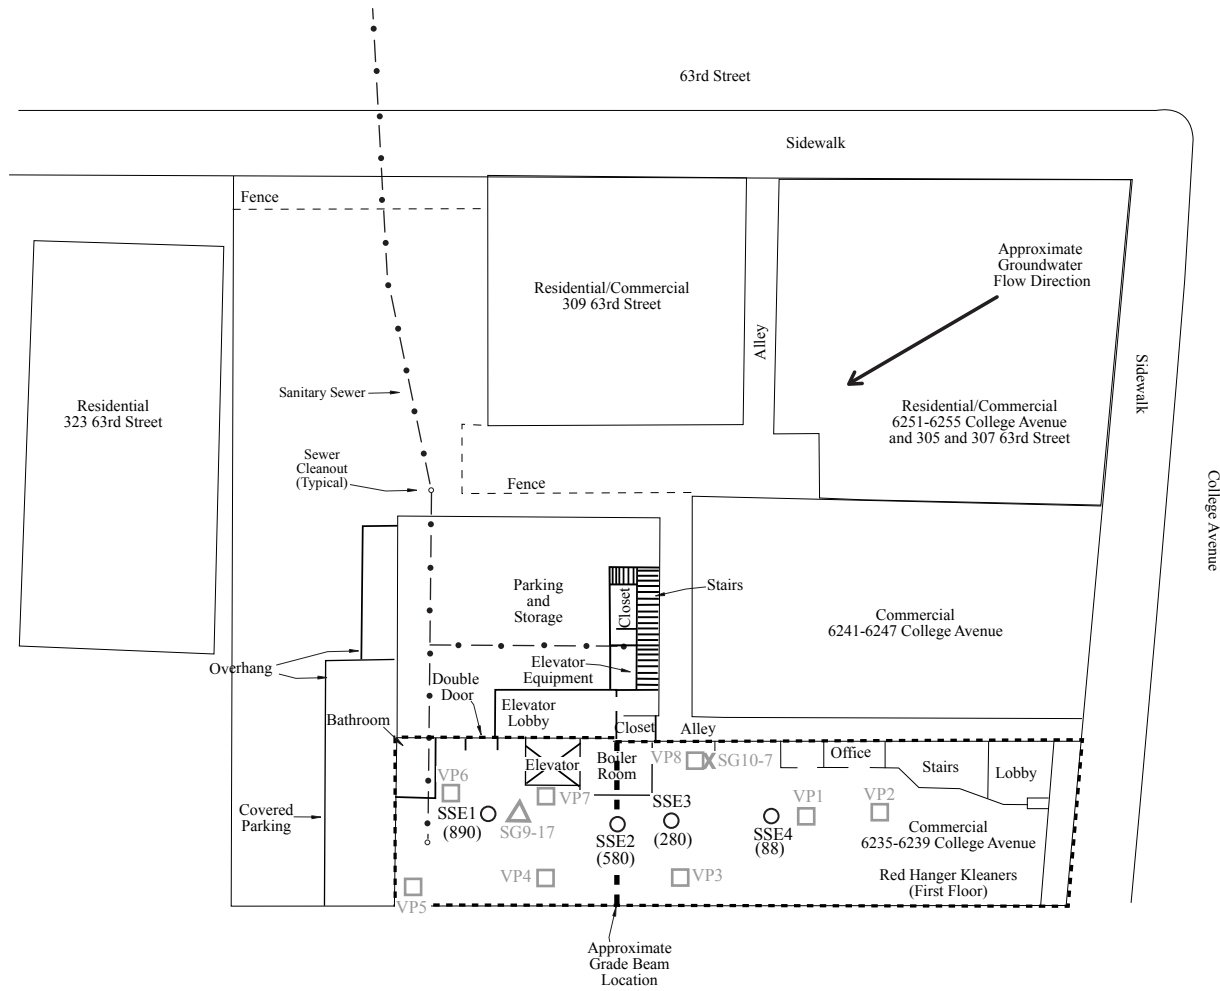
Figure 7
 Site Plan Showing Sub-Slab PCE Concentrations At the Conclusion of Extraction at Each of Locations SSE1 Through SSE4
 Red Hanger Kleaners
 6239 College Avenue
 Oakland, California

PCE was detected in samples SSE1, SSE2, SSE3, and SSE4 at concentrations of 890, 580, 280, and 88 micrograms per cubic meter (ug/m^3), respectively, and ethanol was detected at concentrations of 22, 15, 17, and 26 ug/m^3 , respectively. The only other analytes that were detected were carbon disulfide in sample SSE3 at a concentration of 17 ug/m^3 , and benzene, acetone, methyl ethyl ketone (MEK), and cumene in sample SSE4 at concentrations of 4.6, 56, 21, and 7.4 ug/m^3 , respectively.

Review of Table 4 and Figure 7 shows that the detected PCE sub-slab soil gas concentrations were highest at location SSE1 in the vicinity of the former dry cleaning machines and were lowest at SSE4 at the location farthest from the former dry cleaning machines. Additionally, the PCE concentrations shown on Figure 7 suggest that the sub-slab grade beam may be a barrier to the eastward movement of sub-slab PCE vapors.

The maximum sub-slab soil gas PCE concentration detected during the sub-slab depressurization feasibility test was 880 ug/m^3 at location SSE1. Based on one ppm of PCE being equivalent to $6,783 \text{ ug/m}^3$ PCE, the maximum PCE concentrations extracted during the feasibility test were all below the PID minimum detection concentration for the PID used to monitor extracted soil gas vapor concentrations during the feasibility test.

Based on the sub-slab depressurization feasibility test results, P&D recommends that sub-slab depressurization be performed in an effort to mitigate PCE vapor intrusion into the subject site building. P&D recommends that as part of the vapor intrusion mitigation effort that sub-slab depressurization extraction be performed at accessible locations surrounding the elevator pit in an effort to mitigate PCE vapor intrusion into the elevator pit where the highest historical PCE air concentrations have been detected.
