PHASE I ENVIRONMENTAL SITE ASSESSMENT 1280 DOOLITTLE DRIVE, SAN LEANDRO, CALIFORNIA

ACC Environmental Consultants, Inc. May 8, 1991 ENVIRONMEN

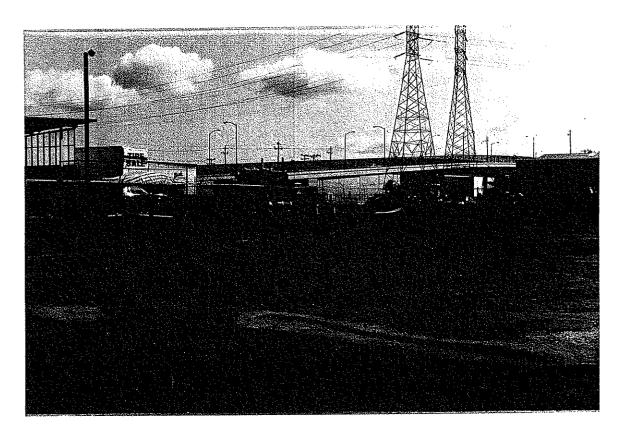
The property itself is owned by Mr. Manuel Senna and has been used periodically in the trucking industry for a number of years. In 1990, one underground storage tank containing diesel fuel was removed. Site Closure was approved by the regulatory agencies when soil samples collected from the tank pit indicated concentrations of the tested parameters within acceptable limits. A newly paved area exists on-site which was required upon the installation of a large lighted billboard. A drain exists on the property which parallels Doolittle Drive and empties into a storm drain located on Carden Street.

View northward from 1280 Doolittle Drive toward 2100 Carden Street. Note the depressed area in the foreground. This is the drain system leading off-site.

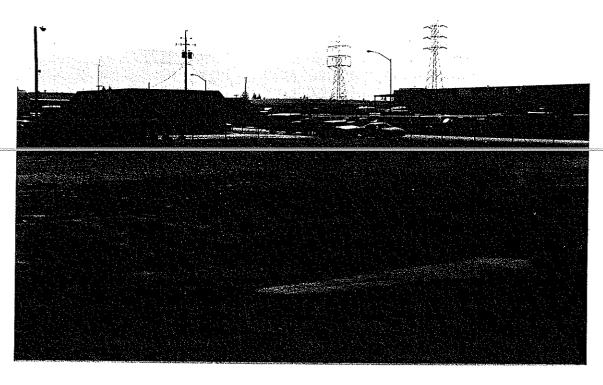
View southeastward from the newly asphalted area toward Carden Street.

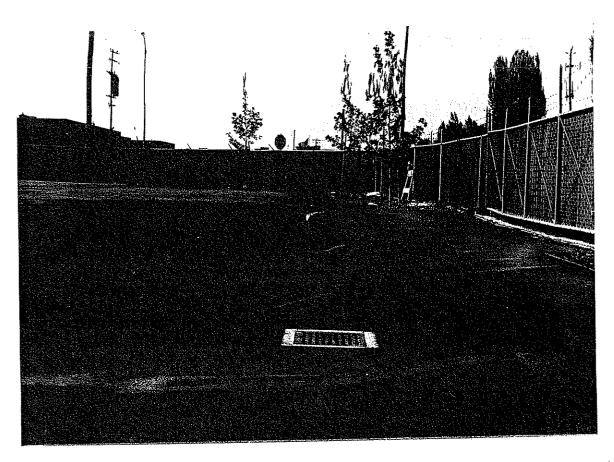
A southerly view of the drainage system from the newly asphalted area. The drain empties into a storm drain at the corner of Doolittle Drive and Carden Street.

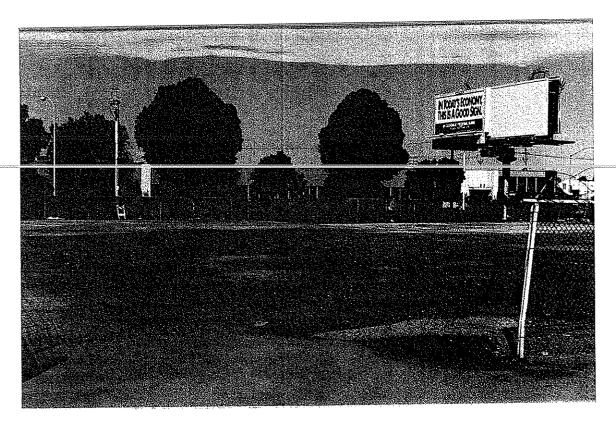
View northwestward of the lighted billboard at the corner of the property. Note the new asphalted area beneath the billboard.

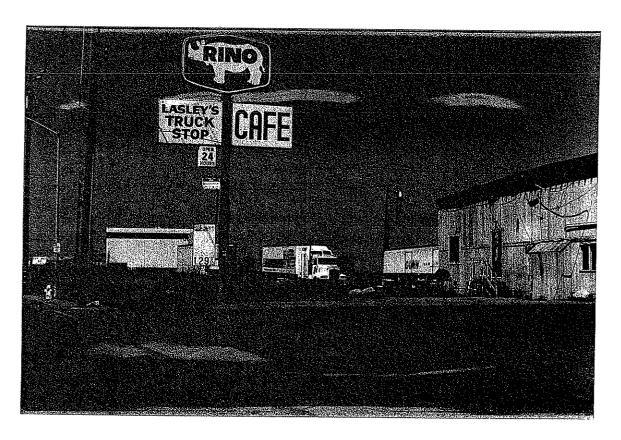
The Lasley Truck Station is located east of the subject site at 1946 Davis Street. The site has recently experienced environmental problems originating from underground tank leaks and from surface spillage from 55-gallon drums. In 1989, three underground tanks storing diesel fuel and gasoline were removed, two 10,000-gallon tanks storing diesel fuel and one 10,000-gallon tank storing gasoline. Soil sampling indicated elevated concentrations of tph-diesel and BTXE. These results prompted the initiation of a preliminary site assessment. This investigation included the installation of three monitoring wells to assess the groundwater contamination. Samples collected from the wells showed excessive contents of BTXE and tph-diesel adjacent to the tanks. In addition, soil samples collected near the drums indicated shallow, but highly concentrated, contamination with oil. A remedial plan has recently been submitted to the regulatory agencies and is undergoing review.

View westward of Lasley's Truck Station. Note the piles of soil and the barrels storing drill cuttings. See text for discussion.

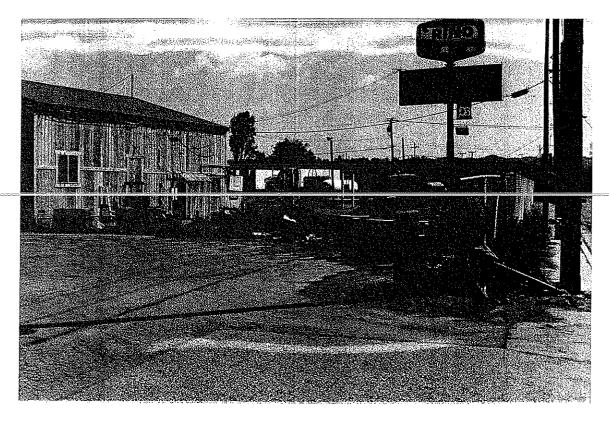
View eastward of Lasley's Truck Station. Again, note the piles of soil and the barrels storing drill cuttings. See text for discussion.
