RIEDEL ENVIRONMENTAL
SERVICES, INC.

Subject: Underground Storage Tank Removals

UNDERGROUND STORAGE TANK REMOVALS

November 13, 1987

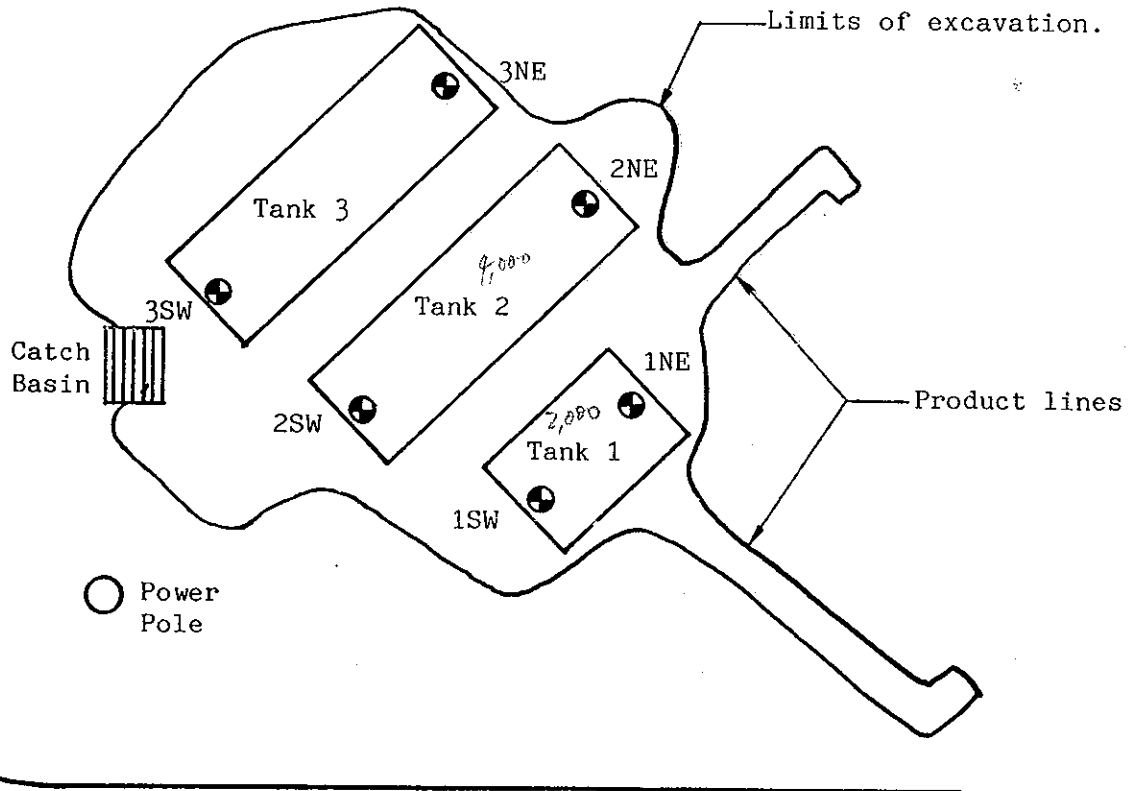
Figure 1

RES started excavation for Tank #2, at the location shown on Figure 1. During excavation it was discovered that the tank was much longer than had been anticipated and a concrete block which was anchoring a guy wire to a power pole at the corner of the intersection would have to be moved. During the time it took to relocate the guy wire, work commenced on excavation at Site #2. After the guy wire was moved, excavation to remove Tank #2 was completed and the tank was inerted with dry ice. Tank #2 was then pulled and transported to a location northwest of the excavation area for cleaning. The tank had a 4,000 gallon capacity and was 6'2" diameter and 18' long. It was intact with the exception of a hole in the top at the south end which was caused when it was hit by the contractor's backhoe during the storm drain excavation.

Soil samples were collected from under both ends of all three tanks as shown in Figure 1. Brass sample tubes were used to collect the samples. Prior to use, the sample tubes were cleaned by rinsing with hexane, scrubbing with detergent, rinsing with tap water, rinsing with hexane, rinsing with deionized water, and rinsing with ASTM Type 2 water.

Laboratory analysis showed the presence of gasoline in one sample. A concentration of 110 milligrams per kilogram (mg/Kg or parts per million) as aged gasoline was identified under the south end of Tank #3. Analysis of all other samples showed no detectable contamination by petroleum hydrocarbons at a detection limit of 10 mg/Kg.

Laboratory results indicate minor contamination by petroleum hydrocarbons is present under the south end of Tank #3. Tank #3 is surrounded by bedrock on the bottom and on three sides. The fourth side is bounded by Tank #2 which exhibited no contamination at either end. Tank #3 was the only tank containing product. Thus, it is assumed that the contamination did come from that tank and has not migrated significantly from the south end of the tank.

<Based upon the low petroleum hydrocarbon and lead levels in the soils at Site #1, no soil excavation is necessary. Because the tank site is underlain by bedrock there is such little threat to groundwater that a monitoring well is not recommended.>

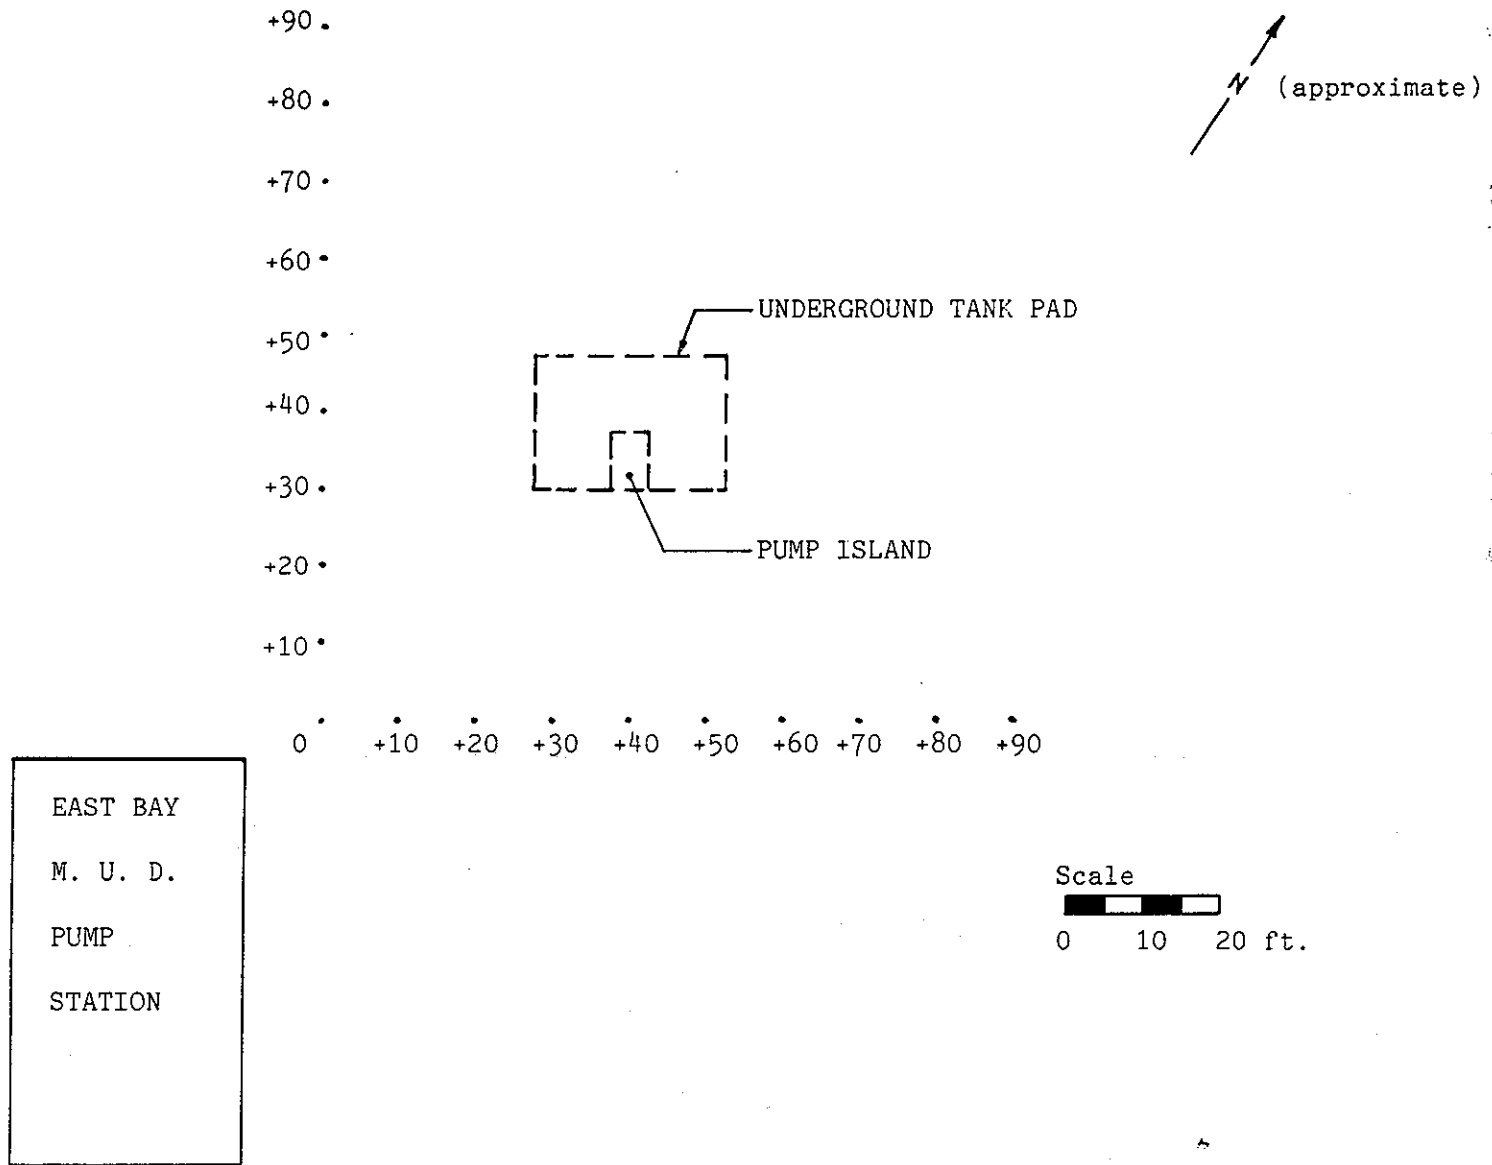
FIGURE 2

Our final effort to locate the tank was to excavate at an area identified on a different drawing than we had been working from originally. This drawing showed a 20' X 20' tank pad with a pump pad on it as shown on Figure 2. We excavated an area approximately 20' X 20' to 8' below grade and found no tank.

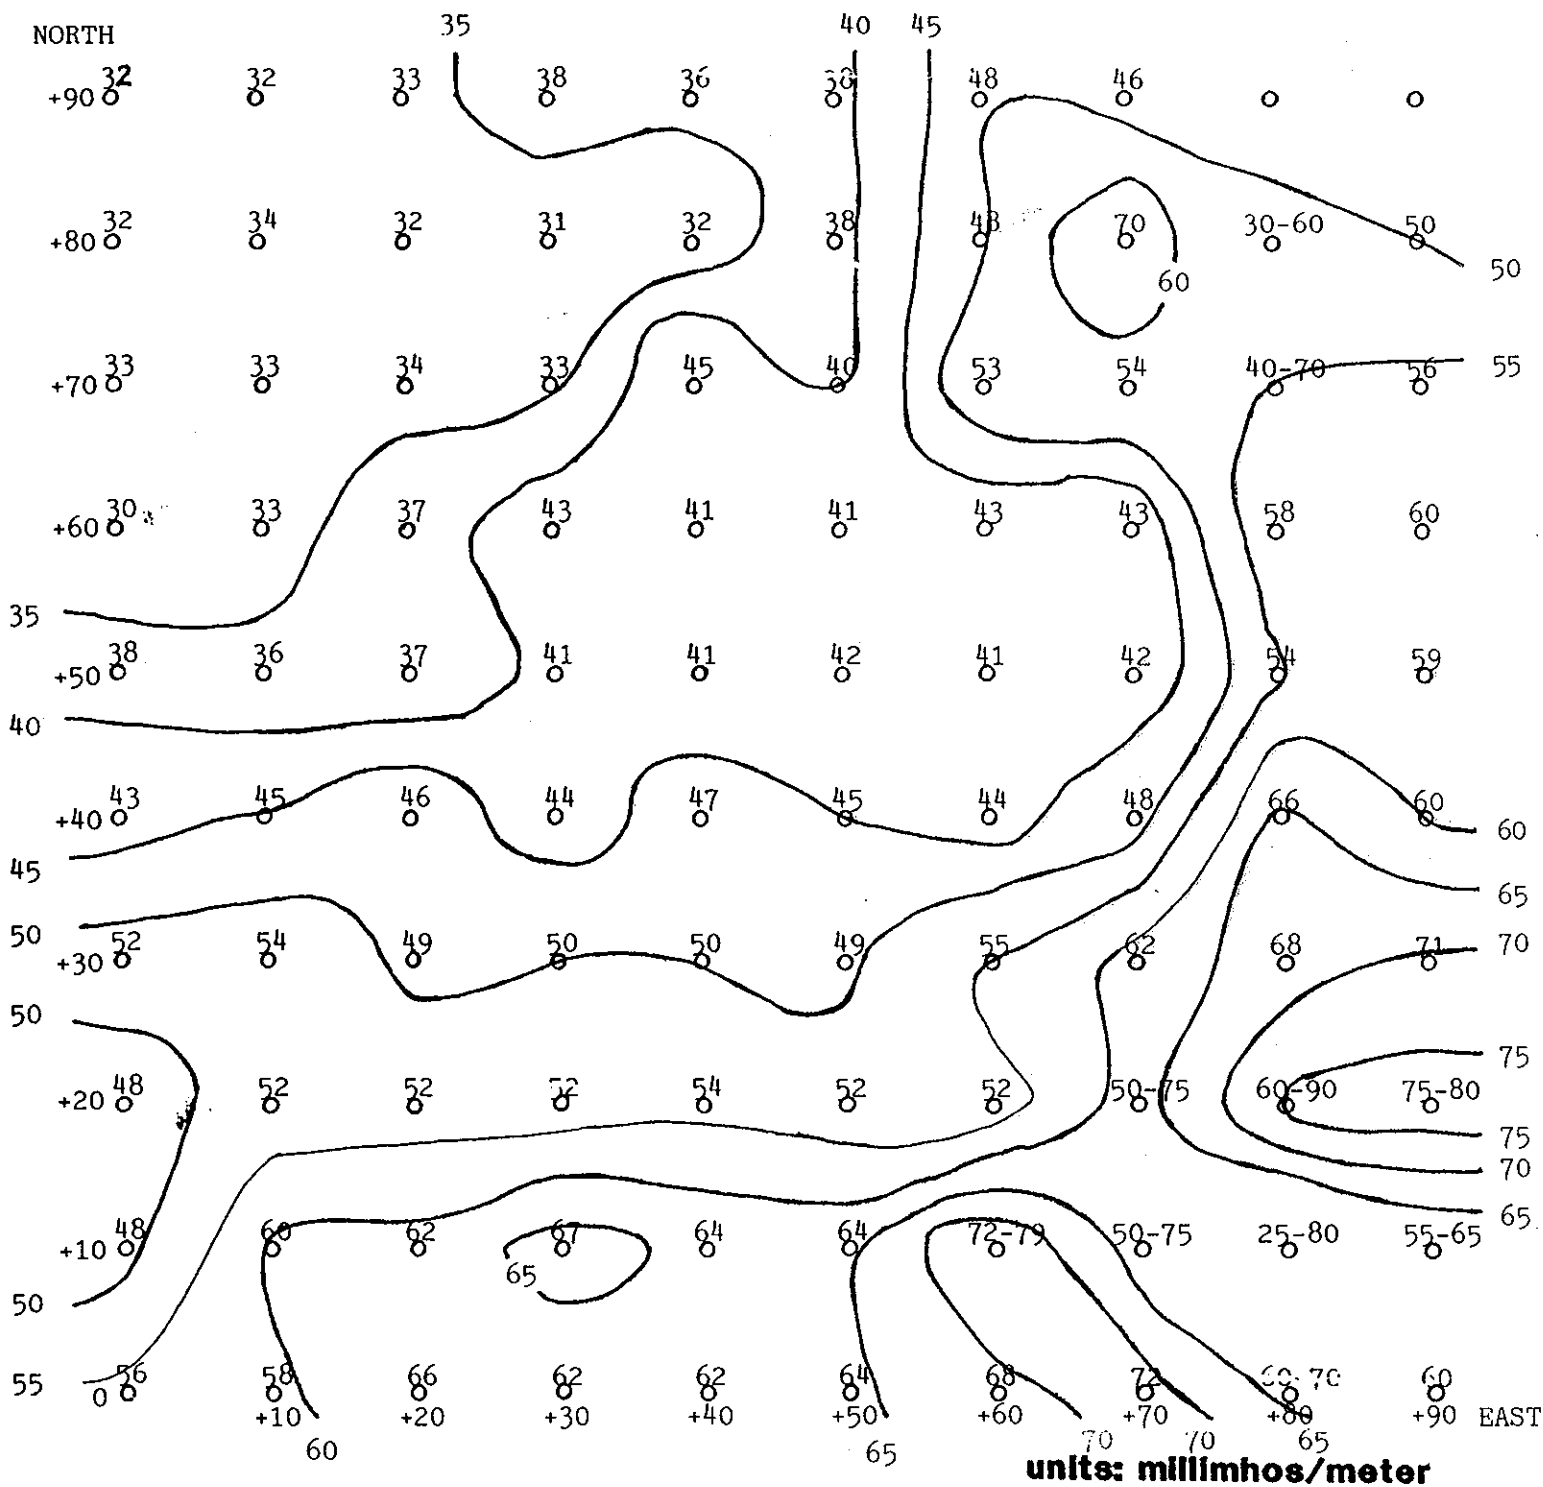
Figure 3

Our next approach was to enlist the services of a geophysicist to try to locate the tank. We laid out a 90' X 90' grid with stations on 10' centers and took ground conductivity readings at each station. This indicated that there were two possible areas where the tank could be located. These locations are identified on Figure 3. These locations were at +80N +70E and at +50N +50E. We resumed our excavation efforts in these two areas but were again unsuccessful in locating anything of significance.
