**Exterior Lead-Based Paint Risk Assessment**

**4701 San Leandro Avenue • Oakland, CA 94601**

**The Alameda County Lead Poisoning Prevention Program**

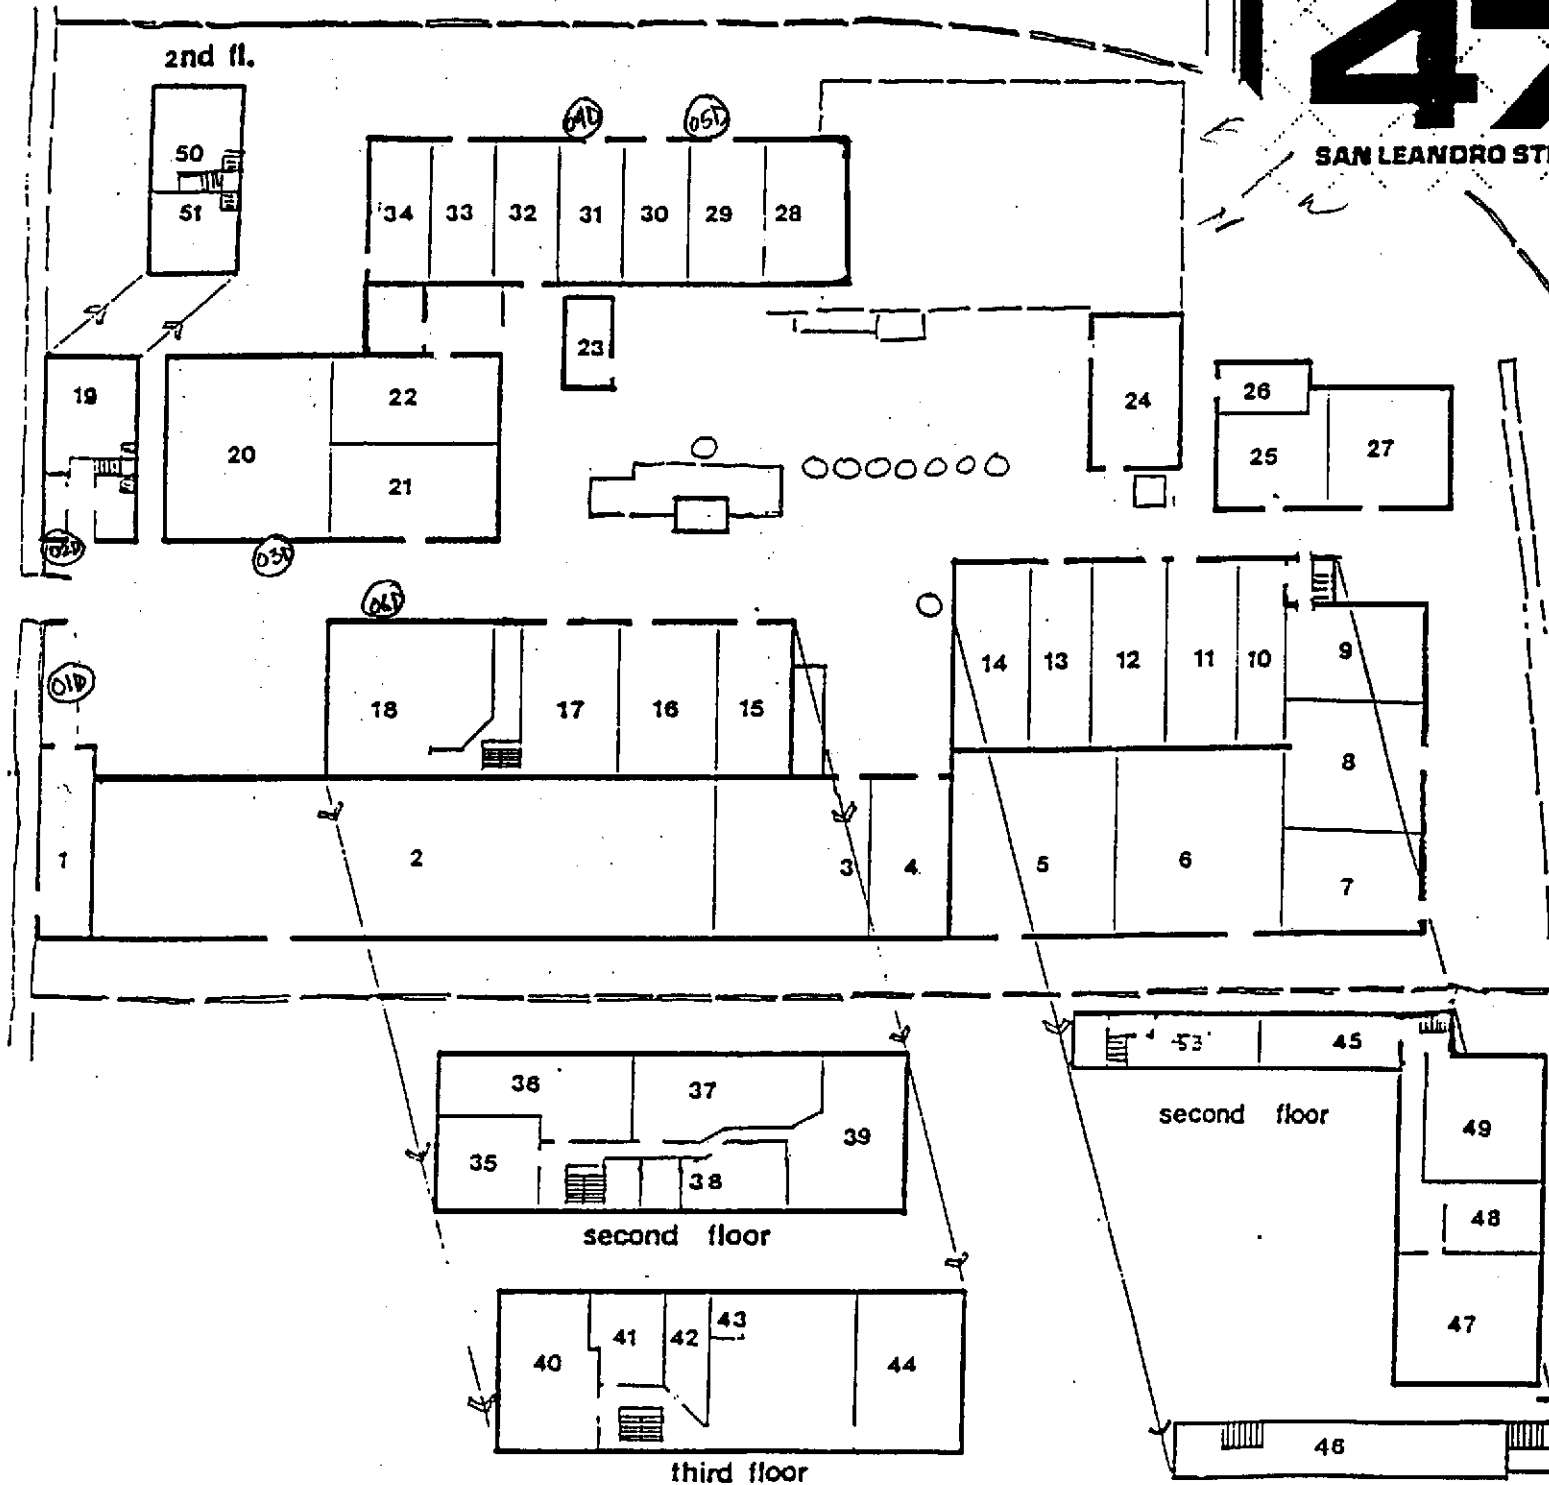
Dust Sample  
Locations

Sample#	Component	Location	Result ( $\mu\text{g}/\text{ft}^2$ )	Standard ( $\mu\text{g}/\text{ft}^2$ )	Child Access	Condx	Risk
01D	Flag pole	grassy area @ main entrance in front of Bldg. #1	8,127	N/A	high	poor	high
02D	Window well	next to 1st doorless entry to Bldg. #19	1,431	800	moderate	good	moderate
03D	Roll-up door	North entrance to Bldg. #20 (facing main driveway)	22,616	N/A	high	poor	high
04D	Wall	edge of wall bordering entrance to Bldg. #31	708	N/A	high	poor	high
05D	Window well	window adjacent to Bldg. #29 entrance (just above bench)	53,916	800	high	poor	high
06D	Window well	ground level window adjacent to main driveway @ Bldg. #18	13,339	800	high	good	moderate

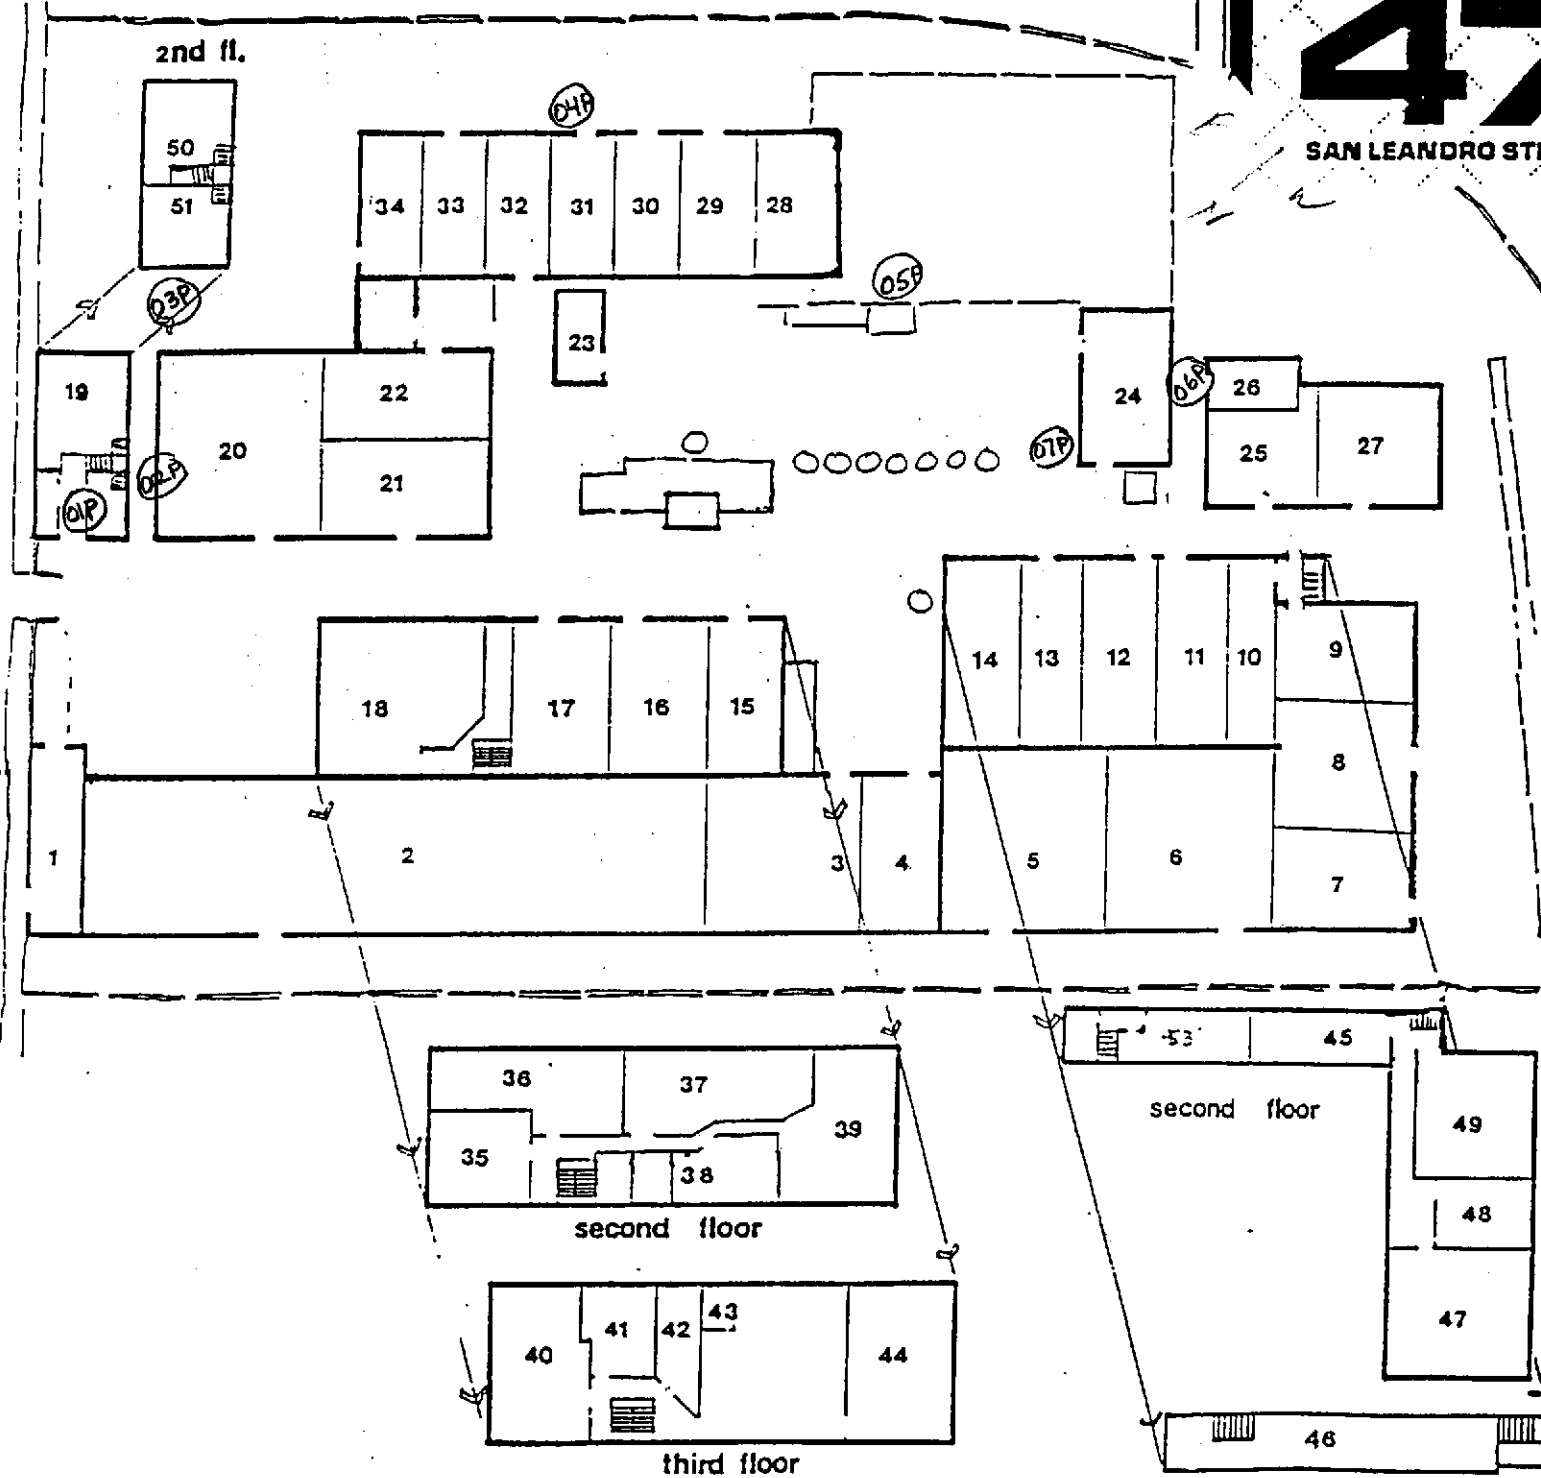
Paint Chip  
Sample Locations

Sample#	Component	Location	Result (ppm)	Standard (ppm)	Child Access	Condx	Risk
01P	Wall	2nd doorless entry to Bldg. #19 (West wall)	135,853	5000	high	poor	high
02P	Roll-up door	East entrance into Bldg. #20	338,559	5000	high	poor	high
03P	Wall (wood siding)	East wall of addition to Bldg. #20	25,730	5000	high	poor	high
04P	Wall (corrugated metal)	South side of Bldg. #31 @ entrance	76,171	5000	high	poor	high
05P	Door	South side of shed in center of complex	204	5000	high	poor	moderate
06P	Wall (wood siding)	West side of Bldg. #24	9,856	5000	high	poor	high
07P	Window well	East side of Bldg. #24	9,991	5000	high	poor	high

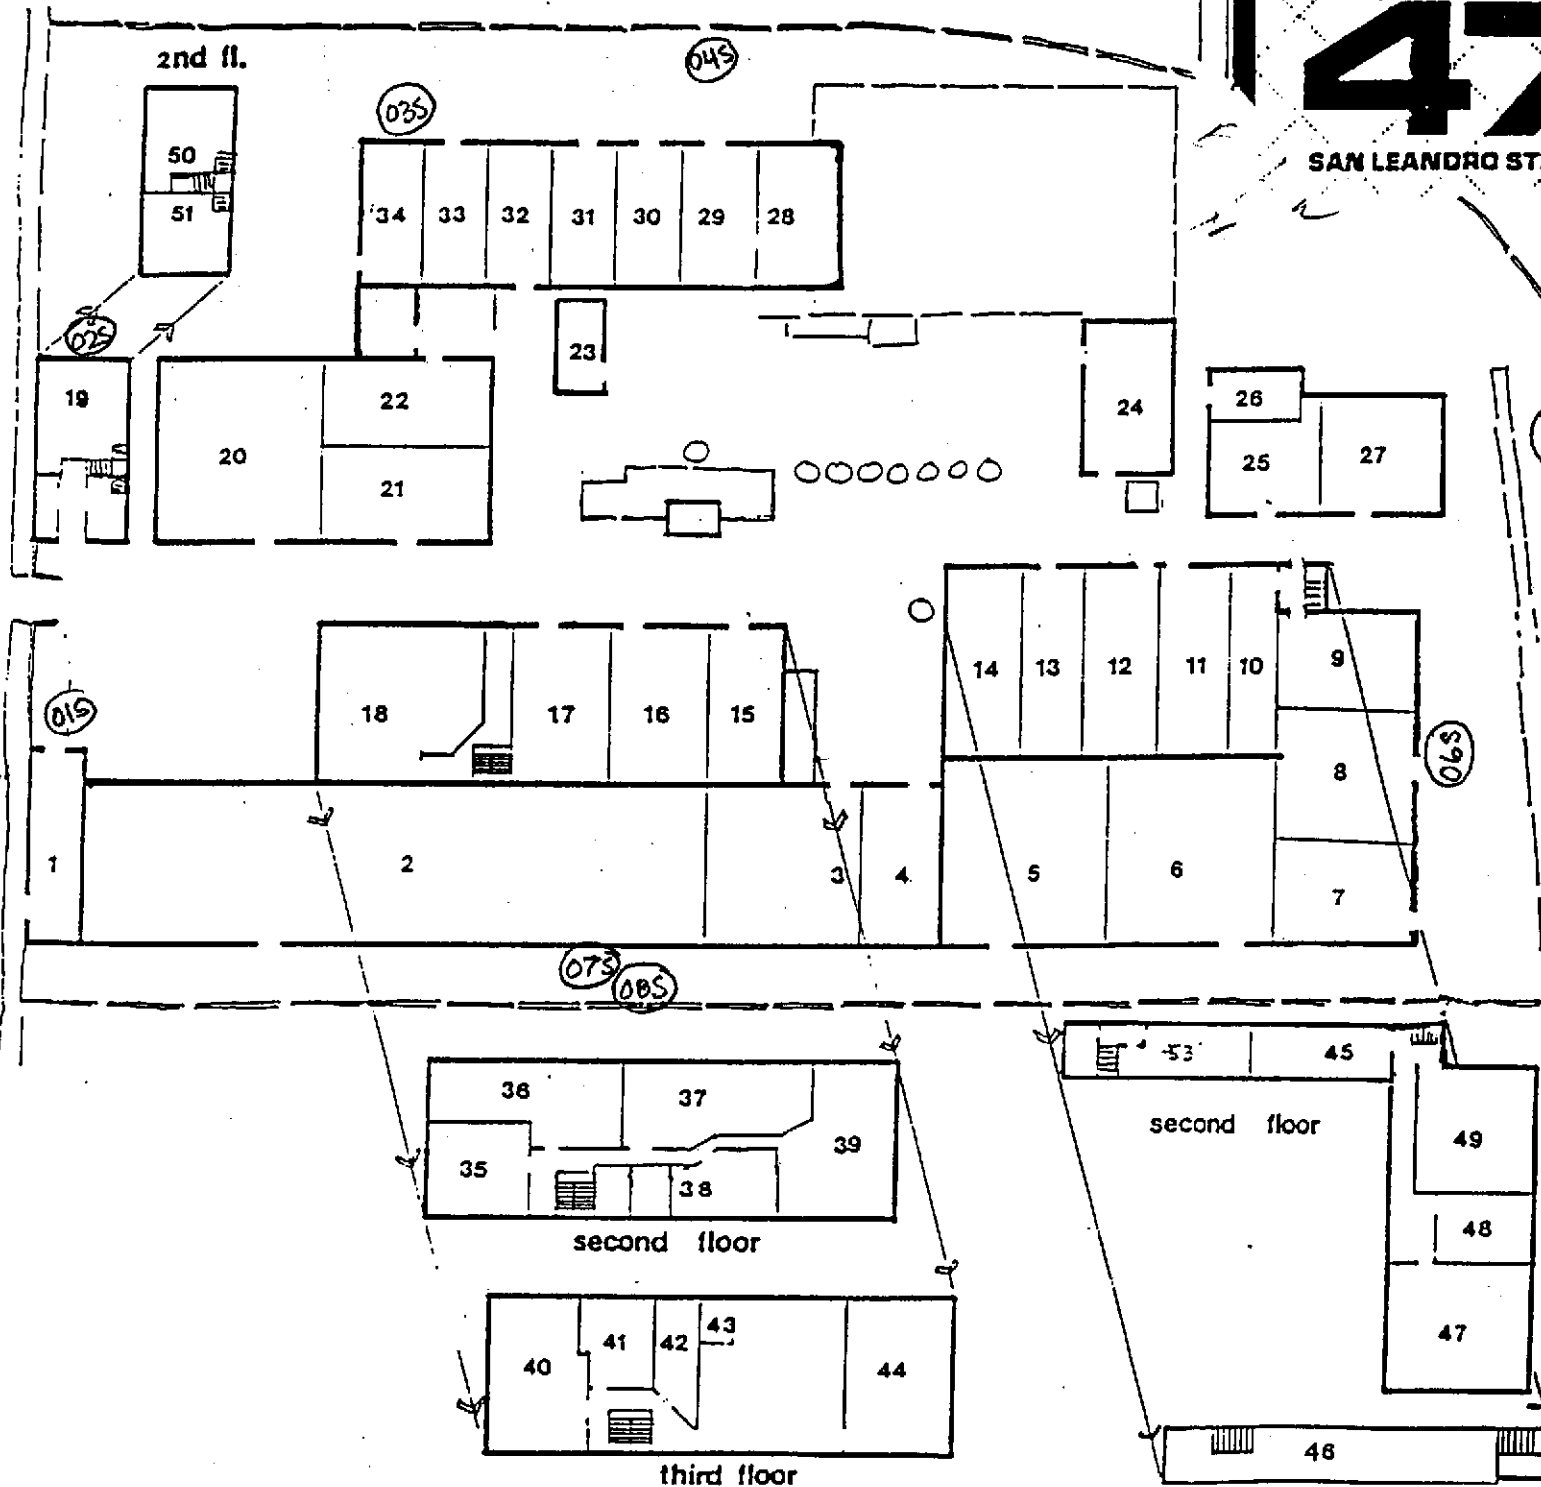
Soil Sample  
Locations

Sample #	Location	Result (ppm)	Standard (ppm)	Ground Cover	Risk
01S	Front of entrance to Bldg. #1	651	500	95.00%	moderate
02S	Rear of Bldg. #19	879	500	90.00%	moderate
03S	Near train tracks Southeast side of property	156	500	90.00%	low
04S	Near train tracks Southwest side of property	24,536	500	50.00%	high
05S	West side of property behind Bldg. #27	1,277	500	40.00%	high
06S	West side of property behind Bldg. #8	325	500	60.00%	low
07S	Child play area outside Bldg. #2	58	500	0.00%	low
08S	Garden outside Bldg. #2	696	500	40.00%	moderate
