Re: TSA Oakland ARC Warehouse Building's basement's elevation and the configuration of the warehouse's three elevators.
The Salvation Army Adult Rehabilitation Center
601 Webster Street
Oakland, CA 94607

Subject: Report on Survey of Basement Elevation and Elevator Configuration
The Salvation Army ARC Building
601 Webster Street,
Oakland, California,
ACEH Fuel Leak Case No. RO3084
Geotracker Global ID T10000003428
ATC Project No: Z054000006

PHOTOS - Elevation Survey of Basement

PHOTOS - Elevators in ARC Building

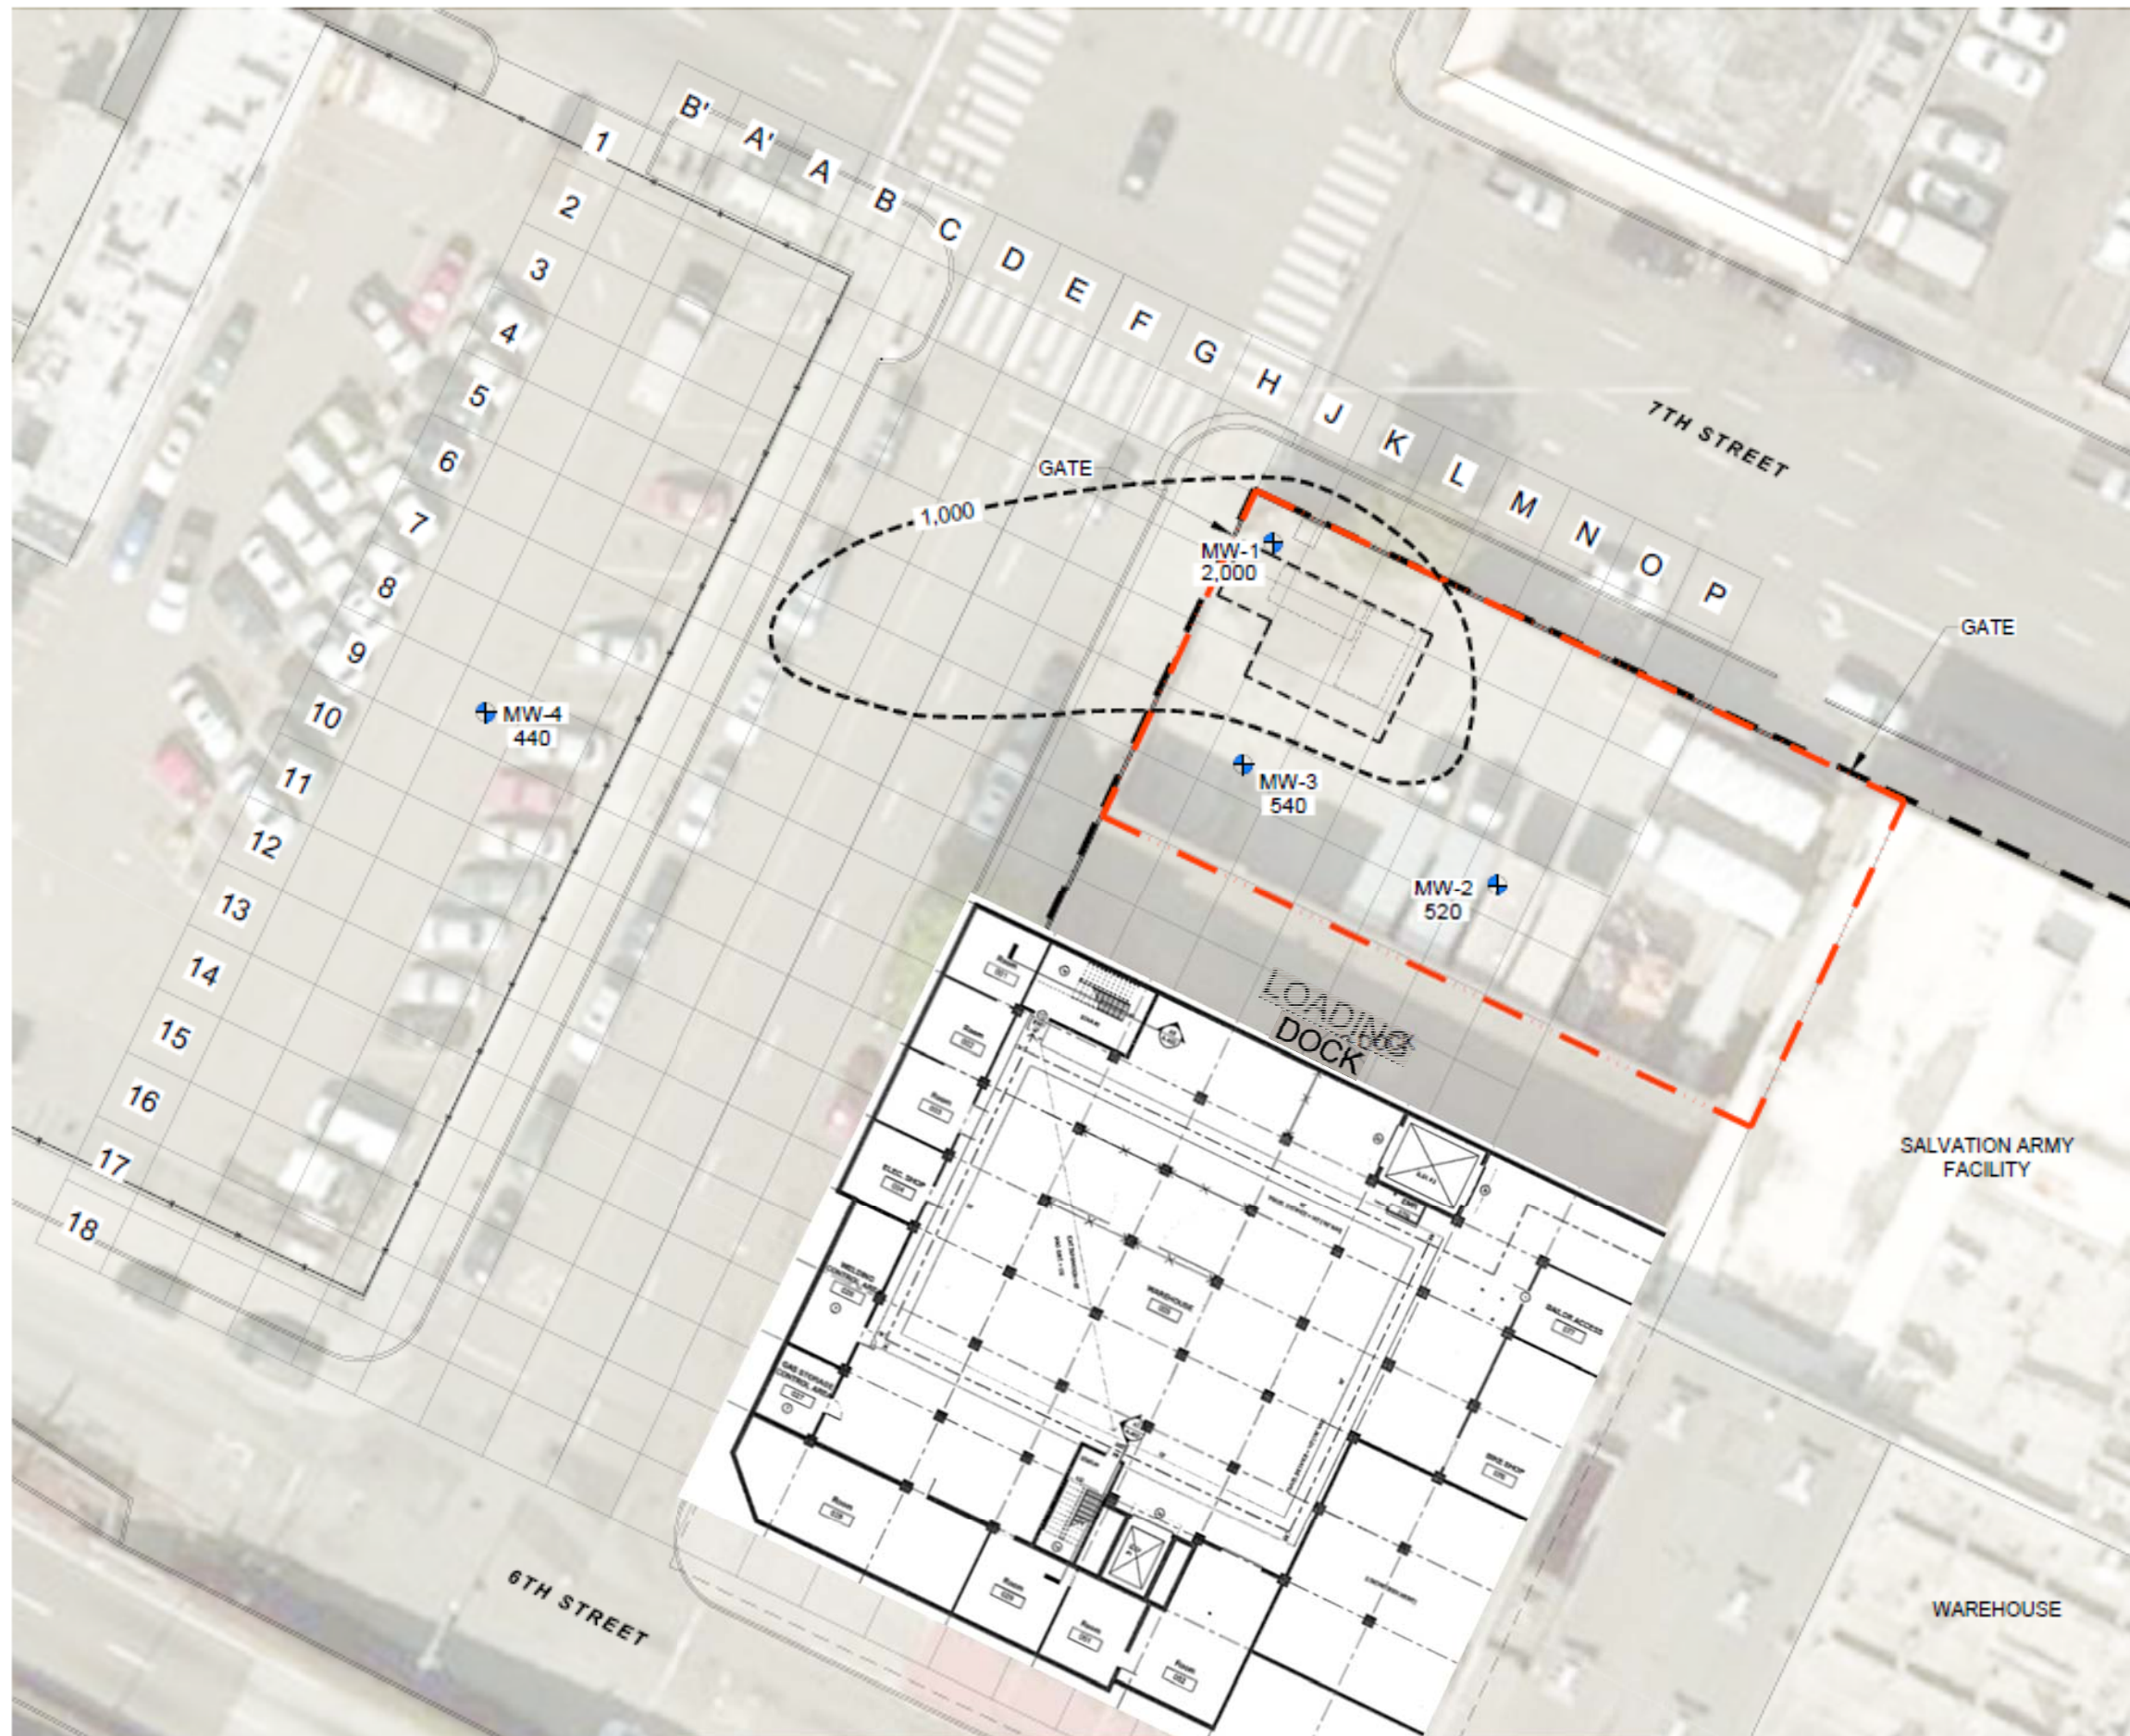
Figure 1

Results of assessment activities indicated petroleum hydrocarbons in soil and groundwater appear to encroach beneath the ARC warehouse building (**Figure 1**). Based on reported dissolved benzene concentrations in groundwater, vapor intrusion risks to structures at the site may be present.

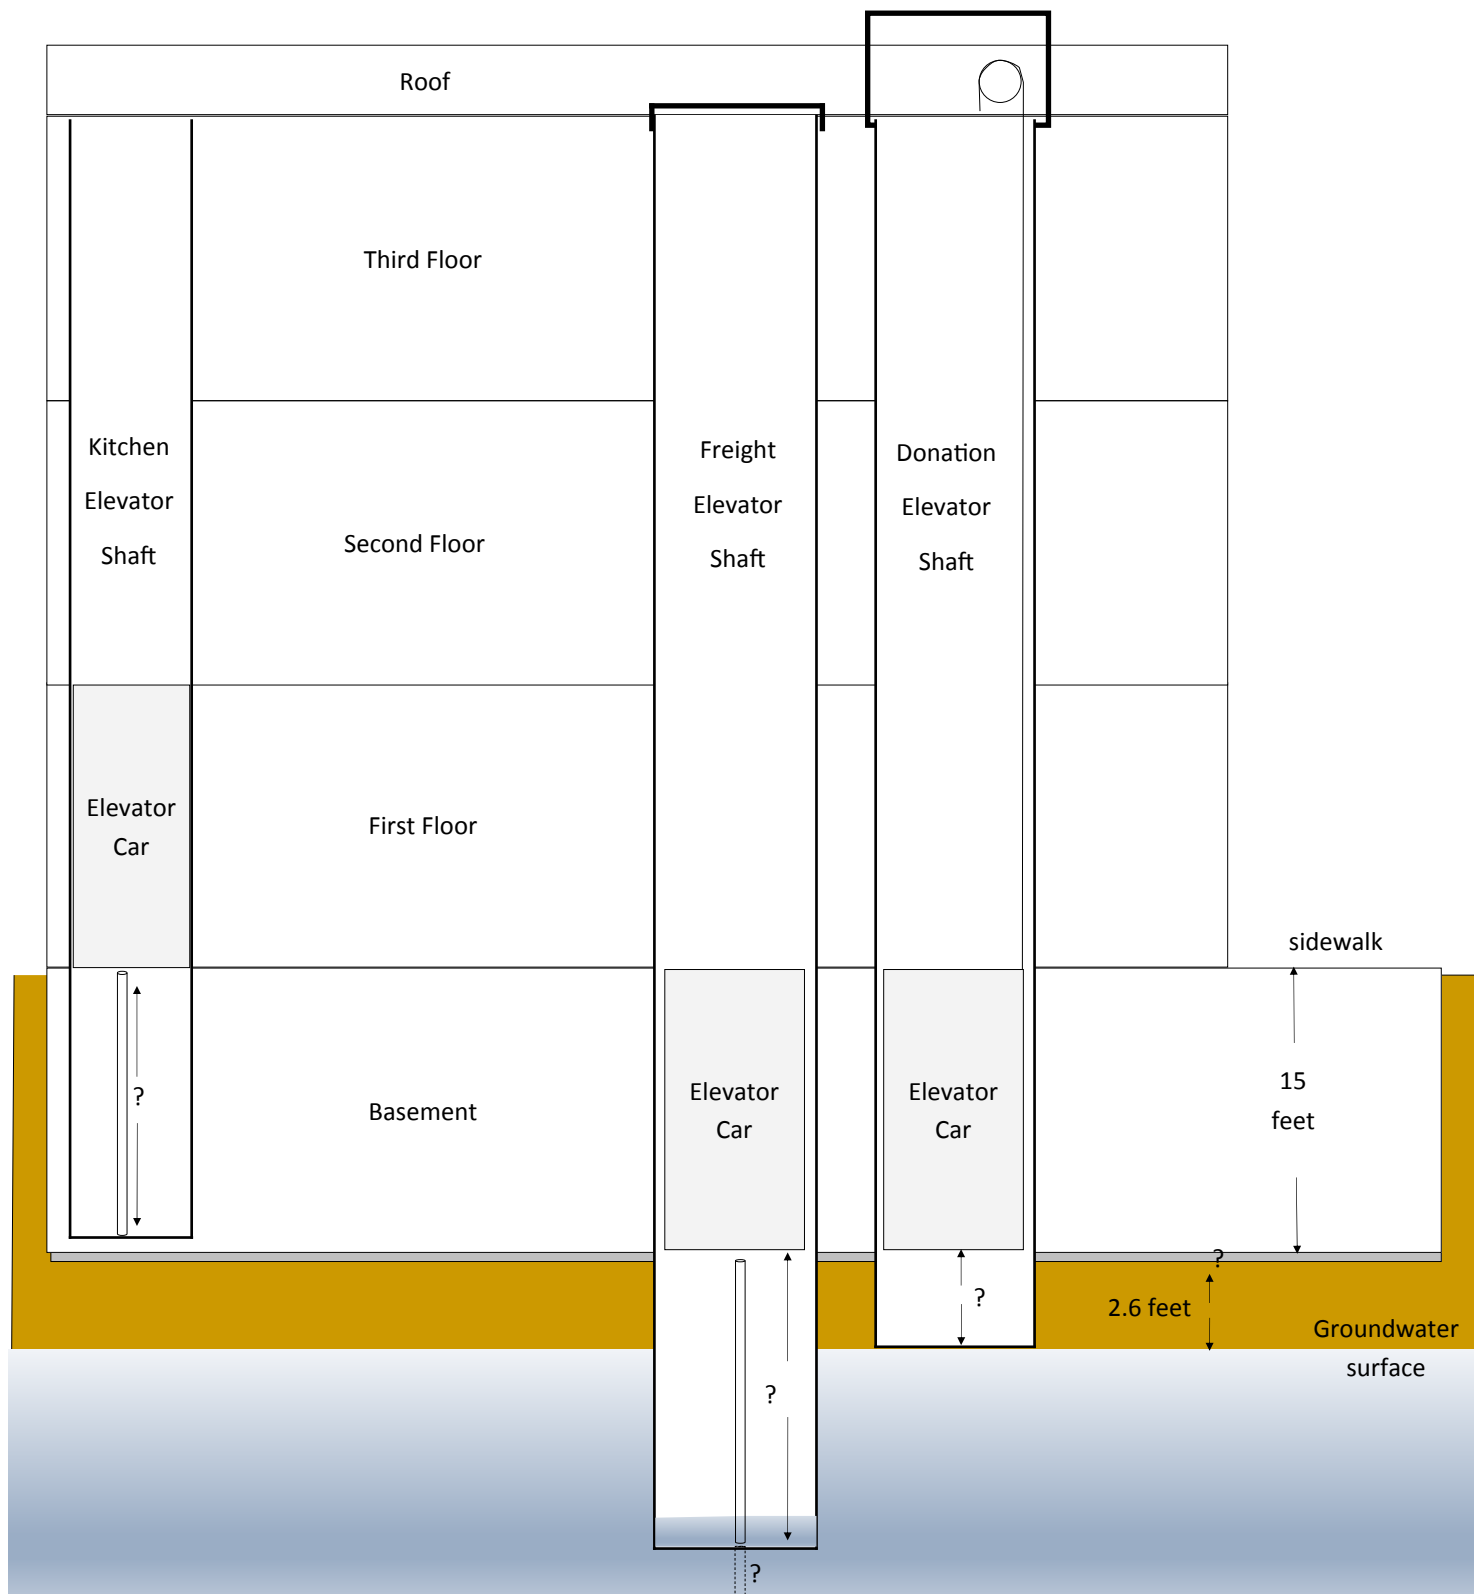
**Fig
2**

On May 11, 2016, ATC performed a basic level survey to determine the elevation of the basement floor. ATC used an optical level survey instrument to perform the survey using the top of well casing of MW1 as the base elevation. The elevation of the basement floor surface was determined to be approximately 16.25 feet lower than the top of casing of MW1. When measured on May 11, 2016, the depth to groundwater in MW1 was approximately 19.45 feet below the top of the casing. Assuming a basement slab thickness of one foot, groundwater is expected to be approximately 2.2 feet below the basement foundation bottom.

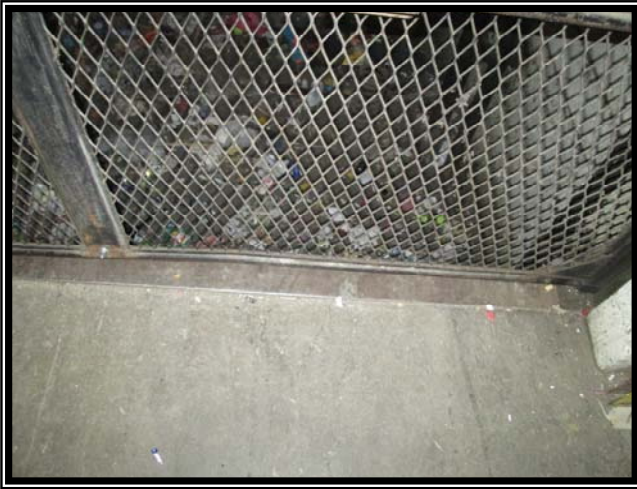
PHOTO 5:

The donation elevator is located on the south side of the warehouse building near Sixth Street. This elevator is a traction-type elevator with the entirety of its lifting mechanisms located exclusively on the roof. The shaft for the donation elevator does extend below the plane of the basement floor approximately 5 to 7 feet. The portion of the shaft extending below the plane of the basement floor was visible. This portion of the shaft did not appear to contain any equipment and it was observed to be dry (**Photo 5**).

View of the Donation elevator shaft that extends below the floor of the TSA ARC Building basement. No water is visible.

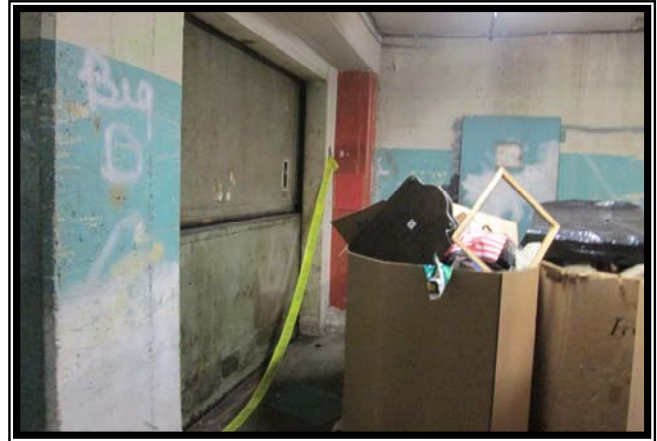
PHOTO 6:

Access door to Freight elevator in TSA ARC Building basement.

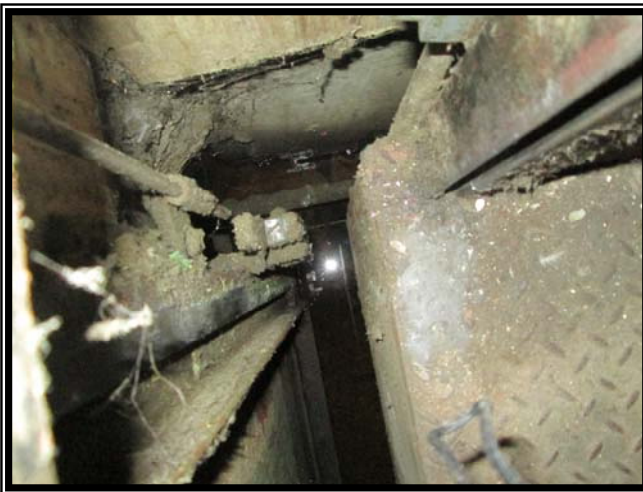
PHOTO 7:

The freight elevator is located on the north side of the warehouse building near the truck enclosure loading dock. TSA sources say that this elevator is in need of repair so it currently is not operational. The shaft extended well below the basement floor but an exact distance could not be measured due to the limited access issues. The mechanisms for lifting were located in the space below the basement floor and this space was observed to be flooded (**Photos 7-8**). None of the available sources of information at TSA could confirm the existence or provide details about any sumps for this elevator.

Gap between the Freight elevator car and its shaft used to view Freight elevator shaft extending below basement floor. Note flash reflection off standing water in elevator shaft.

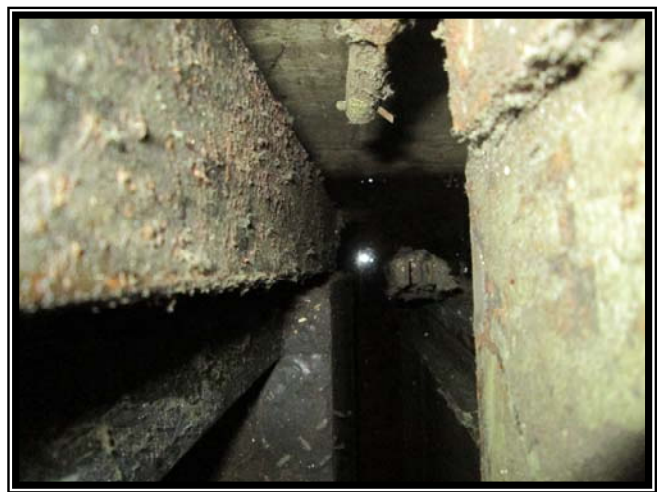
PHOTO 8:

Similar but slightly different view of the Freight elevator shaft extending below basement floor. Note flash reflection off standing water in elevator shaft.
