# RECOMMENDATIONS FOR UNDERGROUND STORAGE TANK CLOSURE FORMER NIELSEN FREIGHT LINES TRUCKING FACILITY EMERYVILLE, CALIFORNIA

Project: 8710018B

Re: RECOMMENDATIONS FOR UNDERGROUND STORAGE TANK CLOSURE

FORMER NIELSEN FREIGHT LINES TRUCKING FACILITY

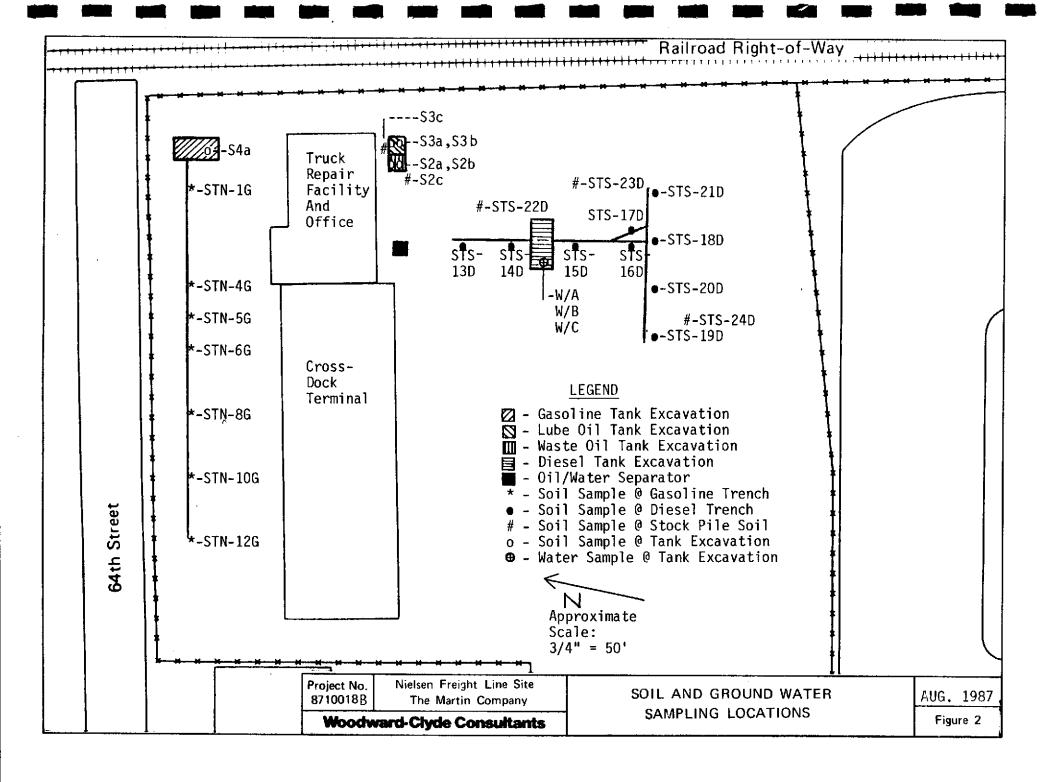
These tanks and manifolds are shown in Figure 2.

analytical laboratory. The locations of samples submitted for analytical testing are shown in Figure 2.

Staining was observed at a number of locations along the base of the diesel manifold trench after it was deepened. Thus, a headspace survey was not done. Rather, samples were taken at about 50 foot intervals to confirm the continued presence of diesel fuel in the soil. These sampling locations are also shown in Figure 2.

The soil and groundwater sample numbers are coded on Figure 2 and are listed in the next two subsections for clarity. Refer to Figure 2 - SOIL AND GROUNDWATER SAMPLING LOCATIONS.

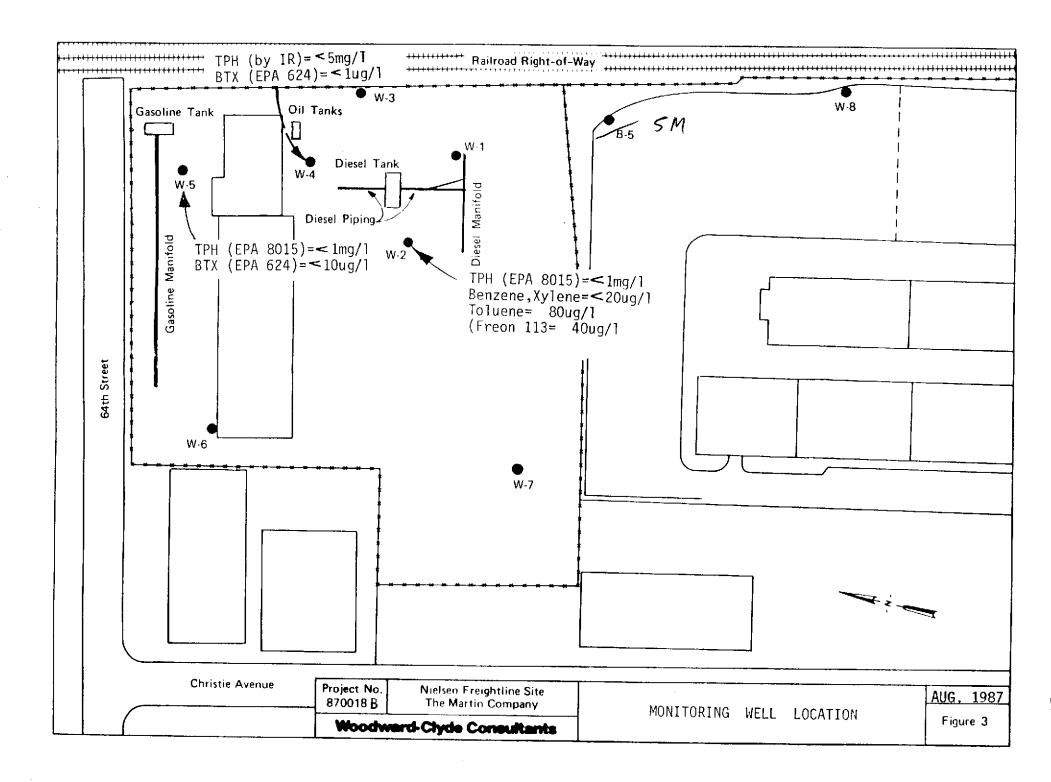
FIGURE 3 - MONITORING WELL LOCATION

As noted in Section 1.0, observation of the tank removals and closure planning are part of a larger site assessment effort. That effort includes the installation of eight groundwater monitoring wells at the locations shown in Fig. 3. Well B-5 was installed on the Marketplace property as part of a previous study (WCC, 1982). Based on existing regional groundwater hydrology, Wells W2, W4, and W5A were located in positions projected to be down-gradient of the diesel, oil, and gasoline tanks, respectively. These monitoring wells are about 30 to 50 feet from the former tank locations. The laboratory test results for TFH, BTX, and ethylbenzene for groundwater samples from monitoring Wells W2, W4, and W5A are indicated on Figure 3. Refer to Figure 3 - MONITORING WELL LOCATIONS. Additional site groundwater information is contained in an accompanying environmental assessment report (WCC, 1987).
