Alameda County CUPA Program
Contaminated Site Case Transfer Form

g. DESCRIPTION: Per NRC FAX: Caller is reporting a release of an unknown amount of PCB's from three transformers at an office building complex, the cause was due to theft, caller stated that someone came to the area and knocked over the transformers. REMEDIAL ACTIONS, Clean-up completed samples of concrete are being conducted.

Re: Emeryville PCBs

Subject: PCB Consulting Services – Hidden Condition Sampling/Clearance
5750-5780 Hollis Street AKA Building A Basement
Project #75.75077.0004

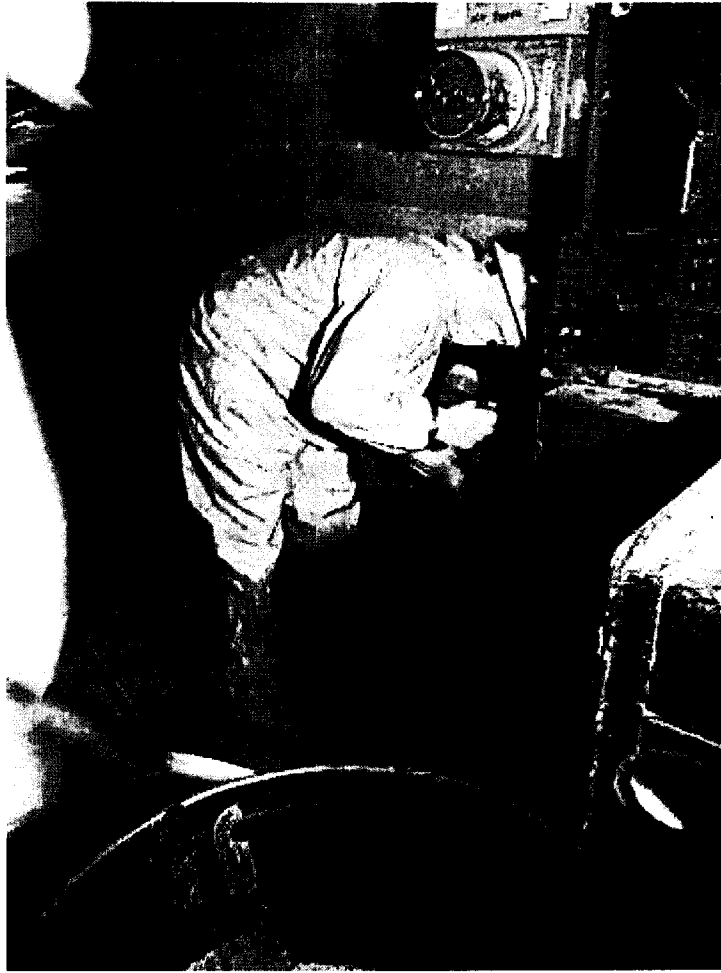
Sweeping

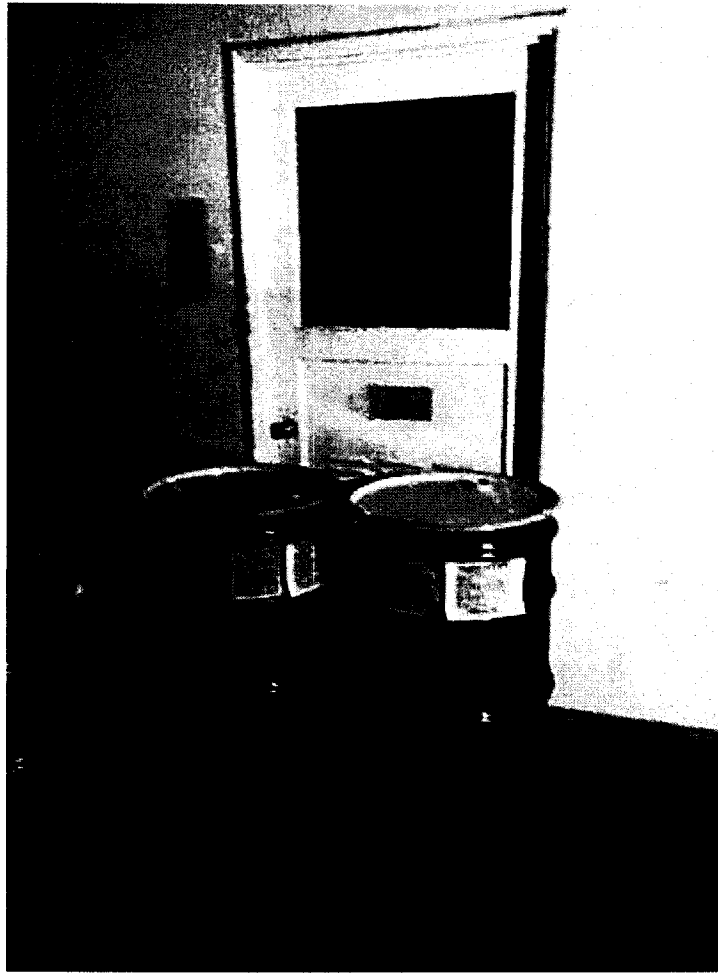
How we left it. Complete with signage.
