RE: Work Plan, Additional Subsurface Investigation, Properties at 760 22nd Street and 2201 Brush Street, Oakland, California 94612

June 6, 2012

**RESULTS OF SUPPLEMENTAL GEOPHYSICAL SURVEY
760 22nd STREET SITE
OAKLAND, CALIFORNIA**

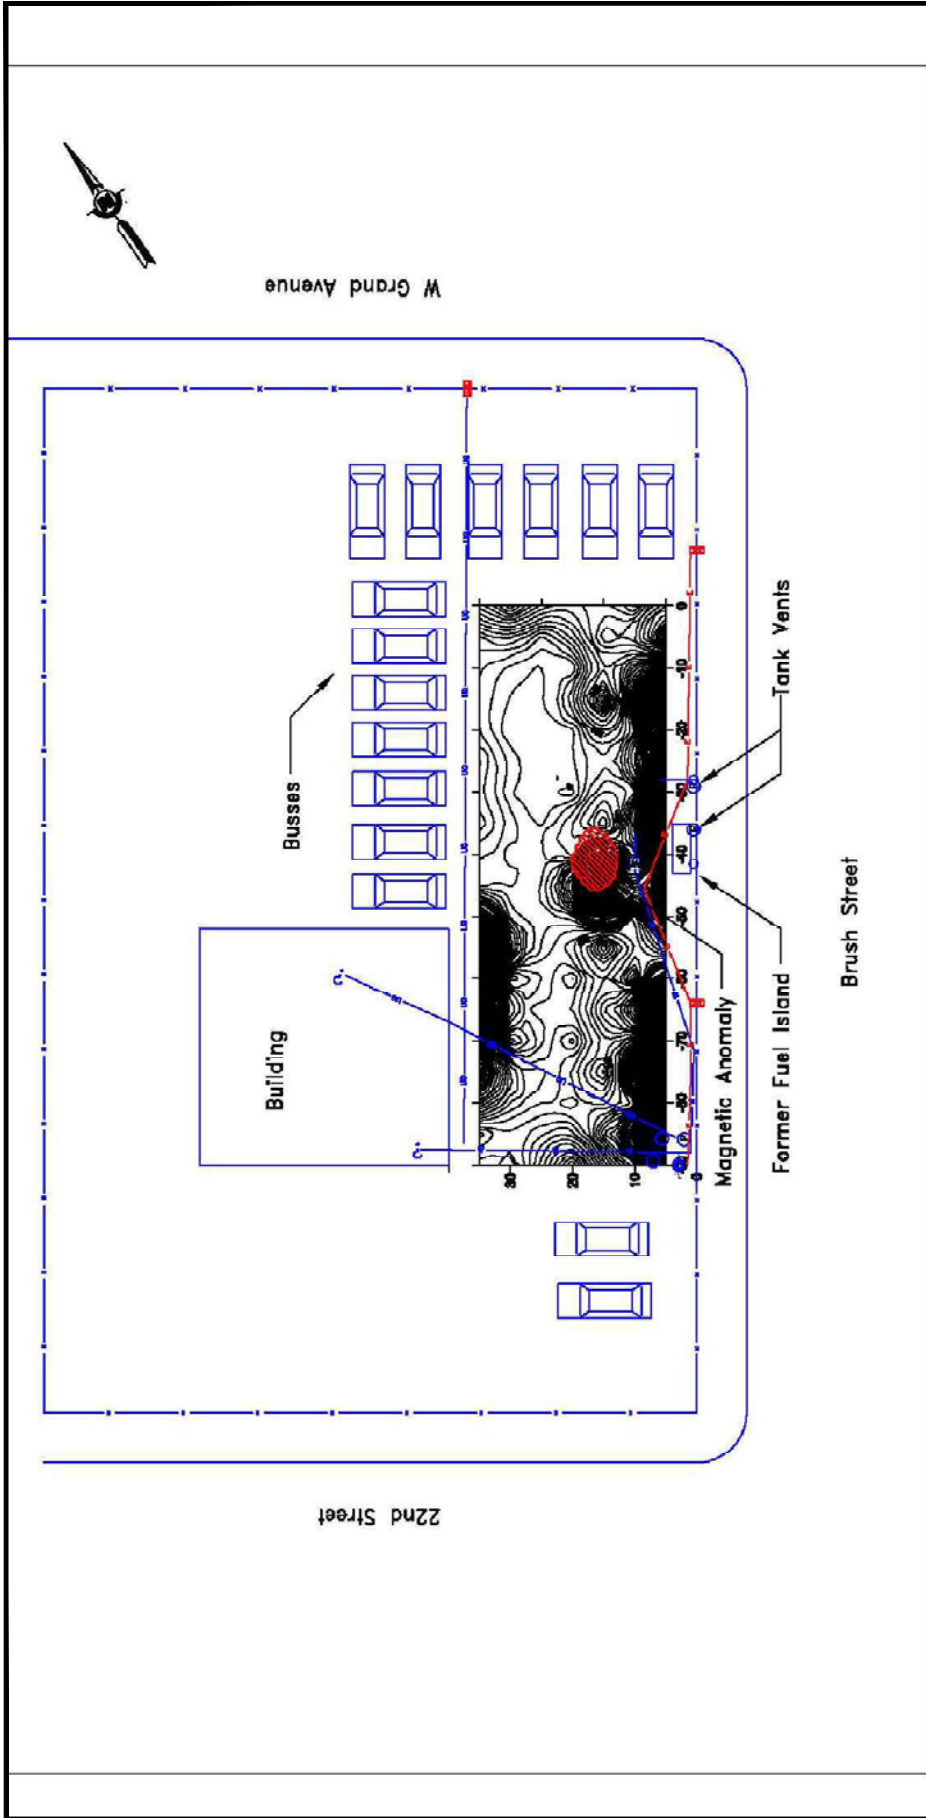
The results of the geophysical survey are shown on Total Field Magnetic Contour Map (map) and GPR images included in Appendix A. As indicated on these figures, the survey located the following features:

- Two pipelines on the eastern side of the Oil Change Building, both of which extended into it. The southernmost line is interpreted to be water and the second line is interpreted to be electrical (note that that the electrical line runs toward the building from a power pole near Brush Street). As shown on the map in Appendix A, the water line makes a 90 degree turn near the property boundary to the north in a sub-parallel direction to Brush Street;

- An electric line that runs sub-parallel to Brush Street;
- Two tank vent pipes near the former fuel island; and
- A metallic anomaly located in the same location as the metallic anomaly found during the initial geophysical survey. As shown on the GPR images included in Appendix A, the metallic anomaly appears to be a near surface feature. JR Associates indicated that the metallic anomaly is very shallow and does not extend down vertically and does not appear to be a UST-related feature.

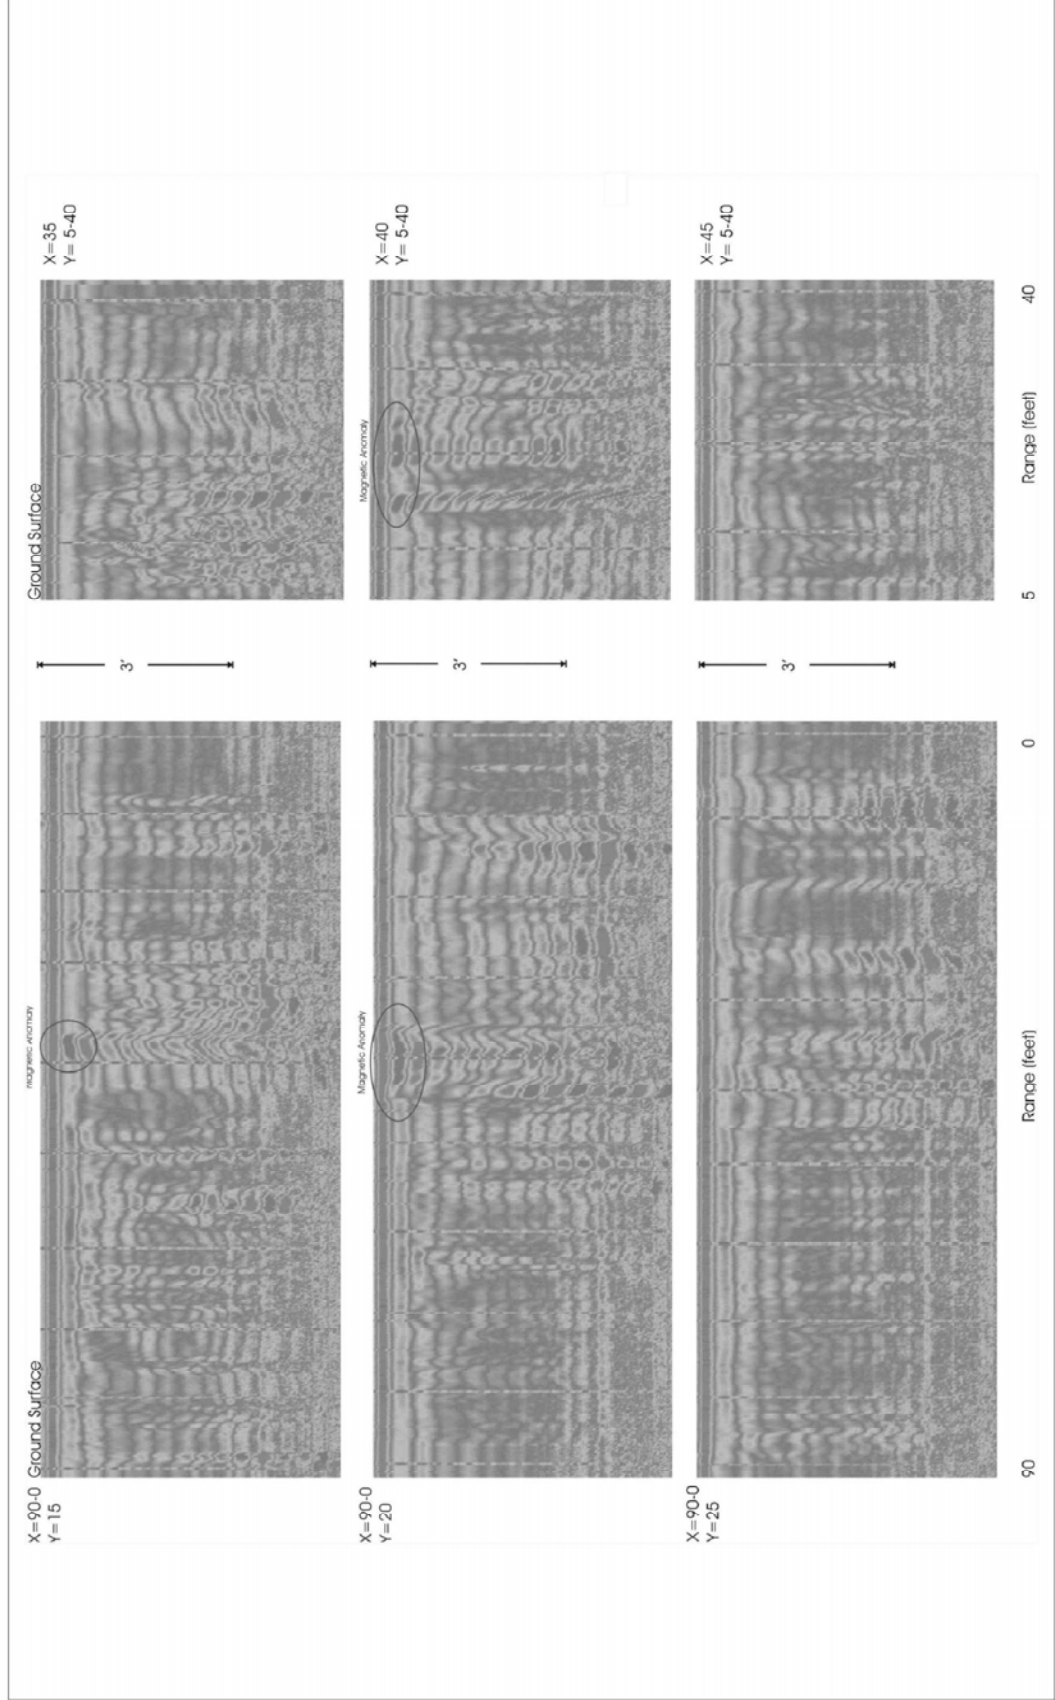
GPR Images

The results of the supplemental geophysical survey do not suggest that a UST(s) or similar metallic feature is present beneath or in the vicinity of the irregularly-shaped metallic anomaly found during both geophysical investigations. Based on the results of the supplemental geophysical survey, JR Associates indicated that the metallic anomaly is very shallow and does not extend vertically significantly beyond the ground surface. In addition, the results of this investigation do not suggest that a UST or similar metallic feature is present beneath the building. The two lines eastern side of the Oil Change Building, both of which extended

Based on the results of the supplemental geophysical survey, no addition work is recommended.
