**REMOVAL ACTION COMPLETION REPORT:
Mercury Removal Project, 1315 Court Street, Alameda, California, 94501
(Site Cleanup Program Case #RO0003167)**

**Report Prepared by: Turner/Maclane Environmental Consulting Inc.
December 28, 2015**

REMOVAL ACTION COMPLETION REPORT:
1315 Court Street, Alameda, California

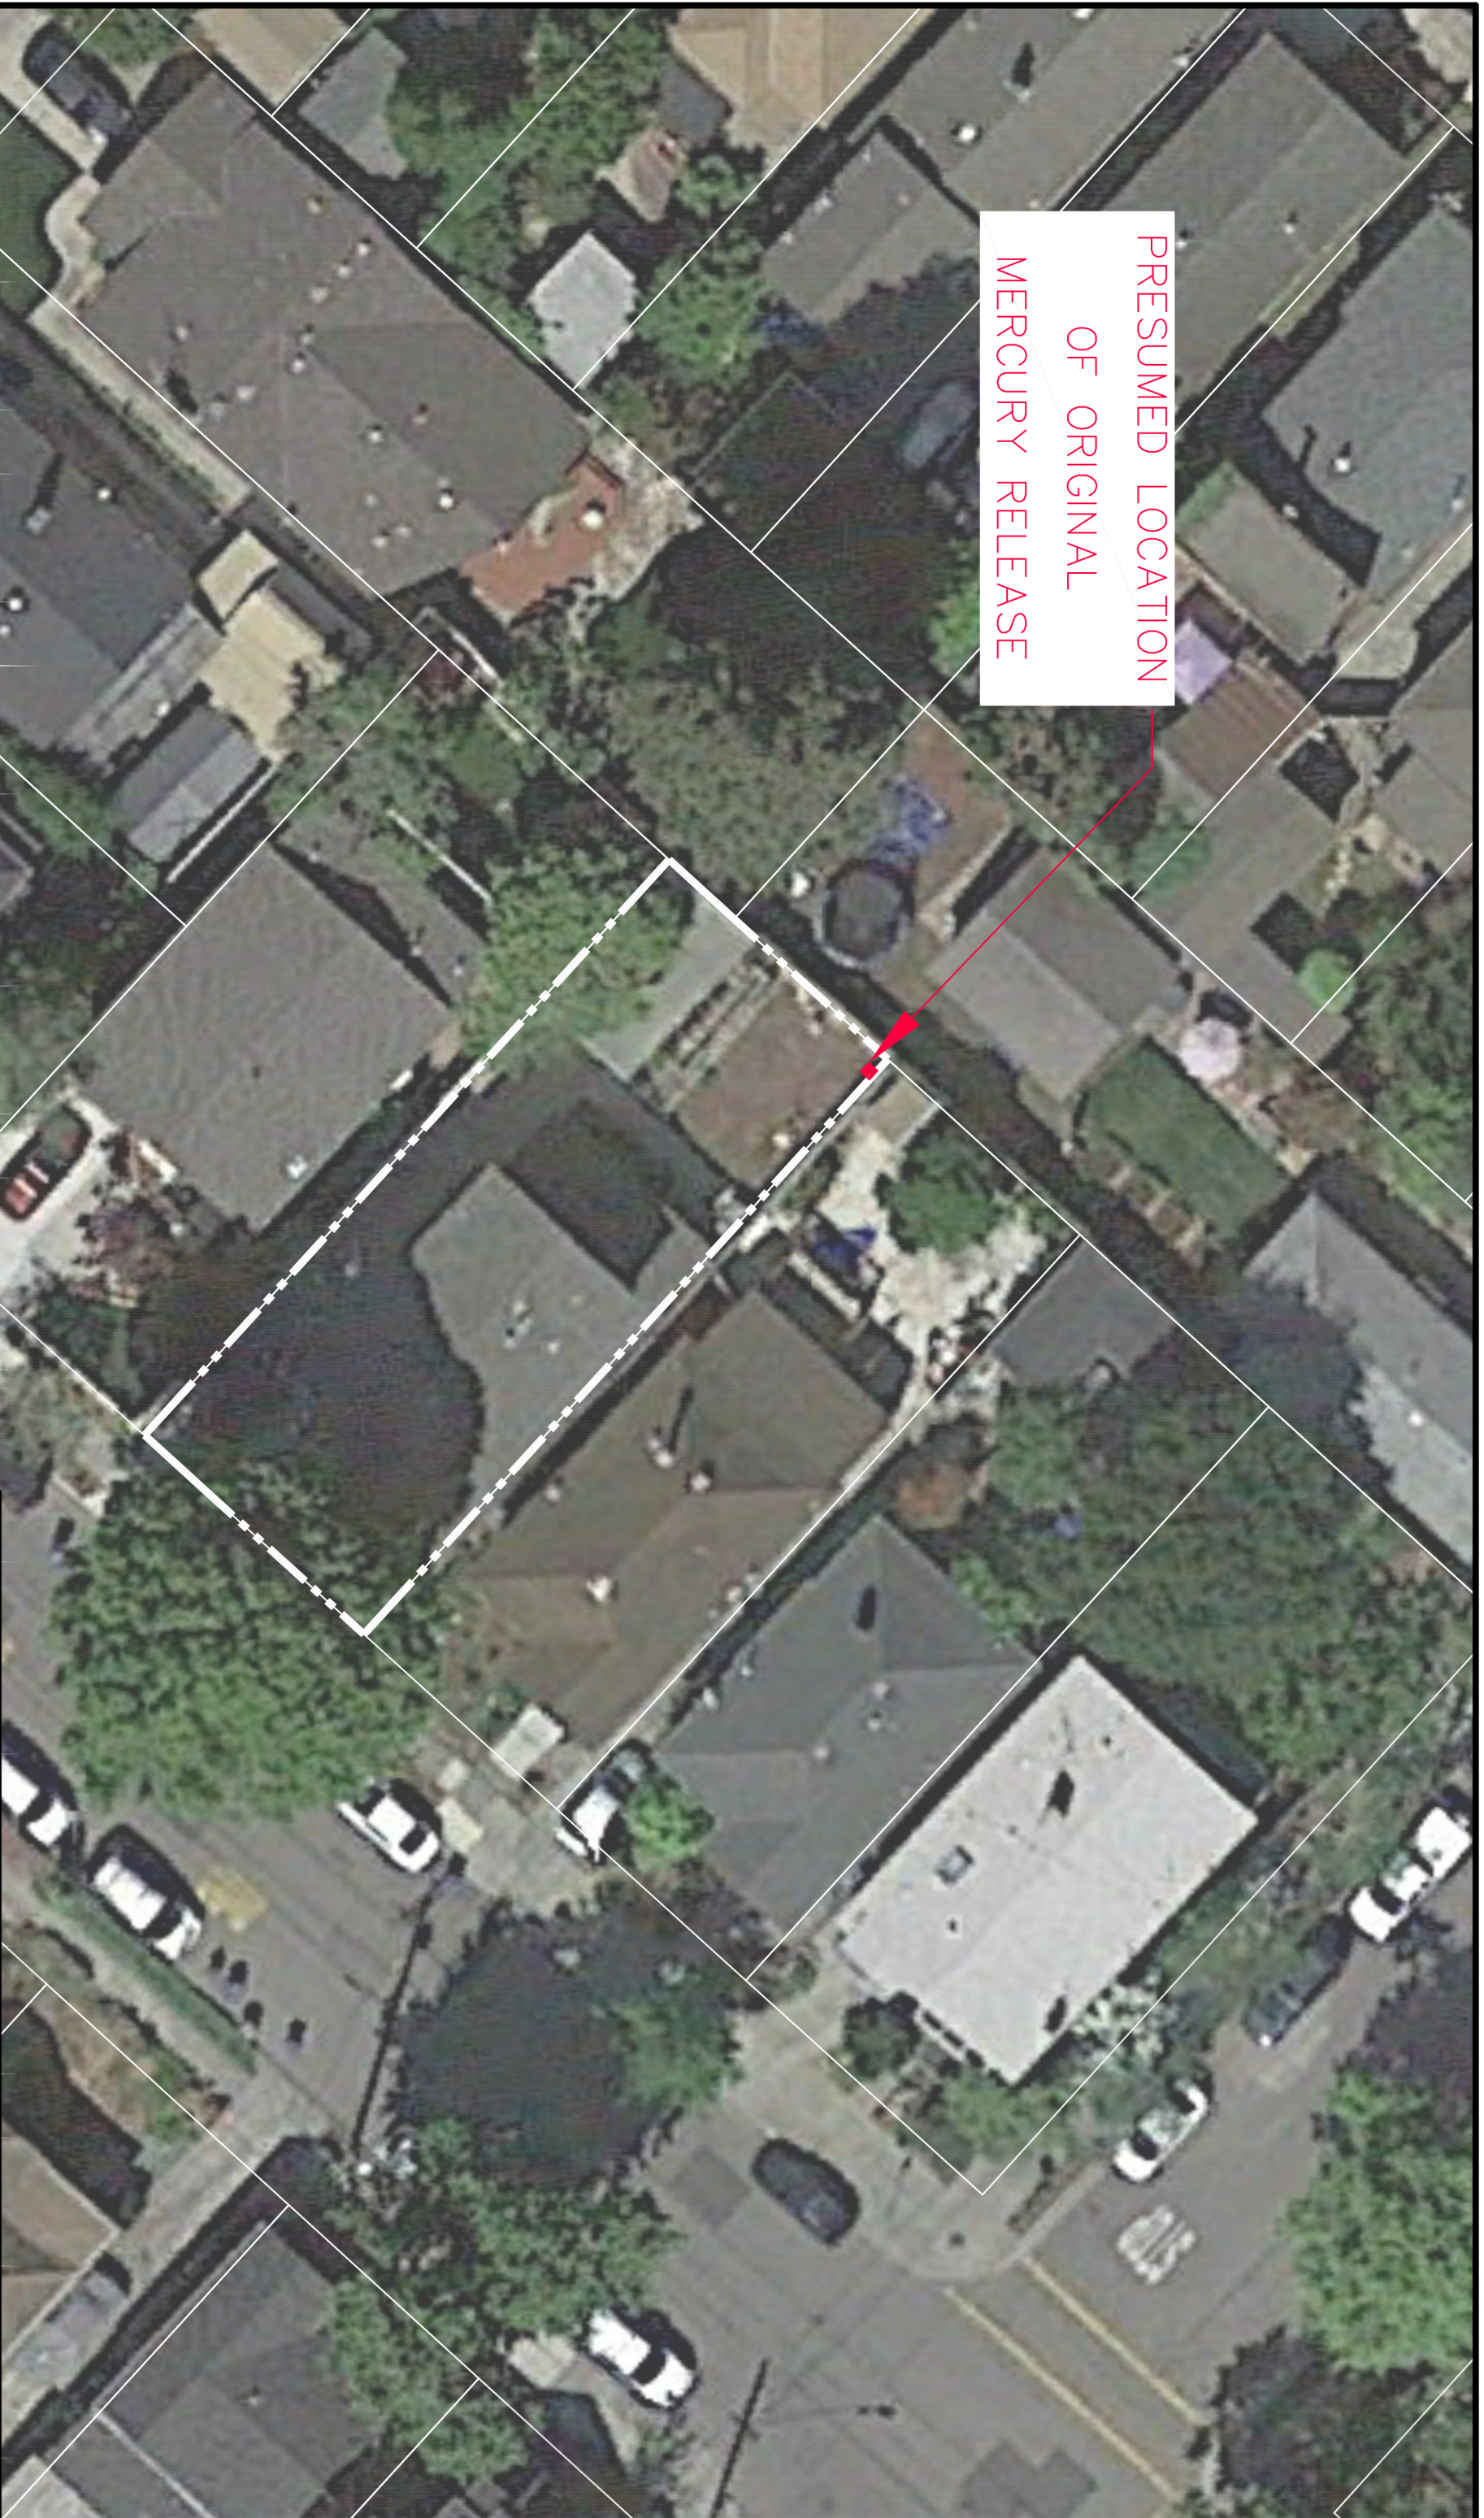
FIGURE #1
SITE LOCATION; 1315 COURT STREET

On January 21, 2014, Mr. Paul Meuser (owner of the subject residence) contacted the California Emergency Management Agency and the National Response Center to report a finding of elemental mercury, in soil, at the rear of his home at the subject address. The Alameda County Department of Environmental Health (ACDEH) was contacted and, in turn, contacted the Department of Toxic Substances Control (DTSC). Ultimately, on January 29, 2014, the DTSC emergency response contractor, Parc Specialty, arrived on site to conduct an initial evaluation and limited cleanup of an elemental mercury release. (The residence and spill release area are shown on Figure 1.)

PRESUMED LOCATION
OF ORIGINAL
MERCURY RELEASE

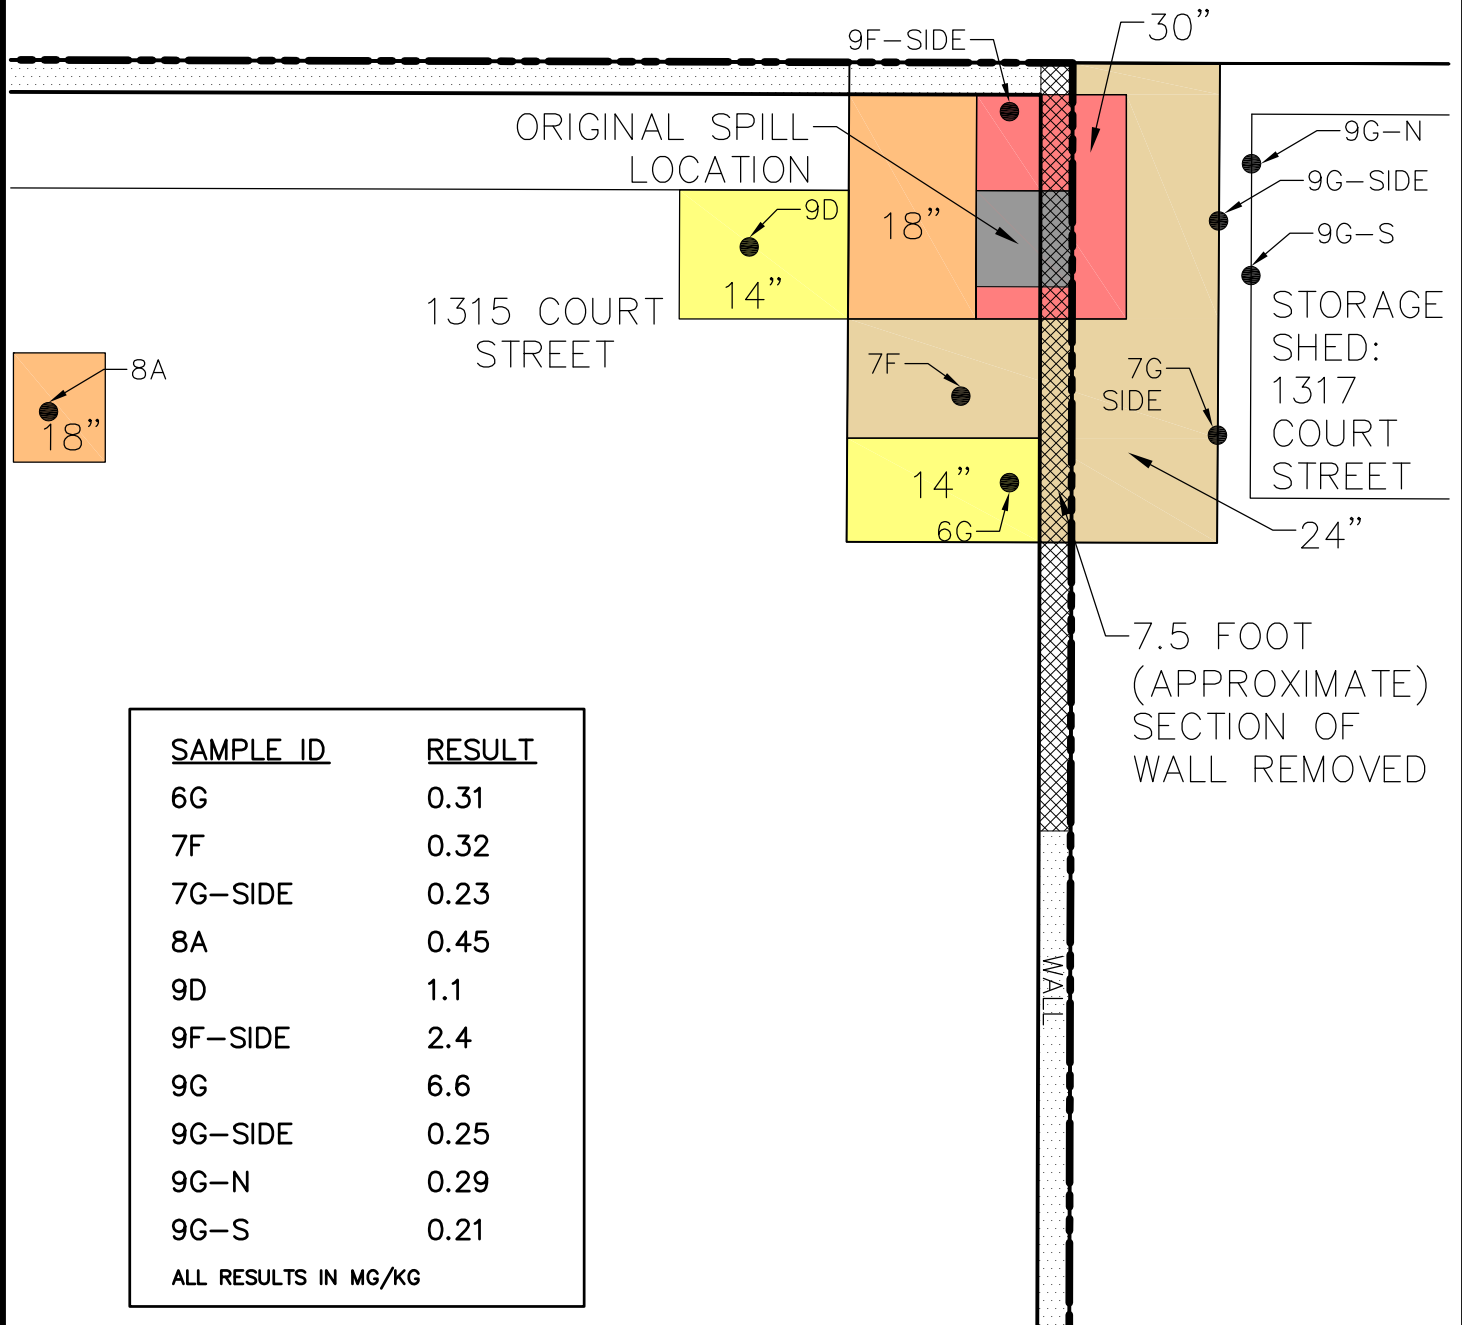
FIGURE #2
 1315 COURT STREET, ALAMEDA CA
 WALL REMOVAL AND SOIL
 EXCAVATION

The complete certified laboratory reports for this project are provided in the attachments to this report. The results indicate that all of the confirmation samples were below the Environmental Screening Level of 6.7 mg/kg established by the Regional Water Quality Control Board. The extent of the removal action, and the laboratory results are shown graphically on the attached Figure #2. The Certified Analytical results for all 1 results for total mercury, as reported for the ten confirmation soil samples. (A photo of the completed excavation, remaining block wall, and storage shed is shown in Photo #8.)

SAMPLE ID	RESULT
6G	0.31
7F	0.32
7G-SIDE	0.23
8A	0.45
9D	1.1
9F-SIDE	2.4
9G	6.6
9G-SIDE	0.25
9G-N	0.29
9G-S	0.21

ALL RESULTS IN MG/KG

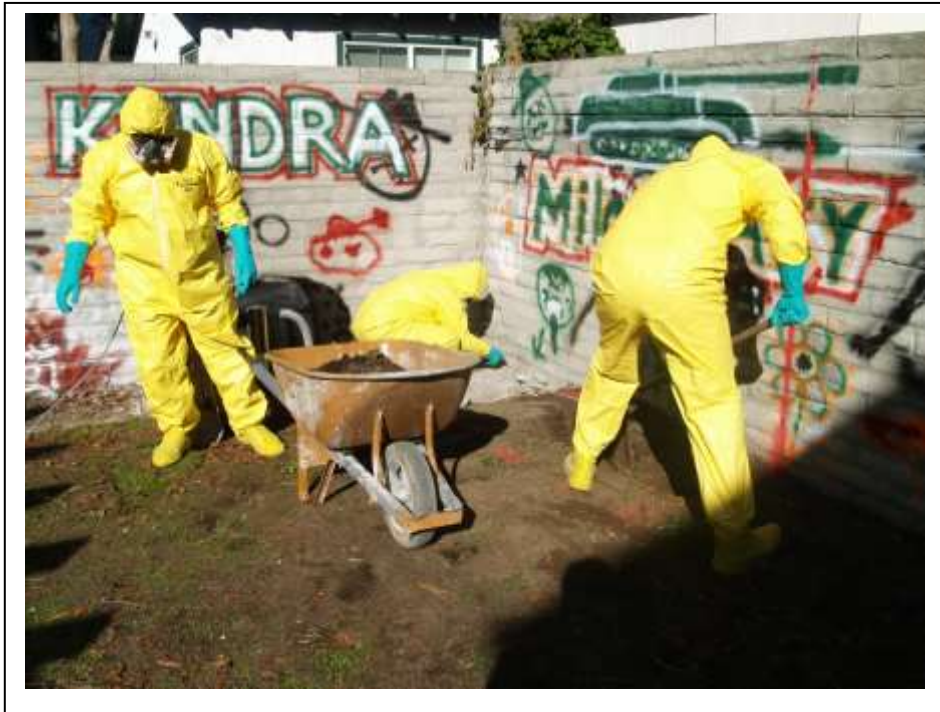
During the course of the removal project, soil and brick surfaces were carefully examined. The mercury vacuum was utilized to remove all visible traces of mercury encountered during the project (Photo #1).

Project No. TM #12.01.15	Description	Initial removal and Mercury vacuuming	Photo #1
	Name	1315 & 1317 Court St. Alameda CA.	Photo Date December 1, 2015

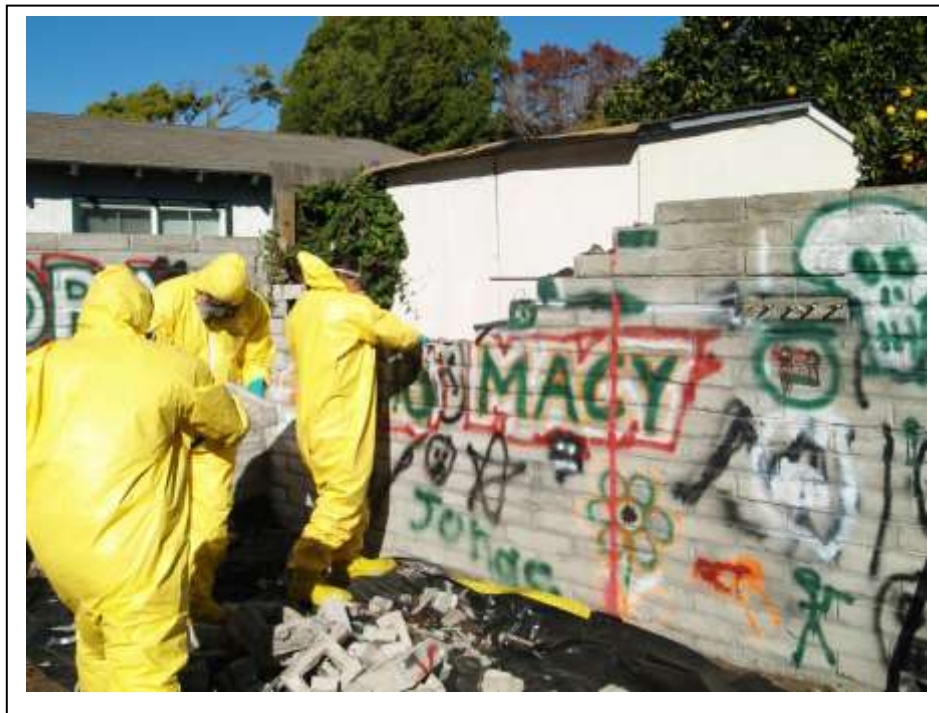
The void spaces in the concrete blocks were also carefully examined for the presence of liquid mercury (Photo #2). It is important to note that the concrete blocks showed no visual evidence of mercury contamination. In addition, following block removal, individual concrete blocks were further evaluated with the use of the Mercury Vapor Meter. No anomalous mercury readings were detected in the brick void spaces. This is a significant finding in that it was previously hypothesized at the time of the initial Turner/Maclane investigation, that a discharge from the block wall may have been the point of origin of the mercury release.

Project No. TM 12.01.15	Description	Wall Demolition and Concrete Block Inspection	Photo #2
	Name	1315& 1317 Court St. Alameda CA.	Photo Date December 1, 2015

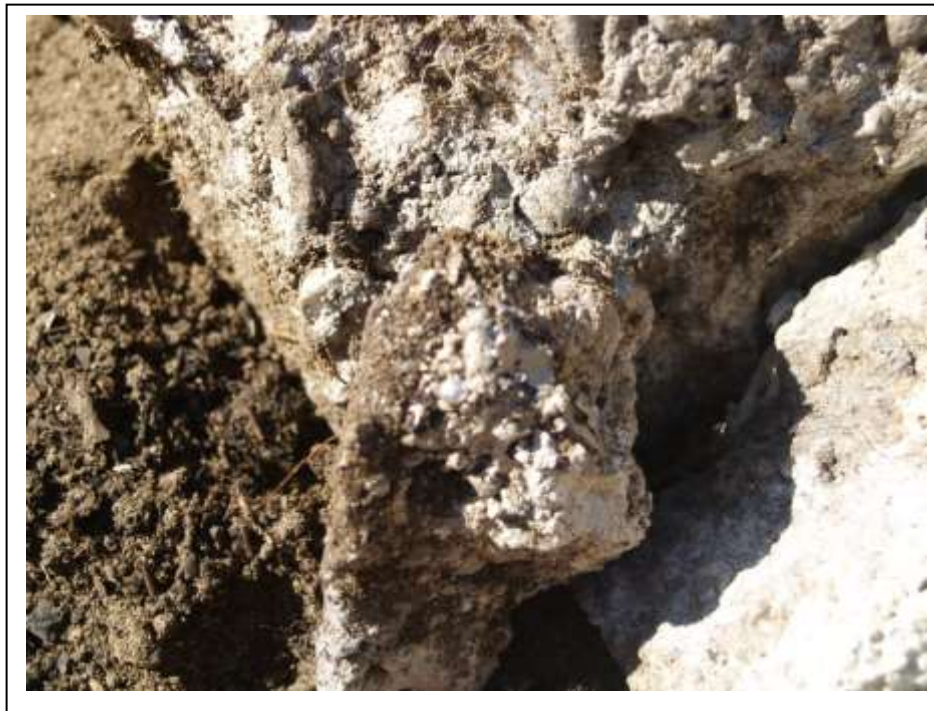
While there were no traces of mercury detected in the actual concrete blocks, mercury was observed to be present in the form of small metallic 'blebs' along the fractures present in the concrete footing that supported the block wall (Photo #3).

Project No. TM 12.01.15	Description	Disseminated 'blebs' of Mercury found on a fracture in the wall footing.	Photo #3
	Name	1315 & 1317 Court St. Alameda Ca.	Photo Date December 1, 2015

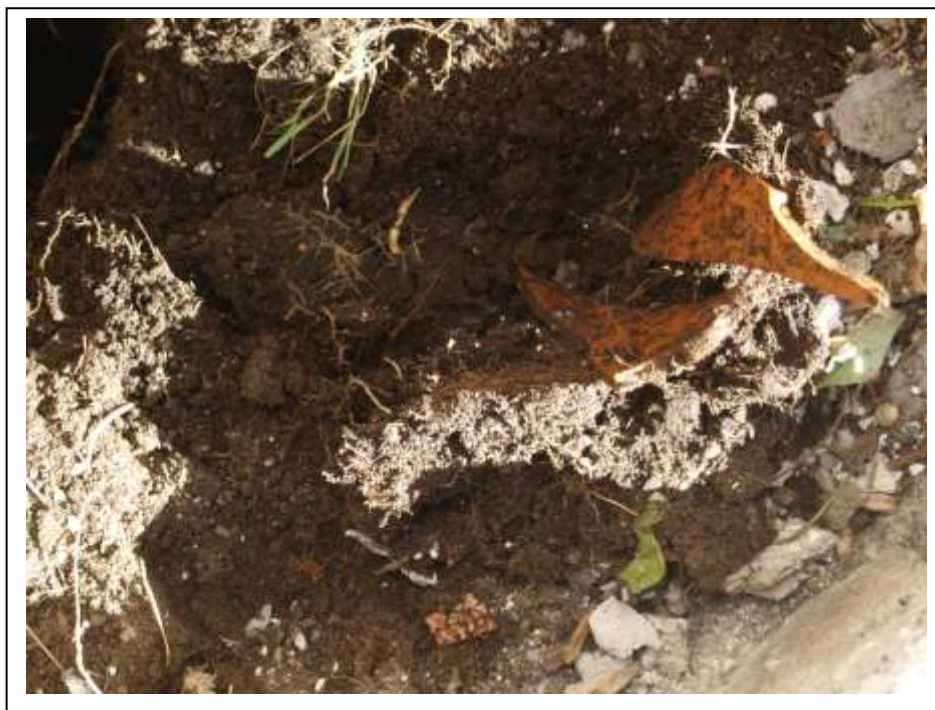
Upon further investigation of the soil excavation on the adjacent 1317 Court Street residence, it was observed that a significant volume of liquid Mercury was present in soil, both inside and outside of a broken clay pot, which had been buried at a shallow depth, adjacent to the block wall. (Photo #4)

Project No. TM 12.01.15	Description	Broken clay pot with liquid Mercury present inside	Photo #4
	Name	1315 & 1317 Court St. Alameda Ca.	Photo Date December 1, 2015

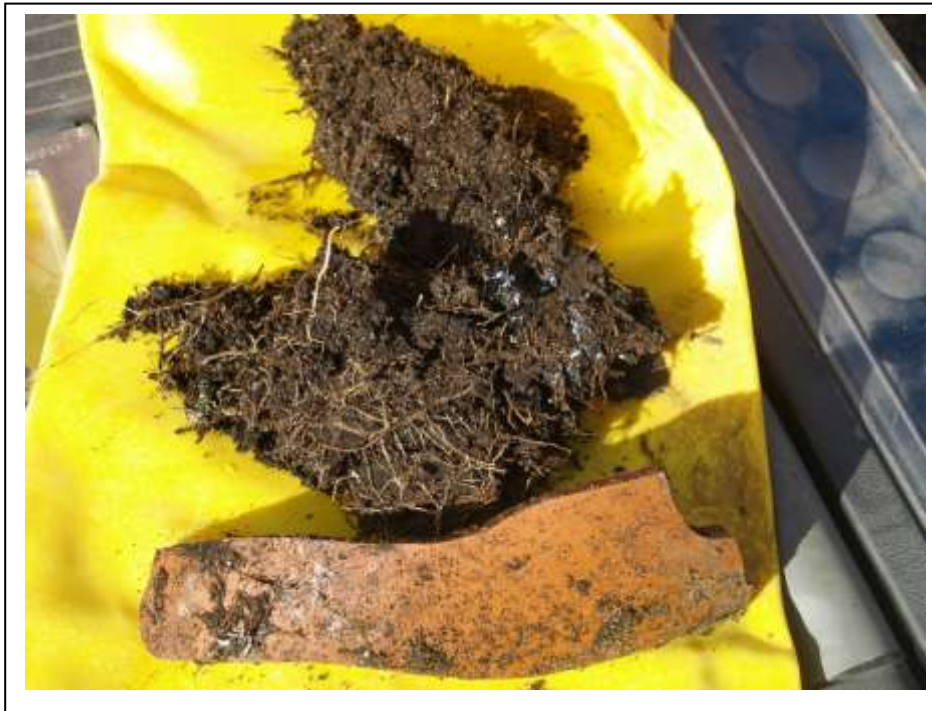
Importantly, a fracture in the concrete footing adjacent to the clay pot fragments was also observed to extend across the width of the footing, terminating at the location of the original mercury release at 1315 Court Street. (See Photos #5 and #6)

Project No. TM 12.01.15	Description	Clay Pot with root mass expressing liquid Mercury	Photo #5
	Name	1317 Court Street, Alameda CA.	Photo Date December 1, 2015

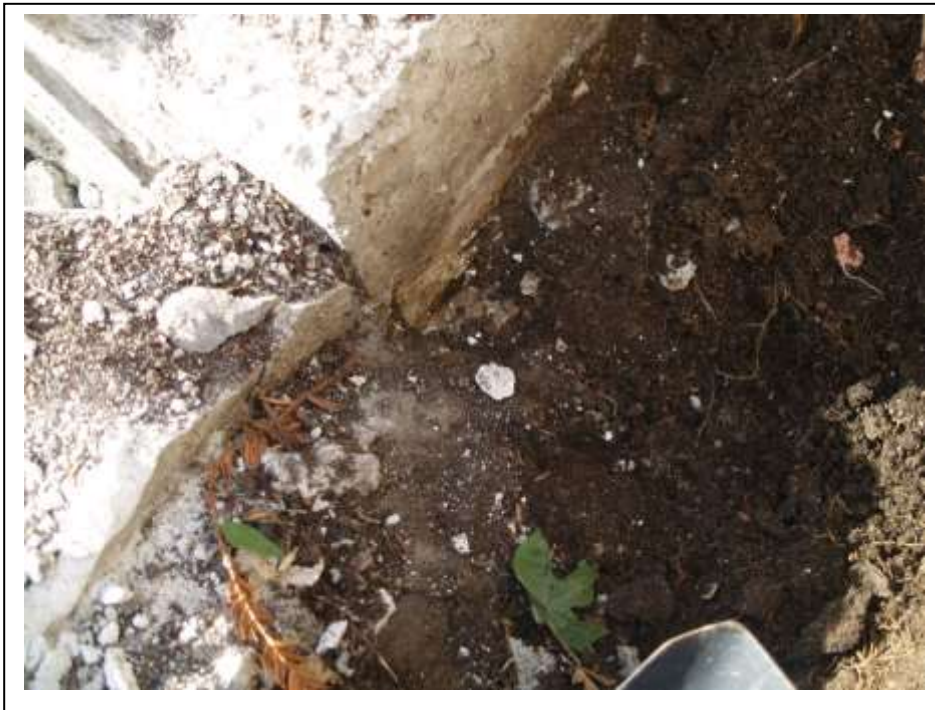
Information and observations gathered during the course of this project indicate that the source of the original mercury spill was located on the property located at 1317 Court Street. The apparent pathway of migration of the mercury found on the 1315 Court Street was determined to be a fracture in the concrete footing adjacent to the mercury contaminated clay pot located on the 1317 Court Street property, which allowed the mercury to migrate onto the 1315 Court Street property.

Project No. TM 12.01.15	Description	Mercury accumulations and adjacent fracture in concrete wall footing.	Photo #6
	Name	1317 Court St. Alameda CA.	Photo Date December 1, 2015

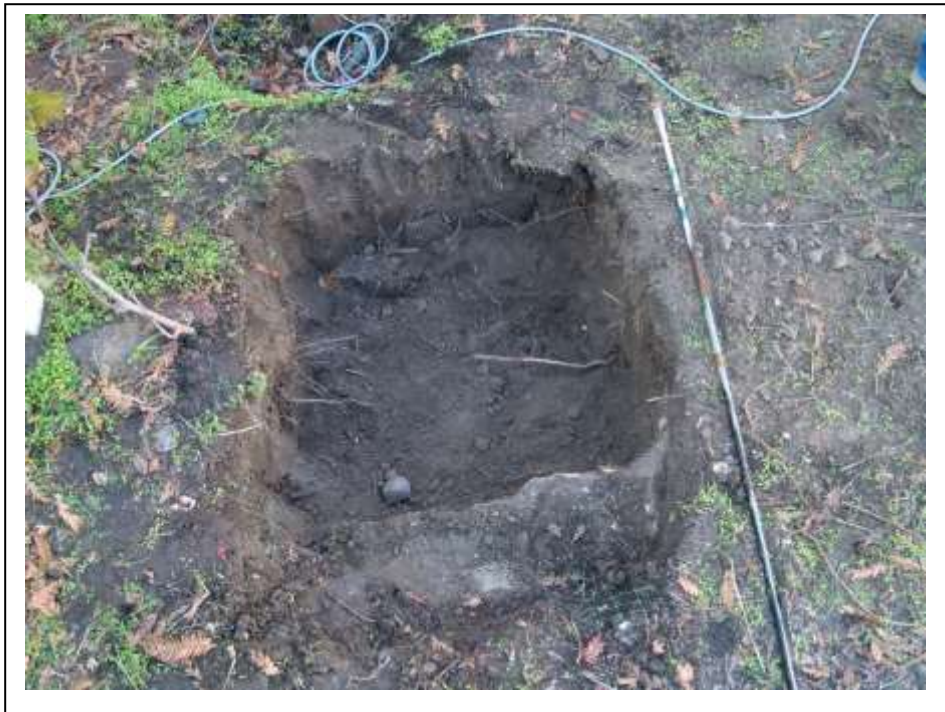
Project No. TM 12.01.15	Description	Excavation at the location of Vapor Sample 8-A	Photo #7
	Name	1315 Court St. Alameda Ca.	Photo Date December 1, 2015

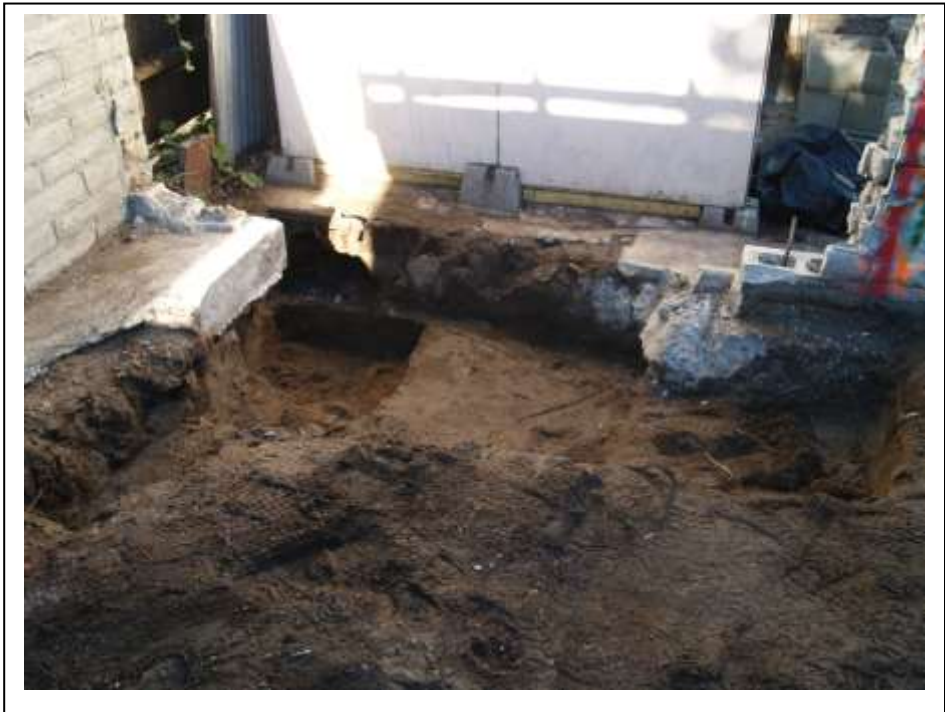
Project No. TM 12.01.15	Description	Removal area showing excavation profile, remaining wall and concrete footing	Photo #8
	Name	1315 & 1317 Court St. Alameda CA.	Photo Date December 1, 2015
