Subject: Response to the Alameda County Department of Environmental Health Former Cox Cadillac Site 230 Bay Place in Oakland, California (ACEH Fuel Leak Case Number RO0000148 and Geotracker Global ID Number T0600100193)

Response to Comments for Fuel Leak Case No. RO0000148 and GeoTracker Global ID T0600100193, Cox Cadillac & Buick, 230 Bay Place, Oakland, CA 94612

FORMER COX CADILLAC
230 BAY PLACE, OAKLAND, CALIFORNIA

PHOTOLOG

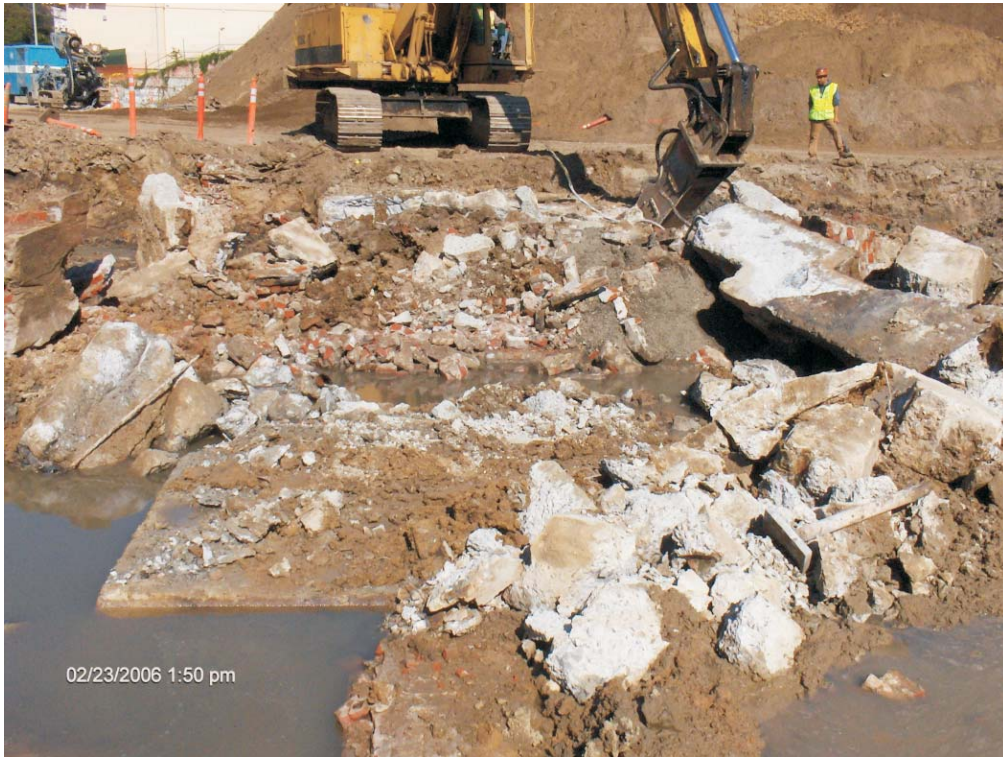
Buried concrete and brick being removed.

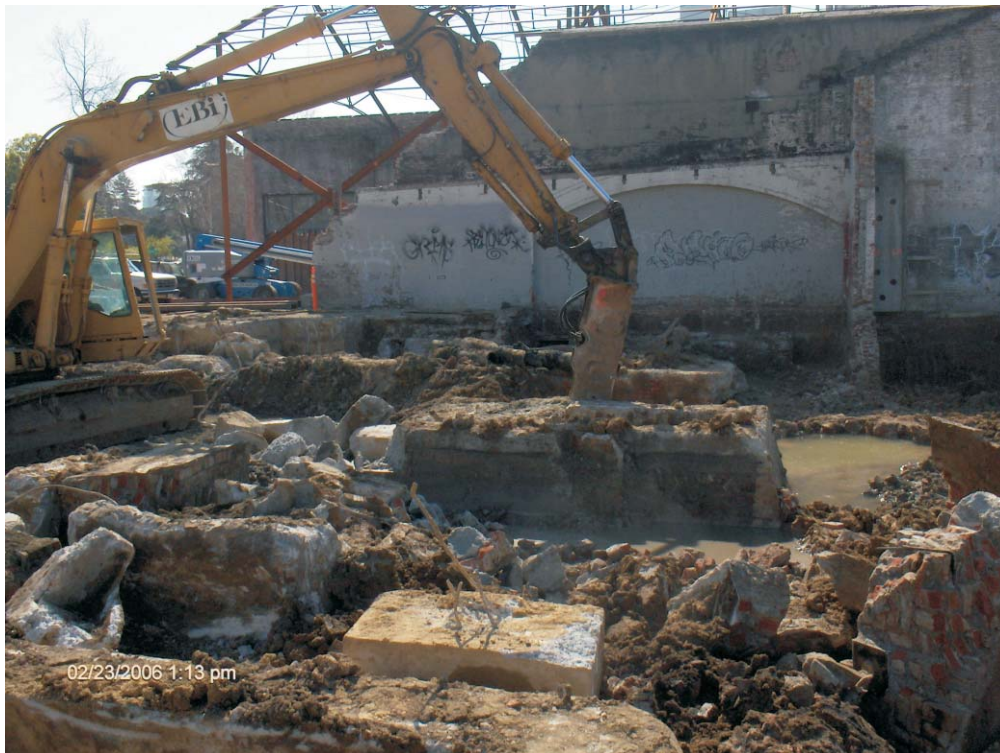
Buried concrete structures to be removed.

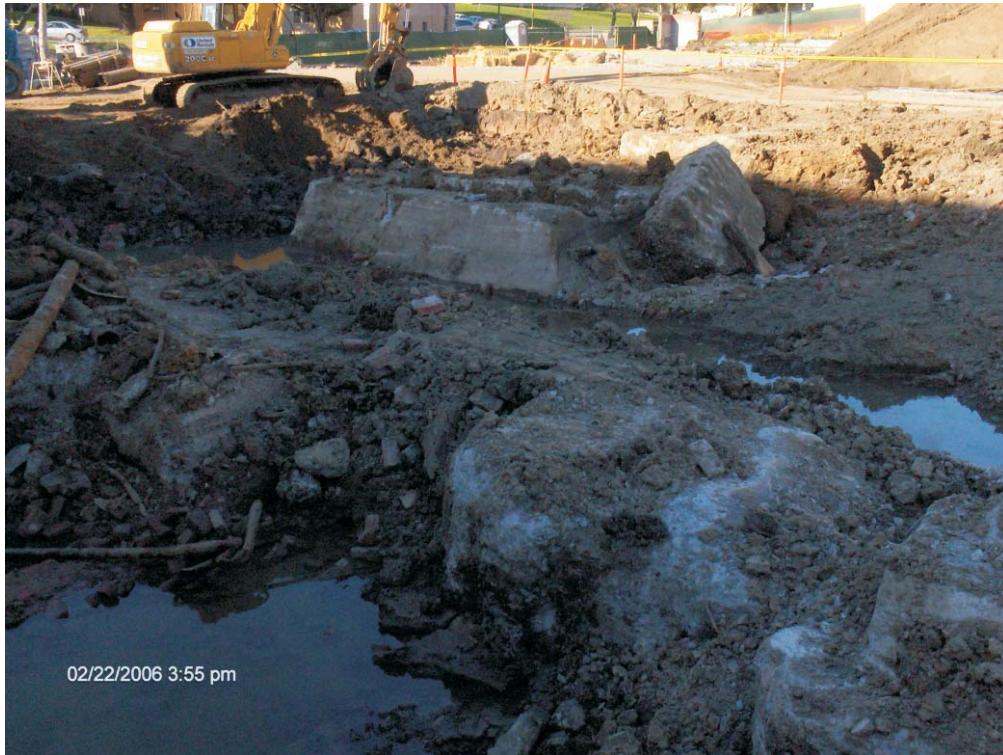
Buried concrete structures.

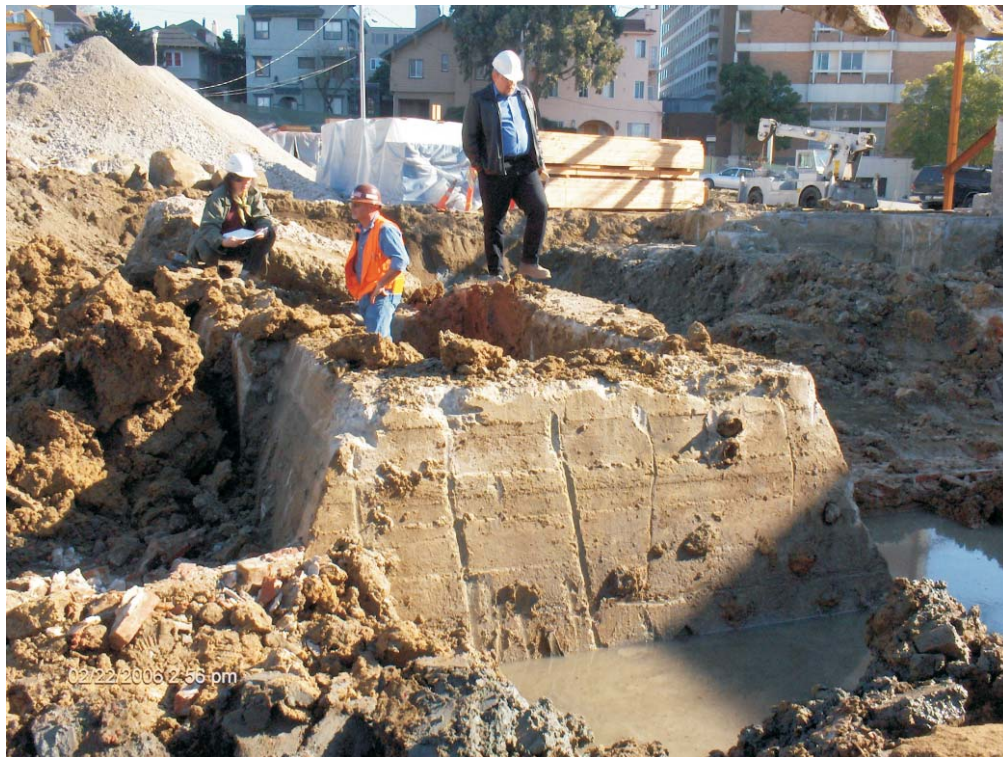
Typical buried concrete structure.

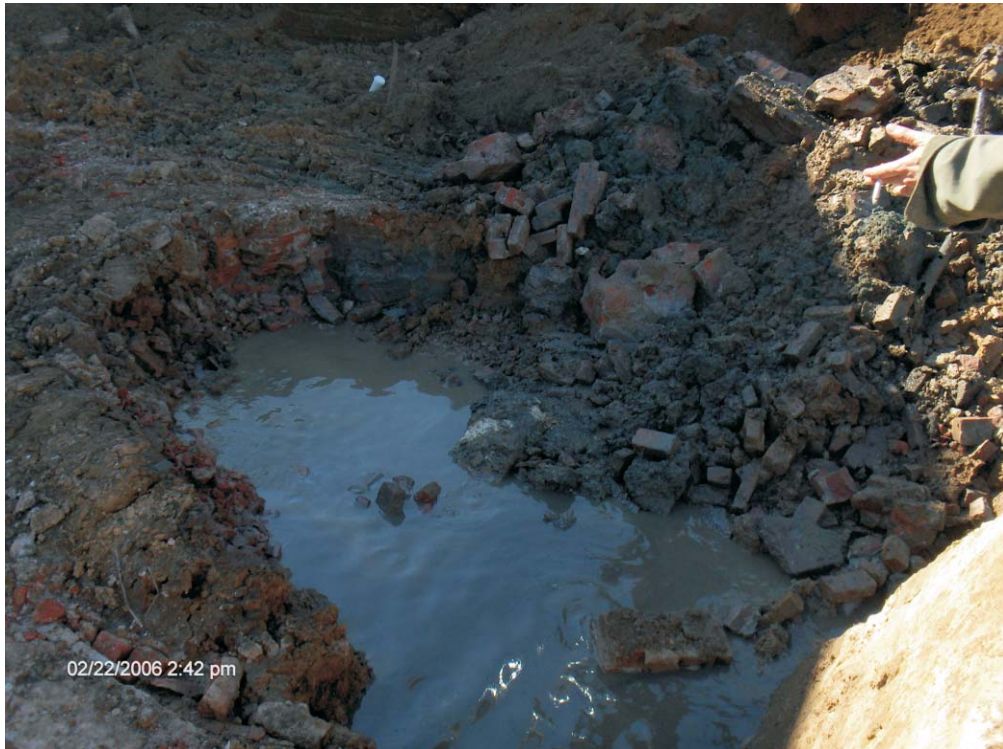
Groundwater in a test pit.

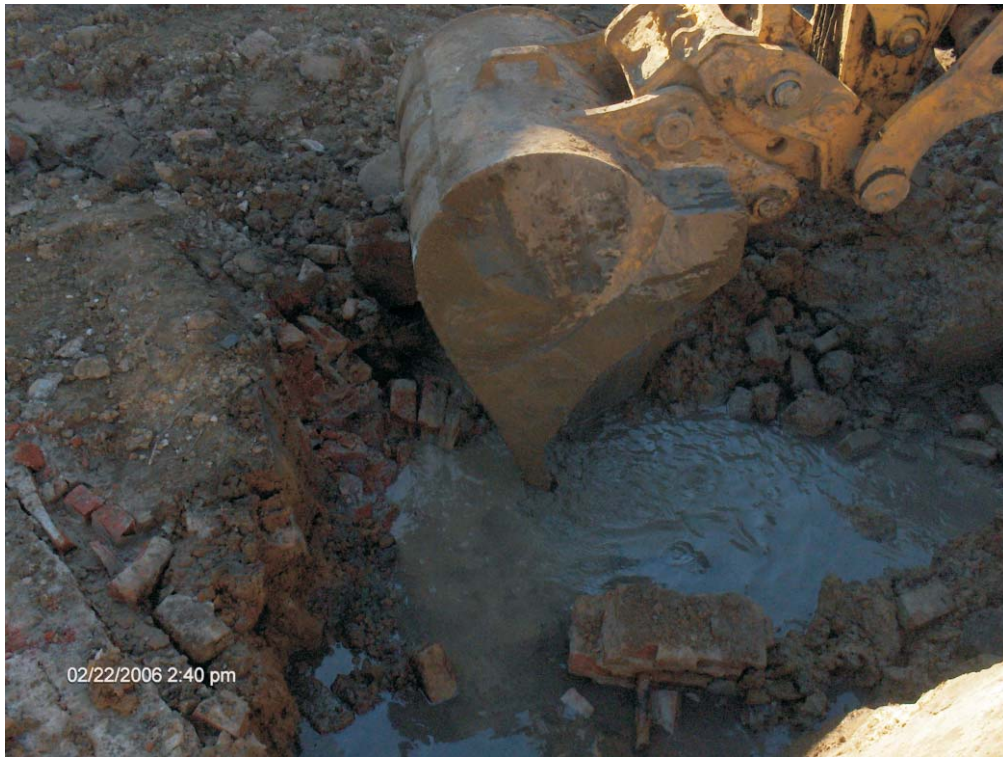
Areas being cleared.

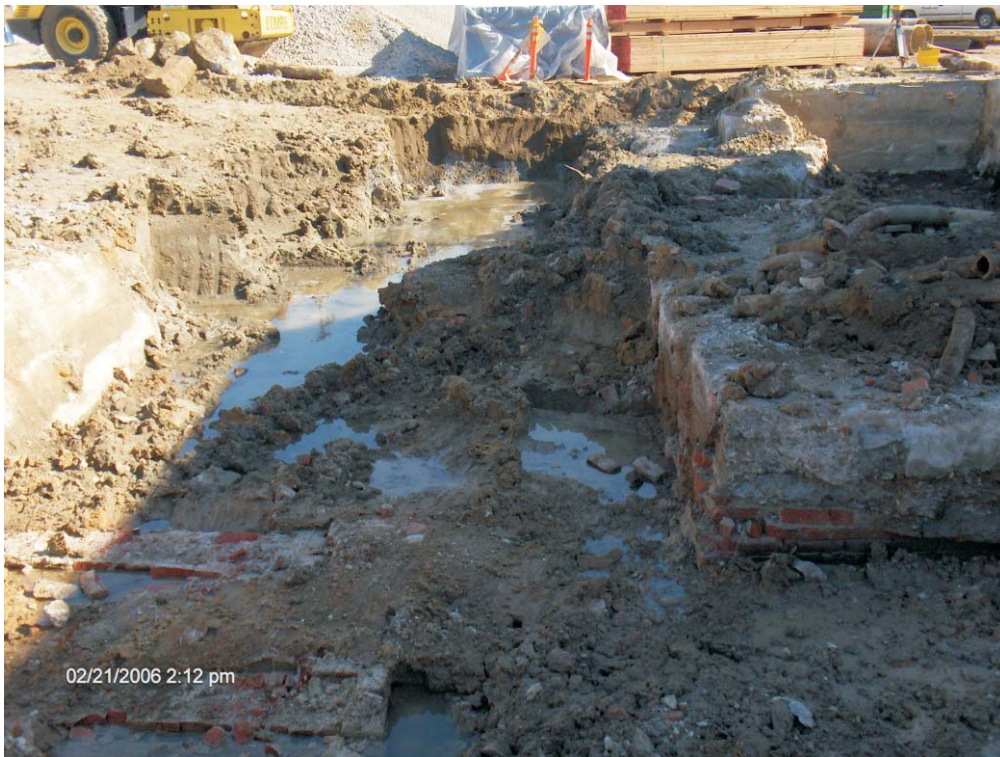
Areas being cleared.

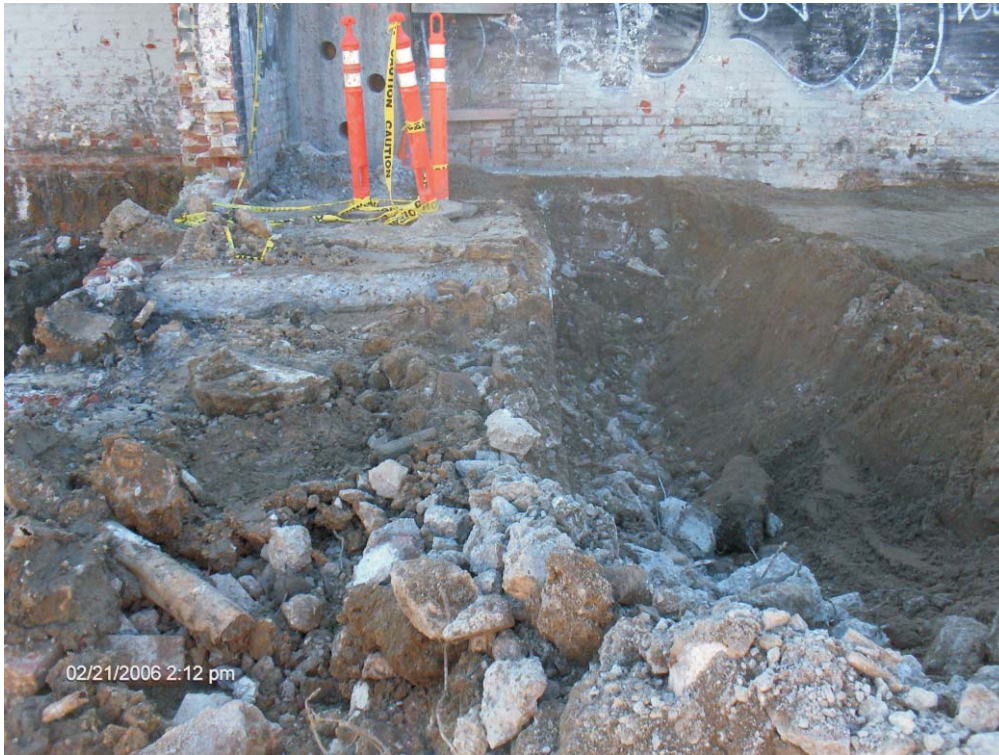
Concrete and debris in place.

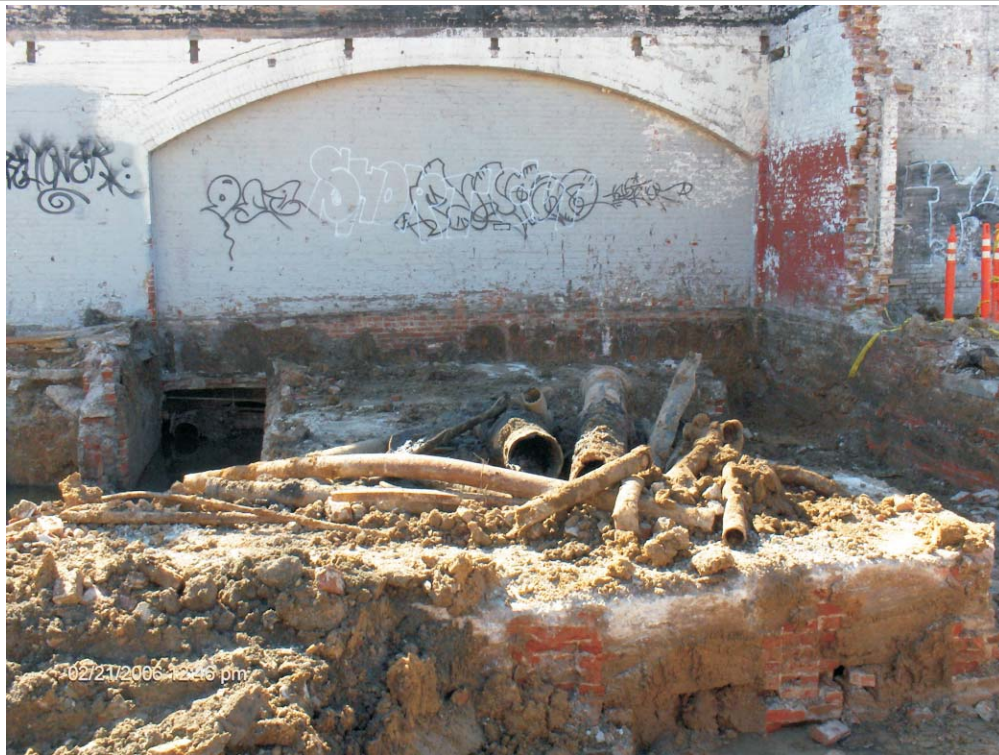
Area north of the former showroom.

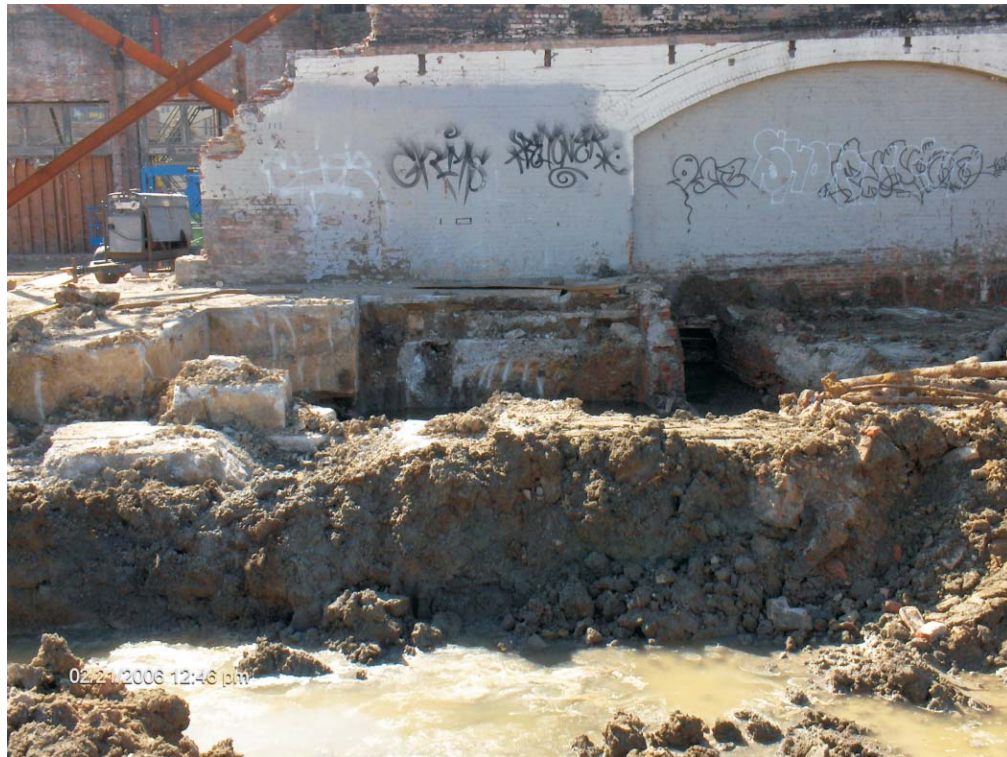
Area north of the former showroom.

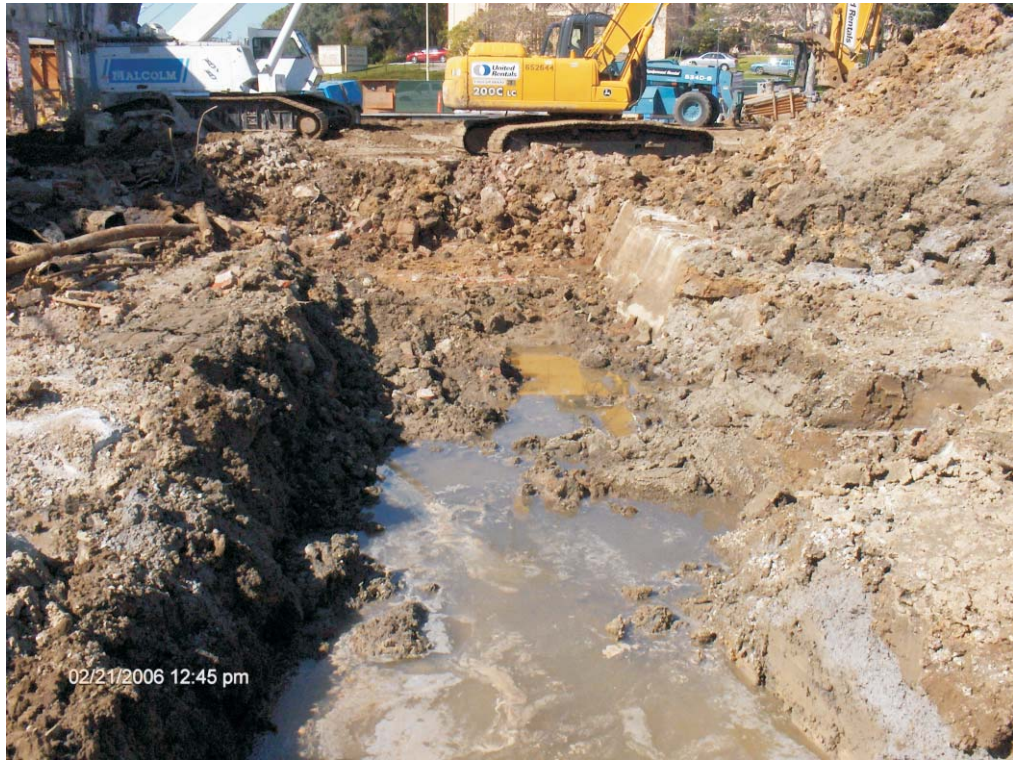
Site Clearing.

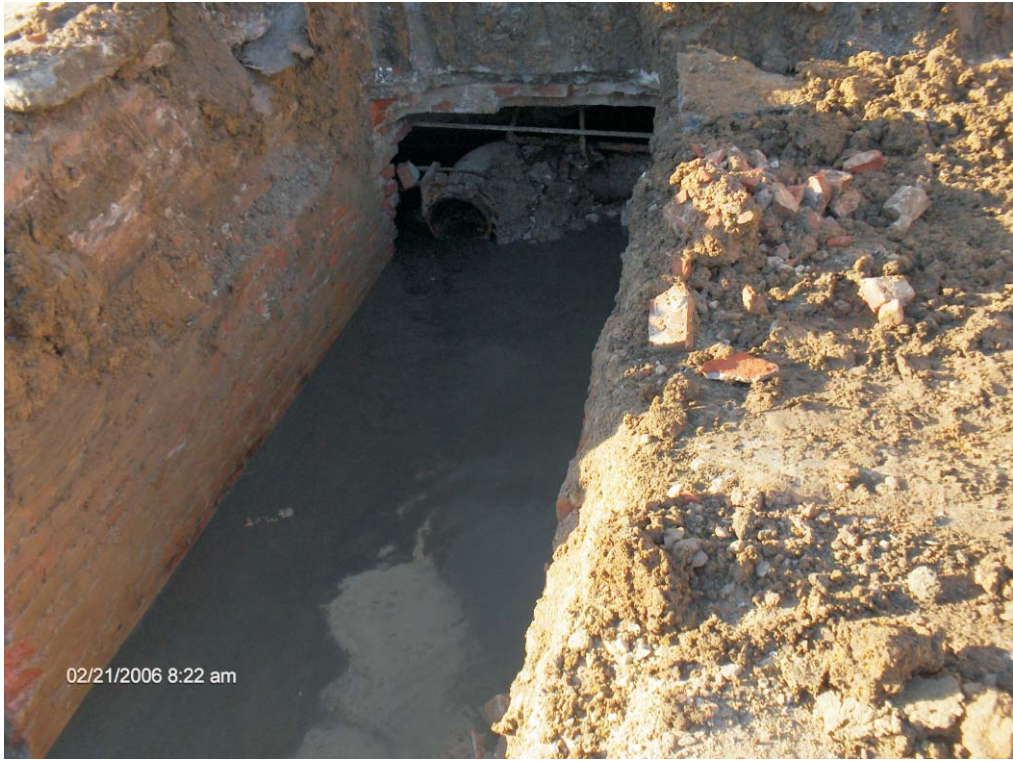
Typical trench filled with water.

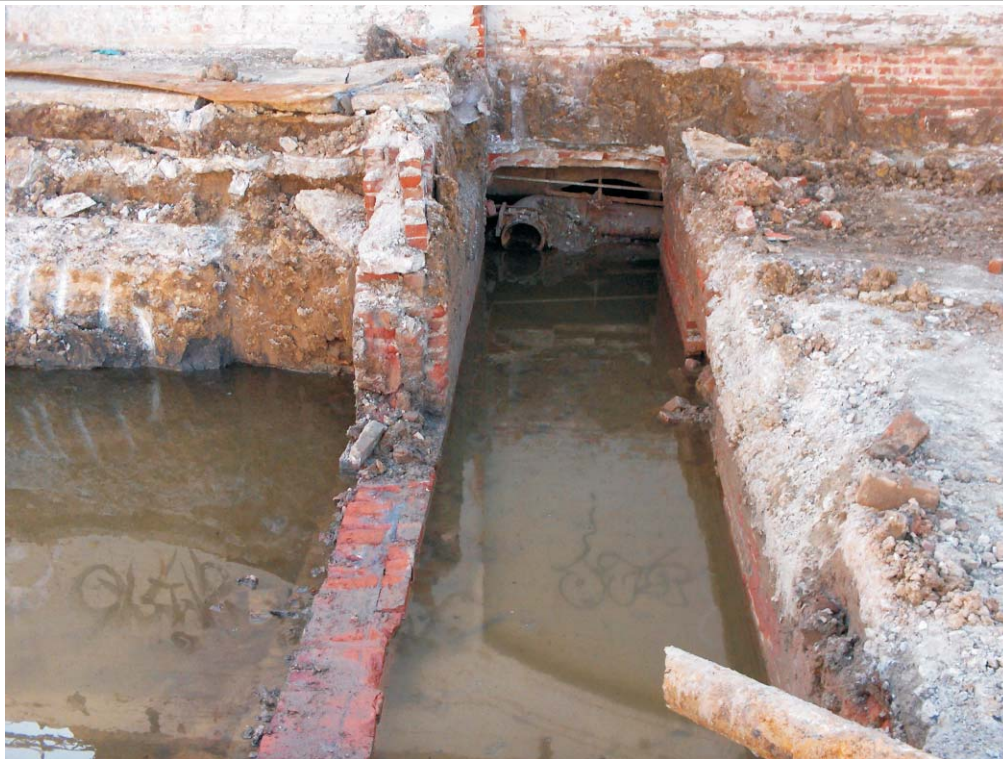
Concrete and brick structures removed from the Site during redevelopment.

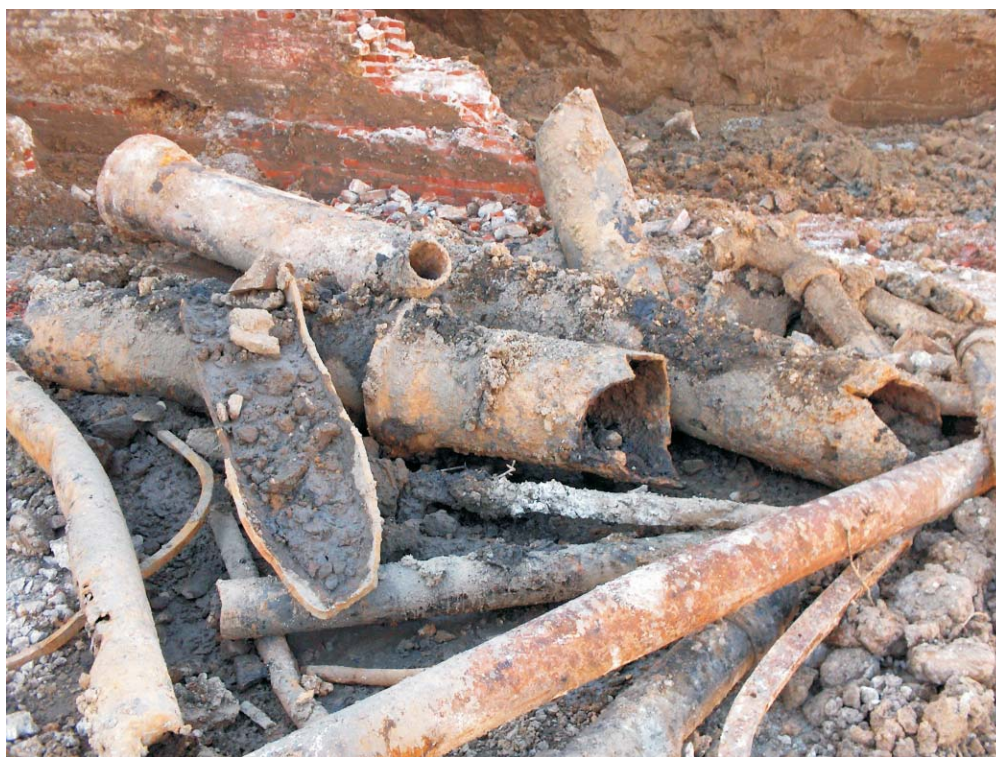
Storm drain and sewer piping removed during redevelopment of the Site.

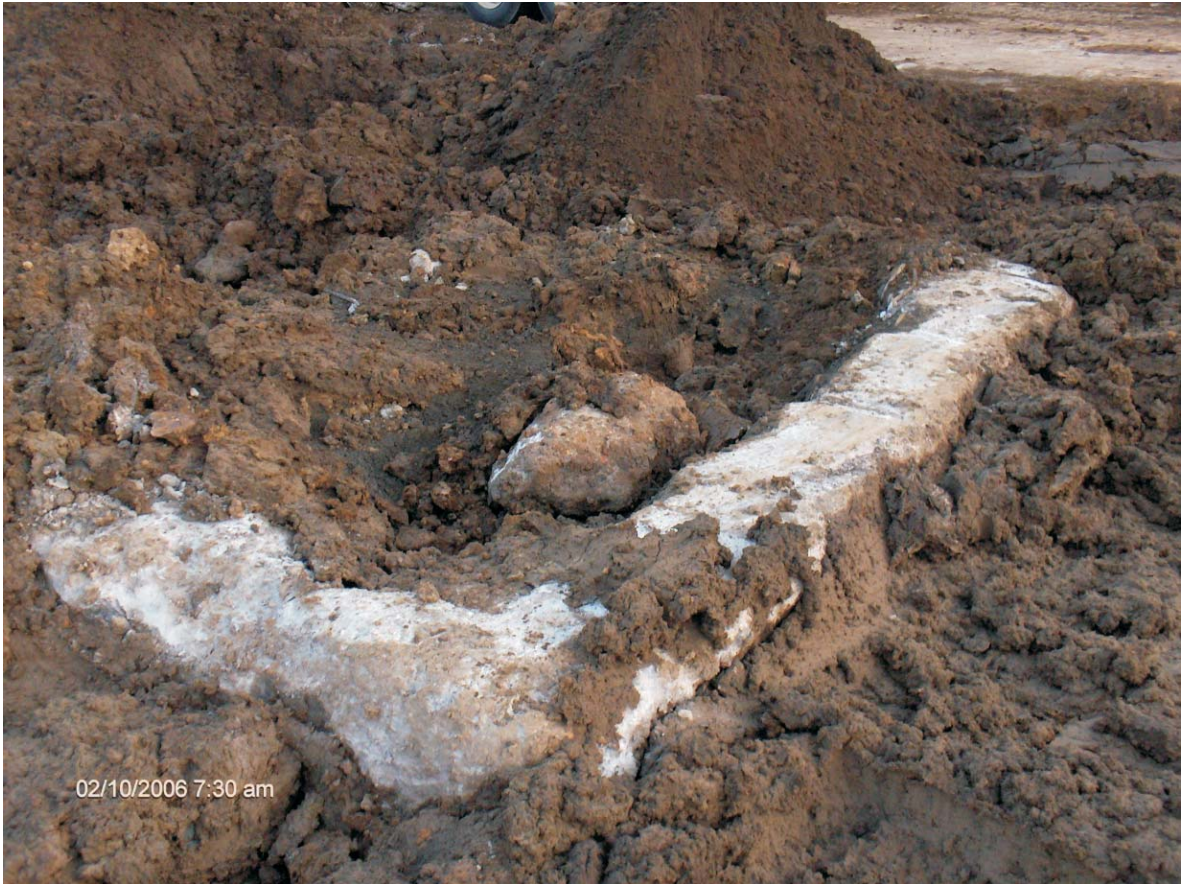
Typical buried concrete structure - in place.

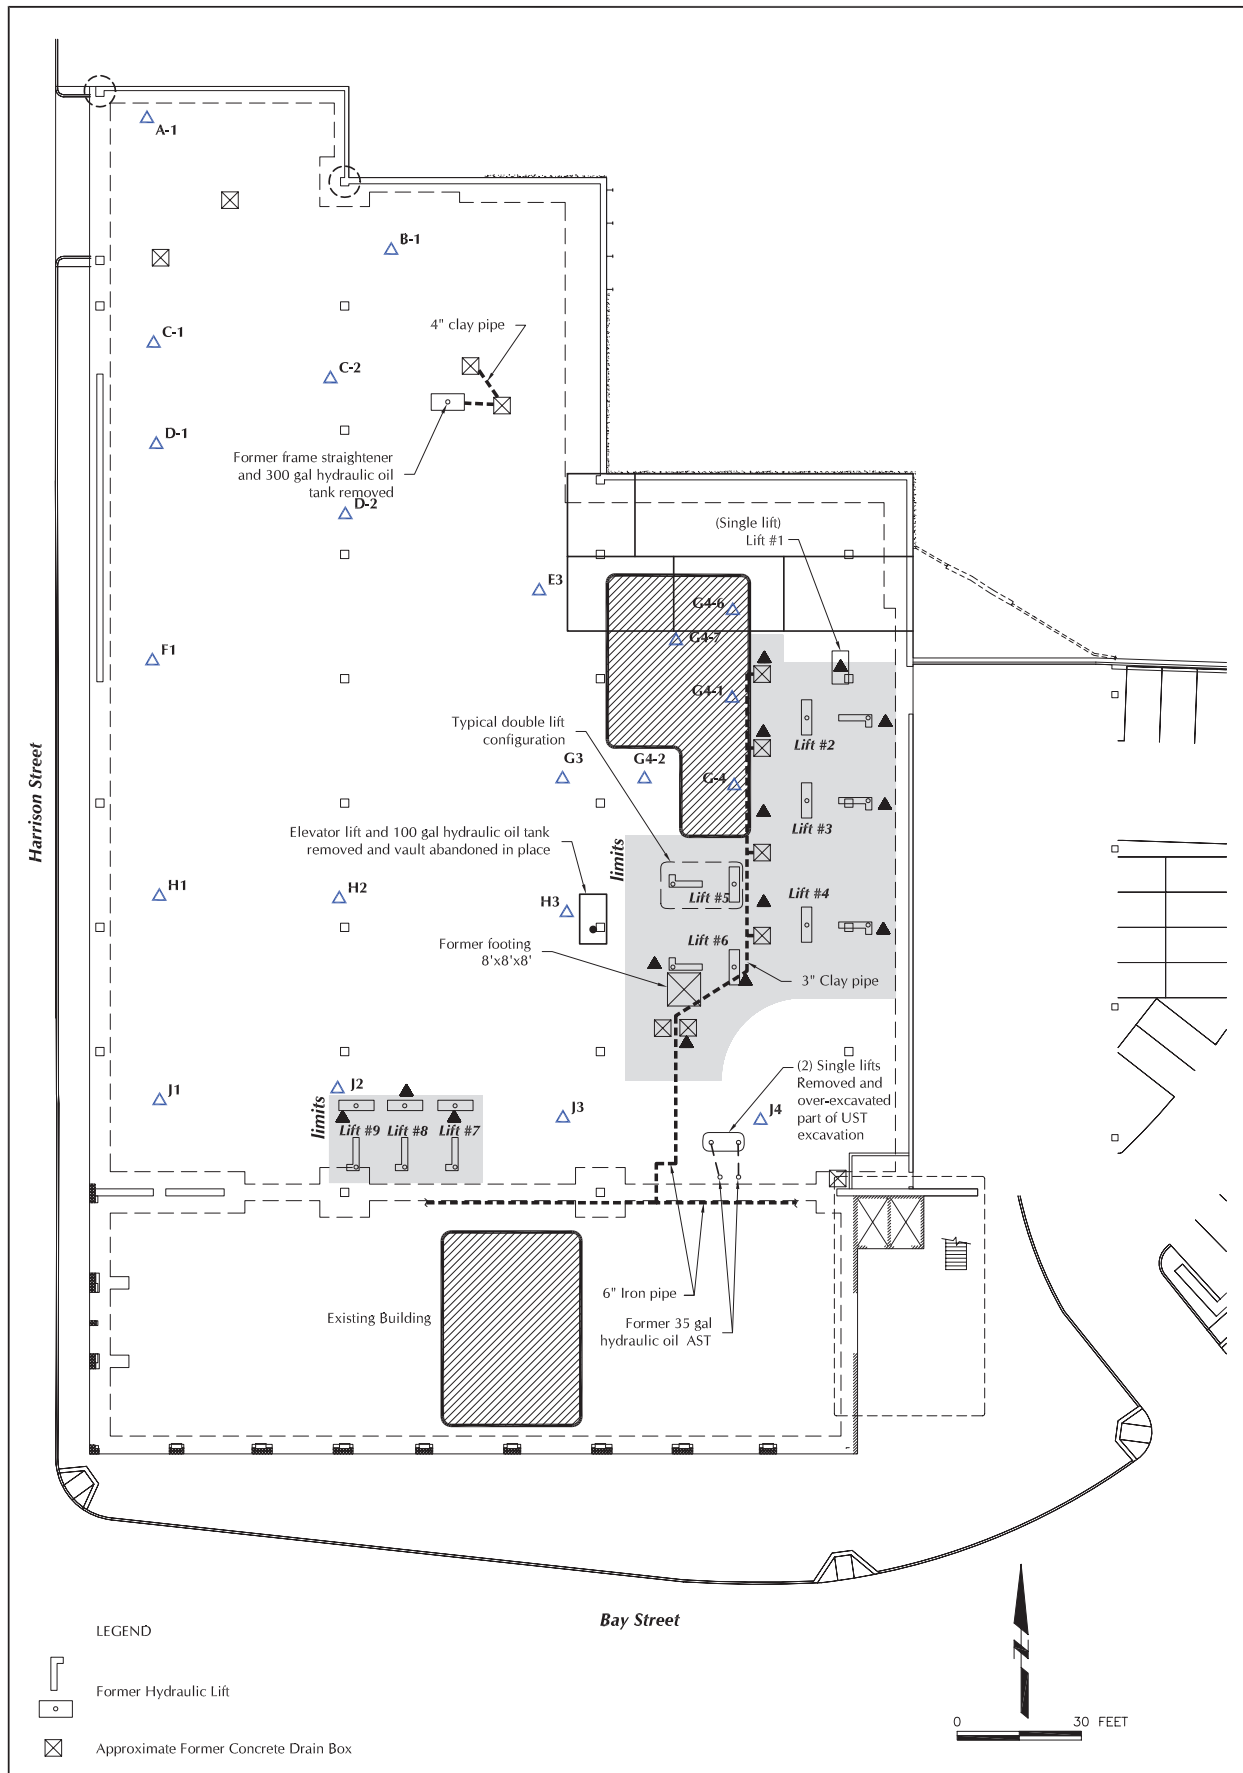
Figure 3

Test Pit Locations and Areas of Excavation for Lead-Affected Soil
