Re: Former Chevron Service Station No. 9-3864  
5101 Telegraph Avenue, Oakland, California

Re: Former Chevron Service Station #9-3864  
5101 Telegraph Avenue  
Oakland, California  
SES Project #1-203-04

This report presents the results of quarterly ground water sampling at Former Chevron Service Station #9-3864, located at 5101 Telegraph Avenue in Oakland, California. Nine wells, C-1 through C-4 and MW-1 through MW-5, were sampled (Figure 1).

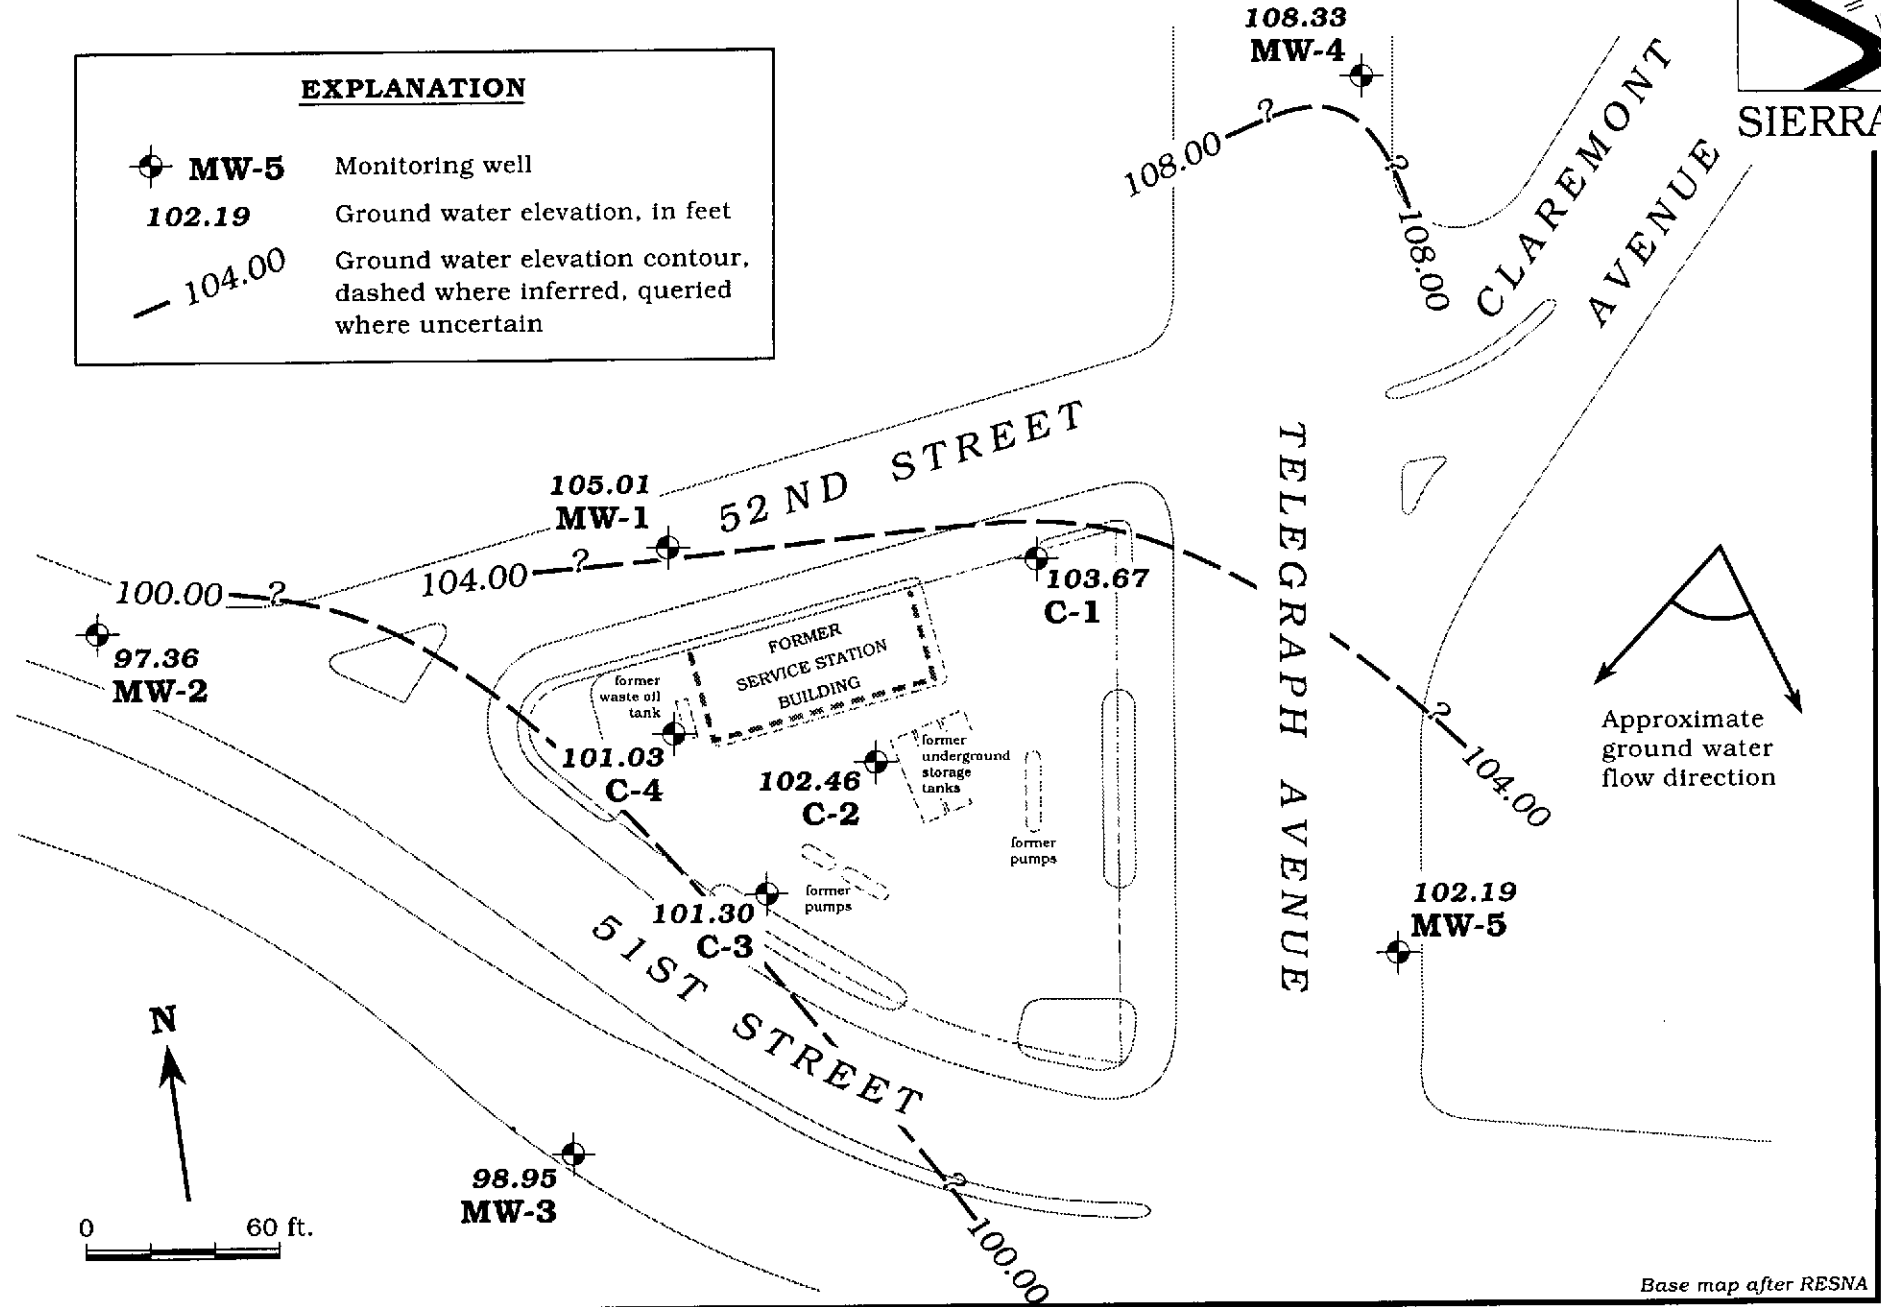
Figure 1. Monitoring Well Location and Ground Water Elevation Contour Map - December 14, 1993 - Former Chevron Service Station #9-3864, 5101 Telegraph Avenue, Oakland, California

On December 14, 1993, SES personnel visited the site. Water level measurements were collected in all site wells and all wells were checked for the presence of free-phase hydrocarbons. Free-phase hydrocarbons were not present in any of the site wells. Water level data are shown in Table 1 and ground water elevation contours are included on Figure 1.
