**ADDENDUM NUMBER 1  
TO THE FINAL  
RISK MANAGEMENT PLAN FOR  
THE 64<sup>TH</sup> STREET PROPERTIES  
EMERYVILLE, CALIFORNIA**

10 July 2000  
(EKI 990016.03)

Subject: Addendum Number 1 to the Final Risk Management Plan  
64<sup>th</sup> Street Properties, Emeryville, California  
(EKI 990016.03)

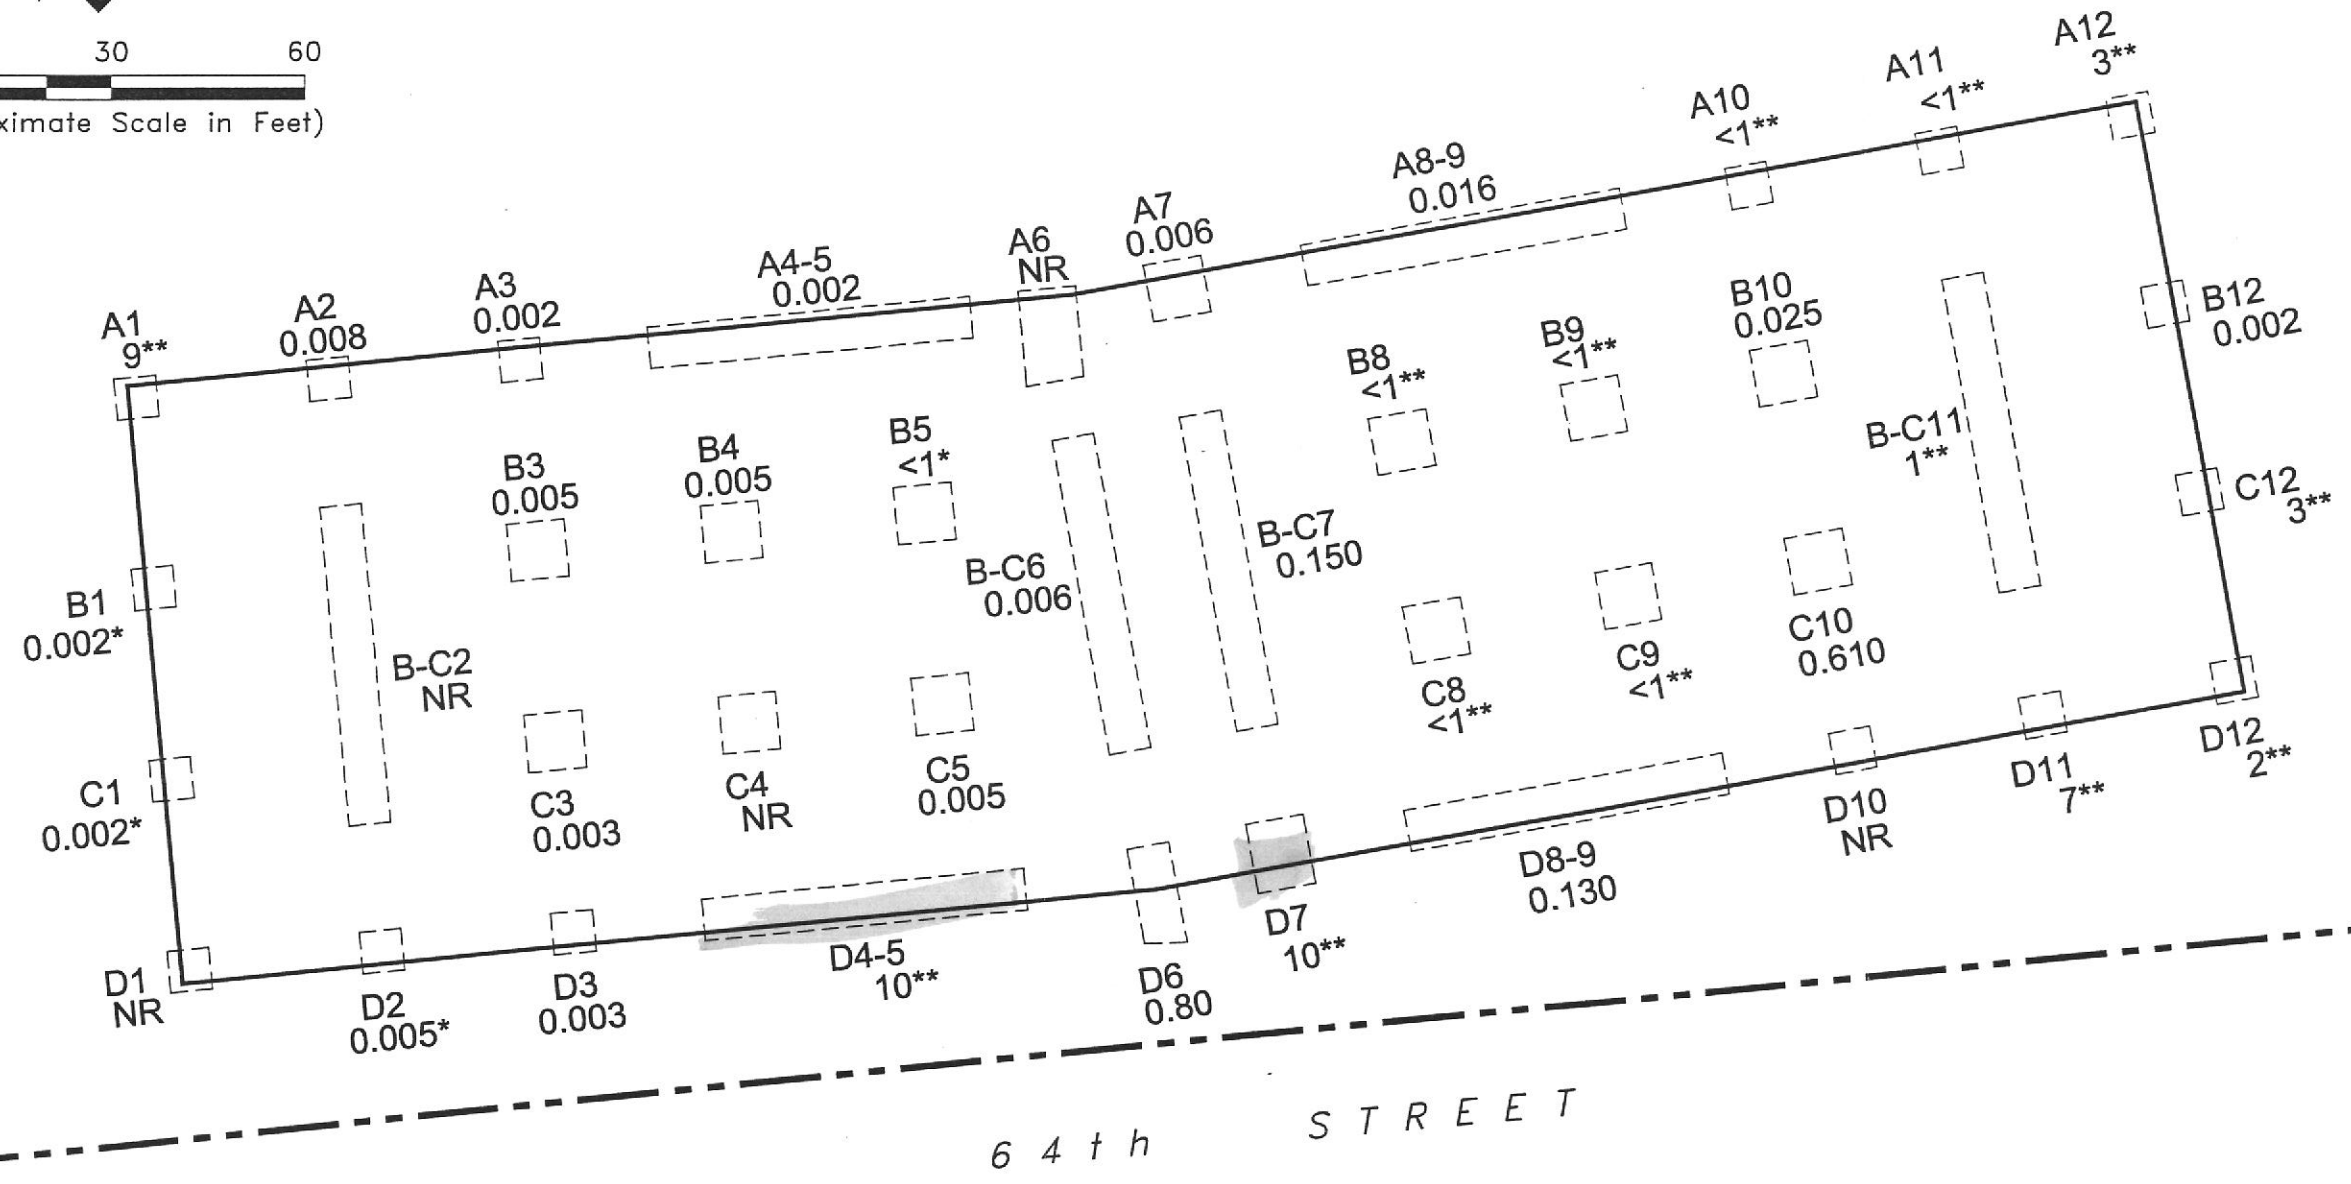
Maximum Breathing Zone Hydrogen Sulfide Concentrations Measured During Construction  
64th Street Properties  
Emeryville, CA  
June 2000  
EKI 990016.03  
Figure 2

The maximum breathing zone concentrations of hydrogen sulfide measured at each foundation excavation for the new office building are shown on Figure 2. The highest concentrations were detected at footing excavations A1 (9 parts per million by volume ("ppmv")), D4-5 (10 ppmv), D7 (10 ppmv), and D11 (7 ppmv).

The concentrations shown on Figure 2 are peak concentrations; sustained concentrations were lower. Hydrogen sulfide concentrations declined within 30 minutes once excavation activities ceased. Hydrogen sulfide was not detected on the Site unless soil excavation was being or had been recently performed.

The maximum hydrogen sulfide concentration detected at the site is 10 ppmv, which is equal to the PEL. However, that concentration and other maximum concentrations shown on Figure 2 were not sustained. In general, hydrogen sulfide concentrations decreased to non-detectable levels within 30 minutes of the cessation of excavation activities. Thus, it is extremely unlikely that future site occupants will be exposed to hydrogen sulfide concentrations on the order of the PEL.
