**ADDENDUM NUMBER 1  
TO THE FINAL  
RISK MANAGEMENT PLAN FOR  
THE 64<sup>TH</sup> STREET PROPERTIES  
EMERYVILLE, CALIFORNIA**

30 January 2001  
(EKI 990016.00, 990016.03, A00084.00)

Subject: Addendum Number 1 to the Risk Management Plan  
64<sup>th</sup> Street Properties, Emeryville, California  
(EKI 990016.03/A00084.00)

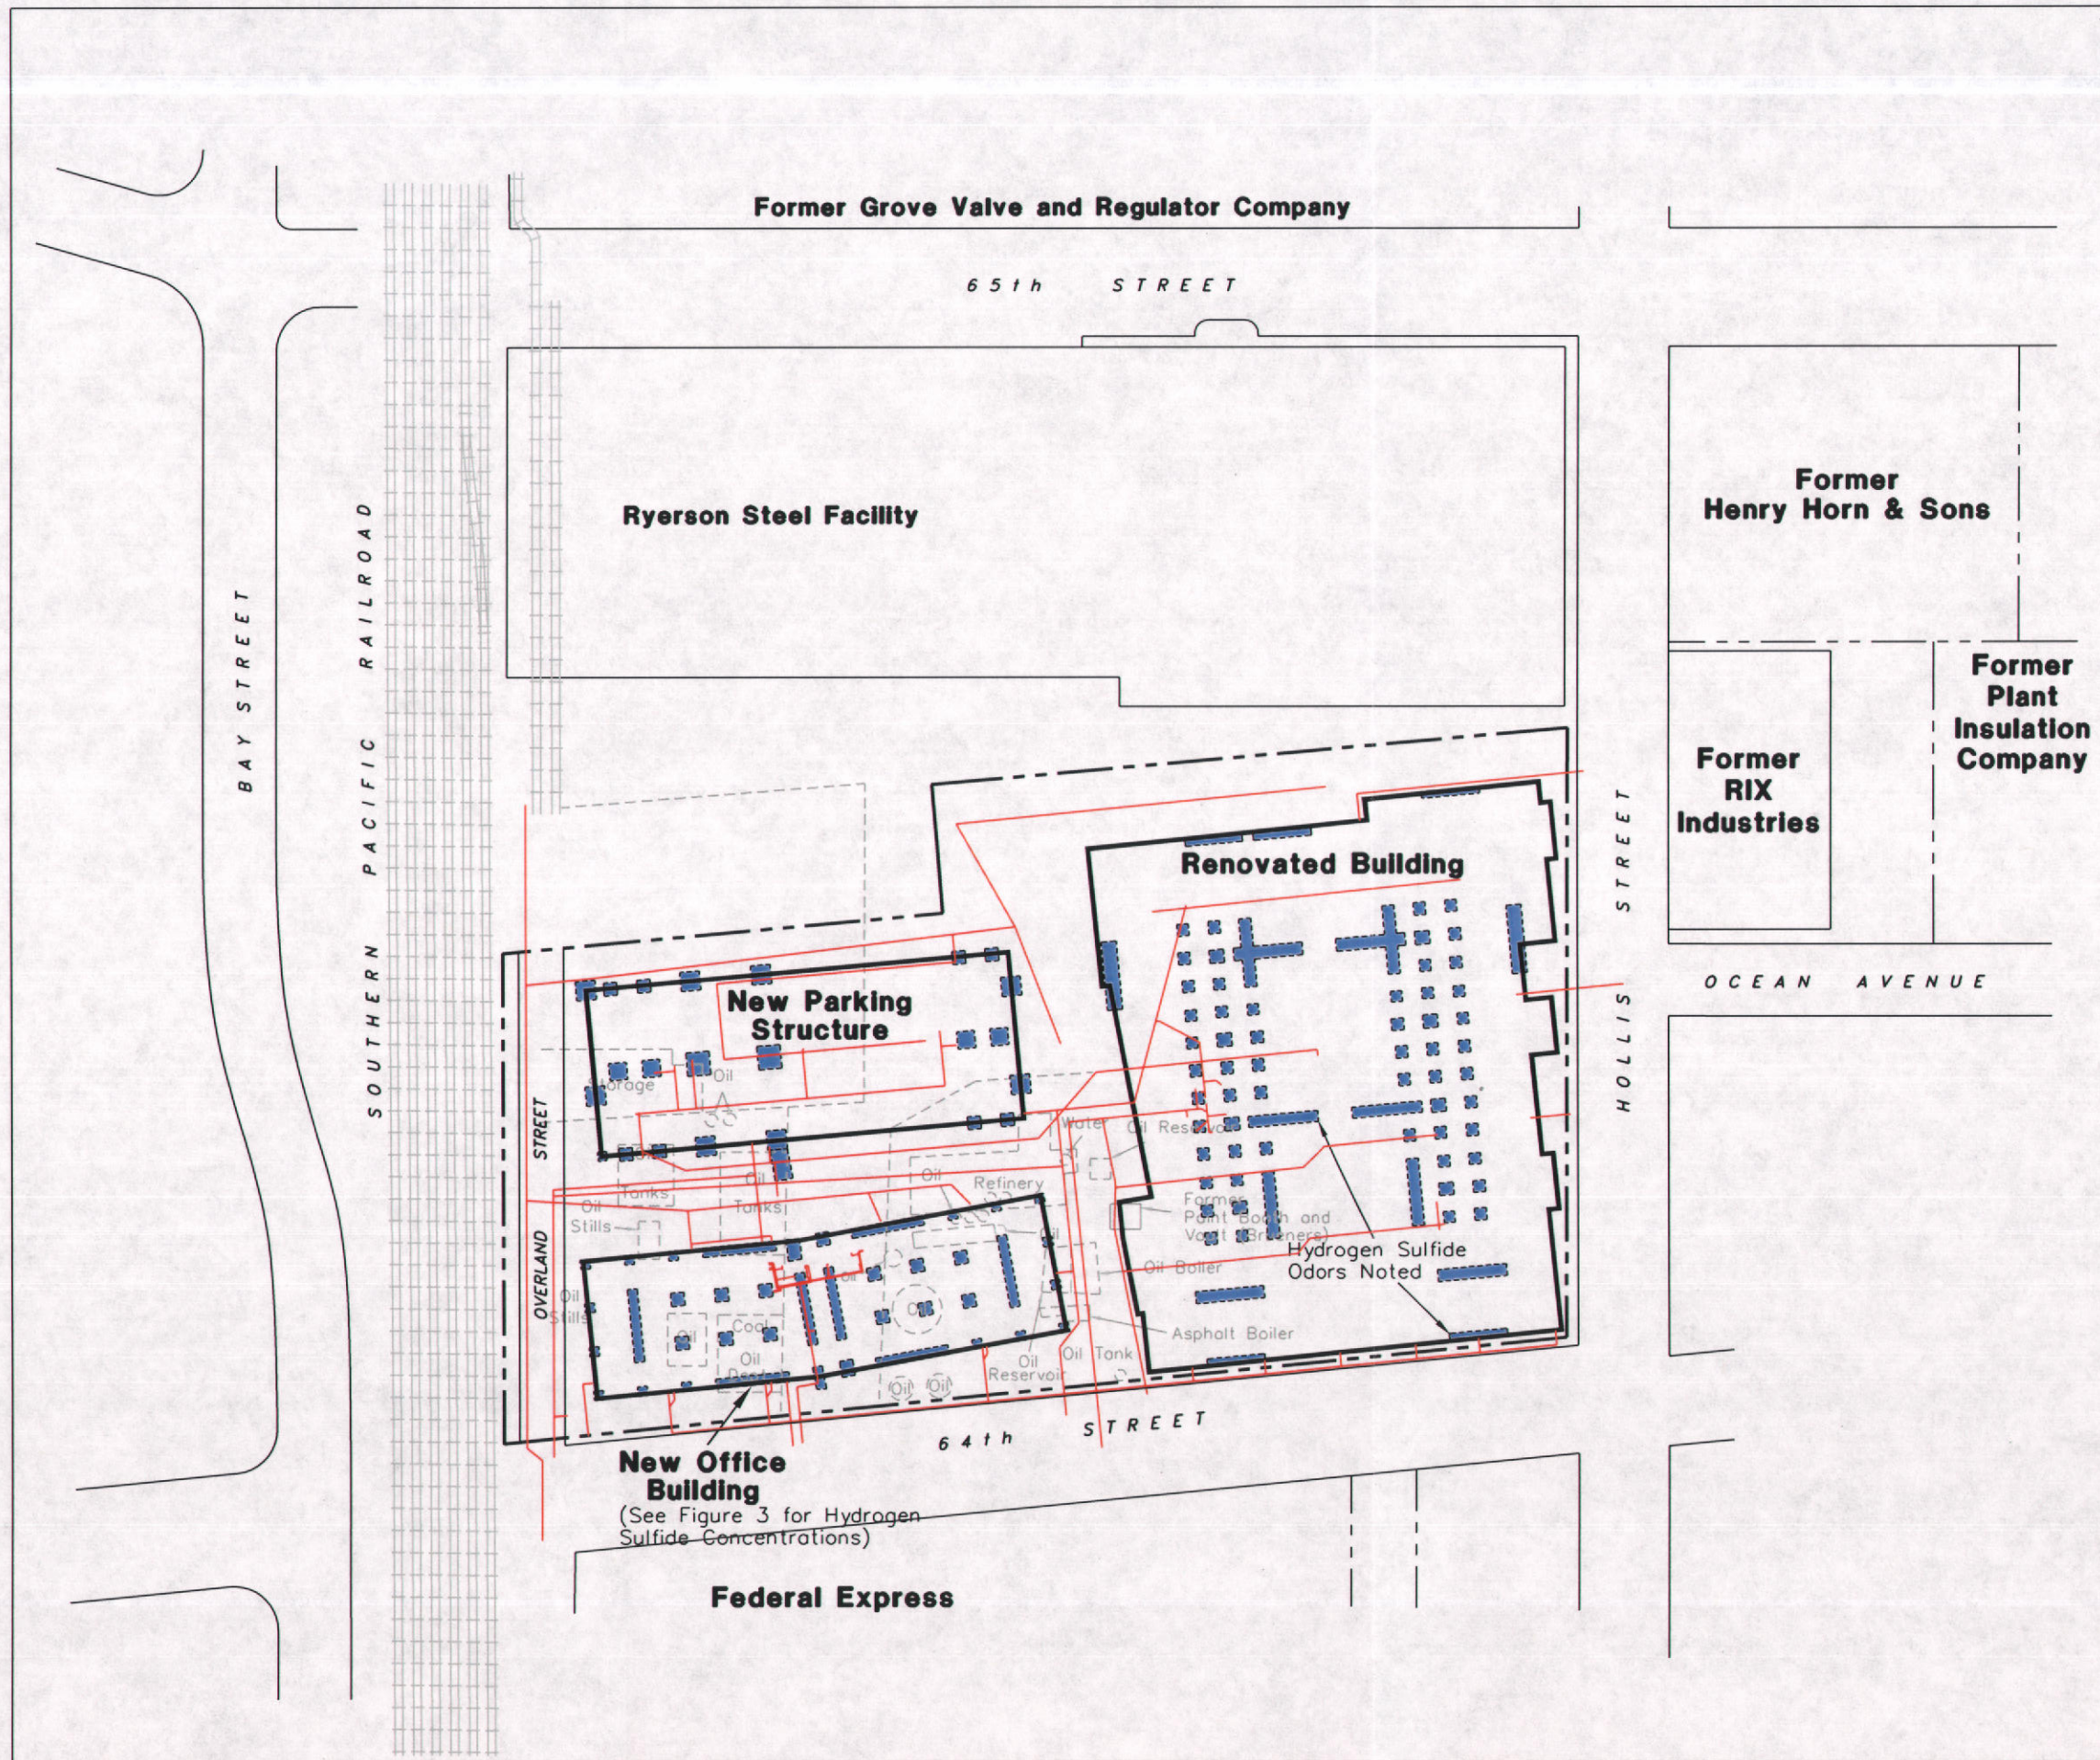
64th Street Properties  
 Emeryville, CA  
 January 2001  
 EKI 990016.03  
 Figure 2

After a rotten-egg odor was noted when performing footing excavations for the new office building in November 1999, measurements of hydrogen sulfide in the breathing zone were made during these excavation activities. Measurements of hydrogen sulfide concentrations were performed by EKI and/or Enviro Group Inc., SBC's industrial hygiene consultant, using direct-reading instruments. Measurements were only performed while excavating for footings for the new office building. According to SBC, hydrogen sulfide odors were not noted while excavating footings for the new parking structure. The approximate locations of footing excavations are shown on Figure 2.

According to SBC, some hydrogen sulfide odors were also noted while performing footing excavations in the central portion and the southeastern corner of the renovated building (see Figure 2). Work was halted when the odors were noted and later resumed while measuring for hydrogen sulfide. However, the odor was no longer present after the resumption of work, and no hydrogen sulfide was detected.

SBC indicated that hydrogen sulfide odors were not noted when excavating trenches for installation of below-grade utilities. The approximate locations of these trenches are shown on Figure 2. In fact, SBC did not note hydrogen sulfide odors after construction of building footings was complete.

The origin of the hydrogen sulfide detected on the 64th Street properties is not known. Given that sustained concentrations of hydrogen sulfide were only encountered in the southwestern portion of the 64<sup>th</sup> Street properties (i.e., in the vicinity of the former refinery, see Figure 2), natural degradation of petroleum residuals from the former refinery

is the likely source of the hydrogen sulfide. The southeastern corner of the renovated building, where hydrogen sulfide odors were noted, is in the vicinity of a former underground fuel storage tank. Given that bay mud underlies the fill on the property, sulfate bacteria capable of producing hydrogen sulfide are likely present amongst residual hydrocarbons remaining from this closed tank. Thus, hydrogen sulfide odors in this vicinity may also be the result of natural degradation of petroleum hydrocarbons. It is also possible that natural degradation of organic material within the bay muds underlying the 64th Street properties contributes hydrogen sulfide to the soil gas.

Building Footing Excavations and Underground Utilities

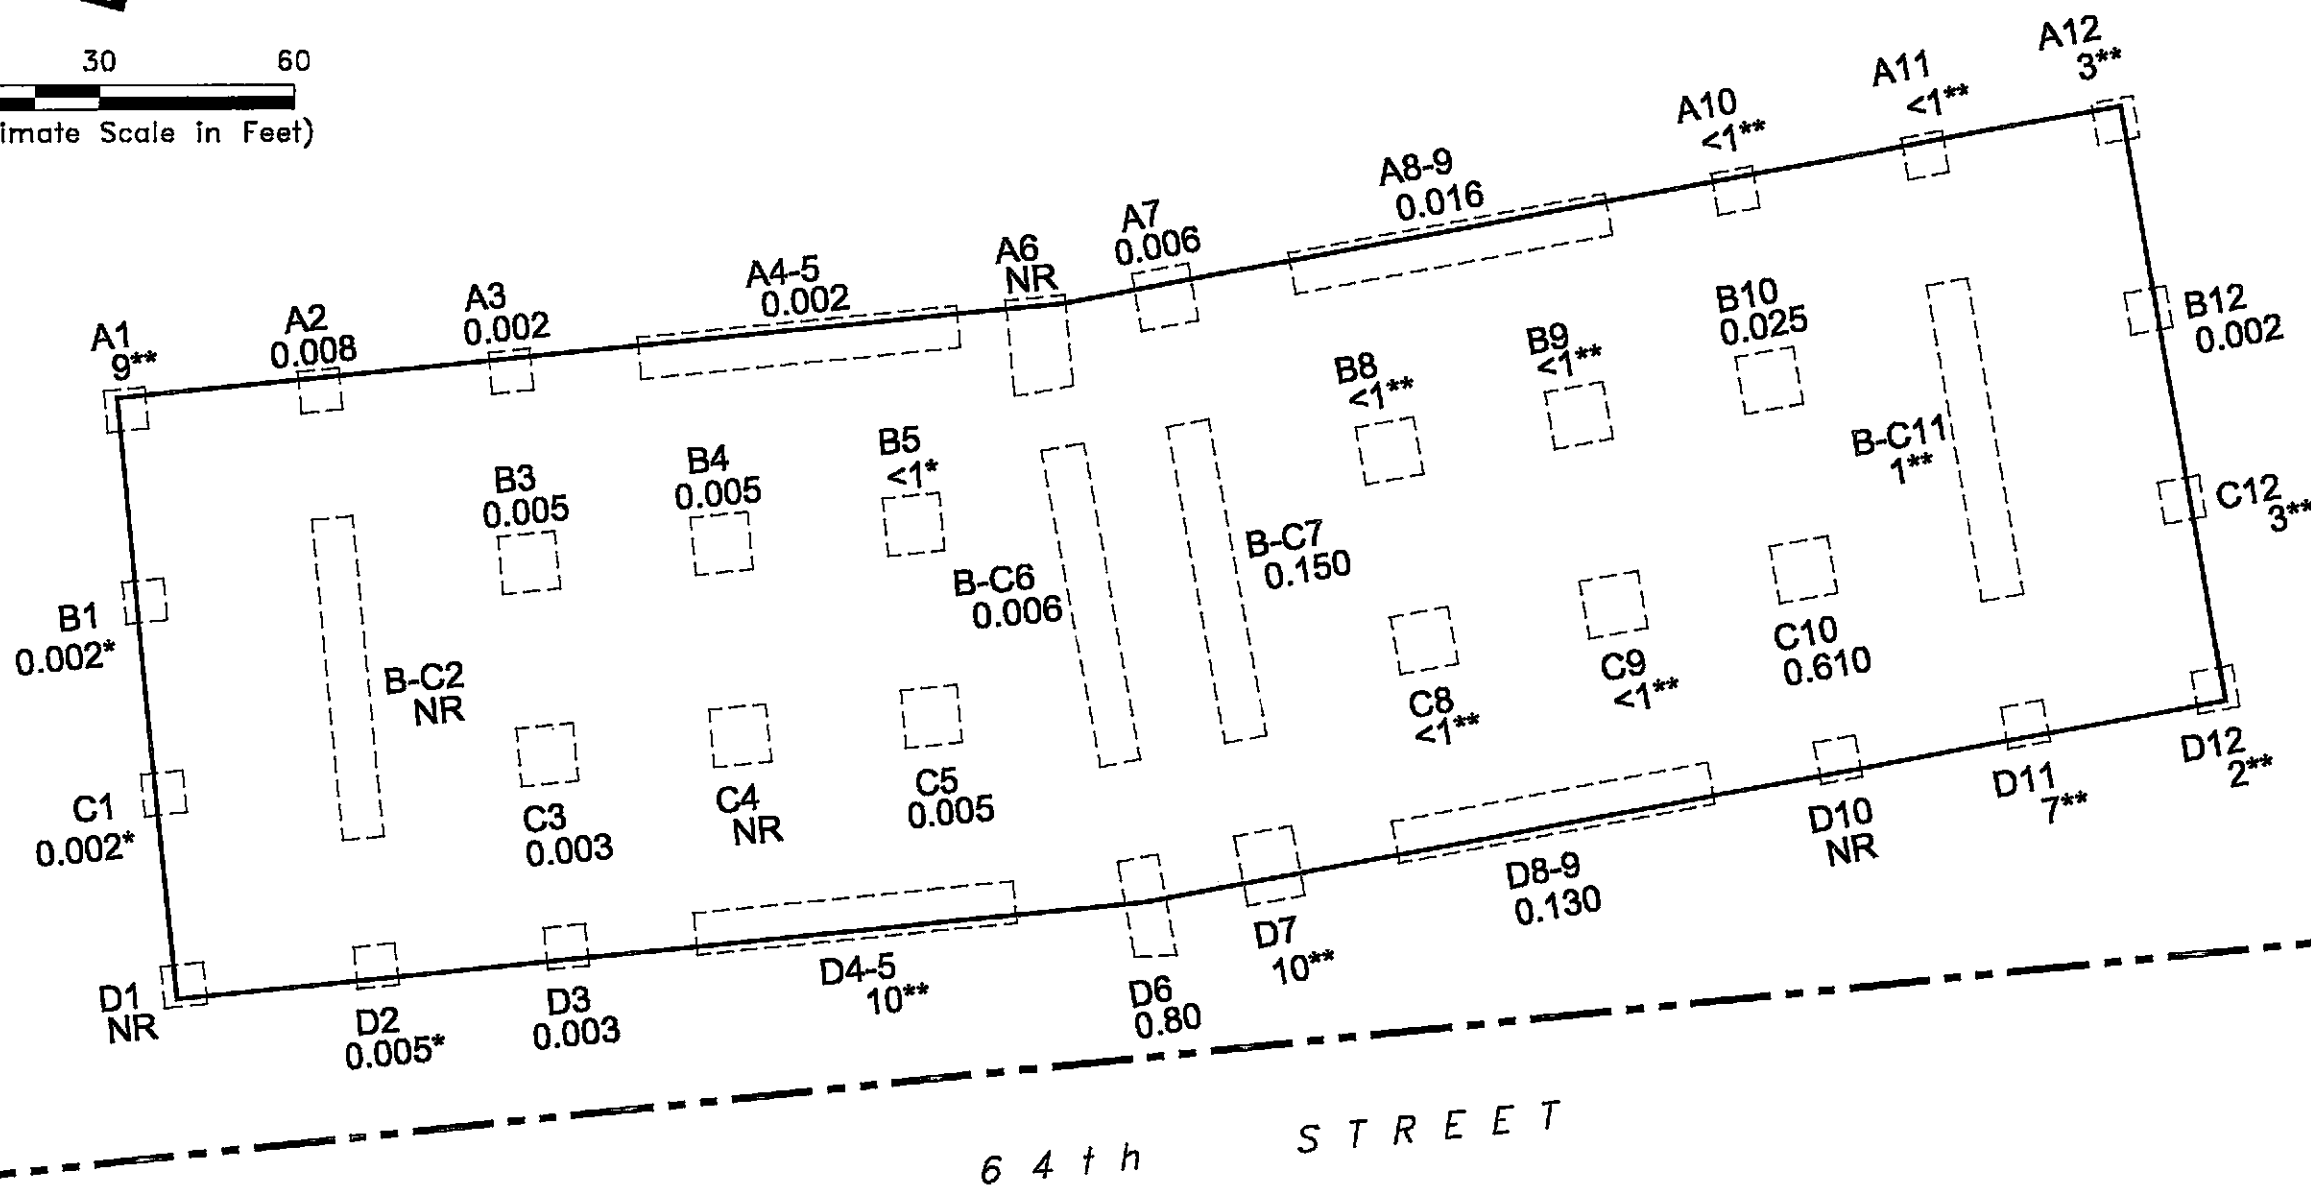
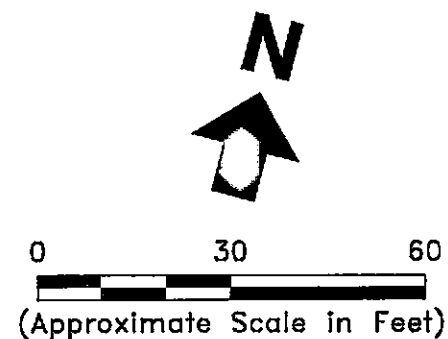
Maximum Breathing Zone Hydrogen Sulfide Concentrations Measured During Construction  
 64th Street Properties  
 Emeryville, CA  
 January 2001  
 EKI 990016.03  
 Figure 3

The maximum breathing zone concentrations of hydrogen sulfide measured at each foundation excavation for the new office building are shown on Figure 3. The highest concentrations were detected at footing excavations A1 (9 parts per million by volume ("ppmv")), D4-5 (10 ppmv), D7 (10 ppmv), and D11 (7 ppmv). As shown on Figure 3, the distribution of hydrogen sulfide is not contiguous; rather, it appears to be concentrated in specific areas.

The concentrations shown on Figure 3 are peak concentrations; sustained concentrations were lower. Hydrogen sulfide concentrations generally decreased to non-detectable levels within 30 minutes of the cessation of excavation activities. Hydrogen sulfide was only detected in the areas shown on Figure 3, and only when soil excavation was being or had recently been performed.

The maximum hydrogen sulfide concentration detected at the site is 10 ppmv. As noted above, the PEL is also 10 ppmv; however, the PEL is an 8-hour time-weighted average, while the maximum hydrogen sulfide concentrations shown on Figure 3 were not sustained. In general, hydrogen sulfide concentrations decreased to non-detectable levels within 30 minutes of the cessation of excavation activities. Thus, it is extremely unlikely that future site occupants will be exposed to hydrogen sulfide concentrations on the order of the PEL (i.e., an 8-hour average of 10 ppmv).

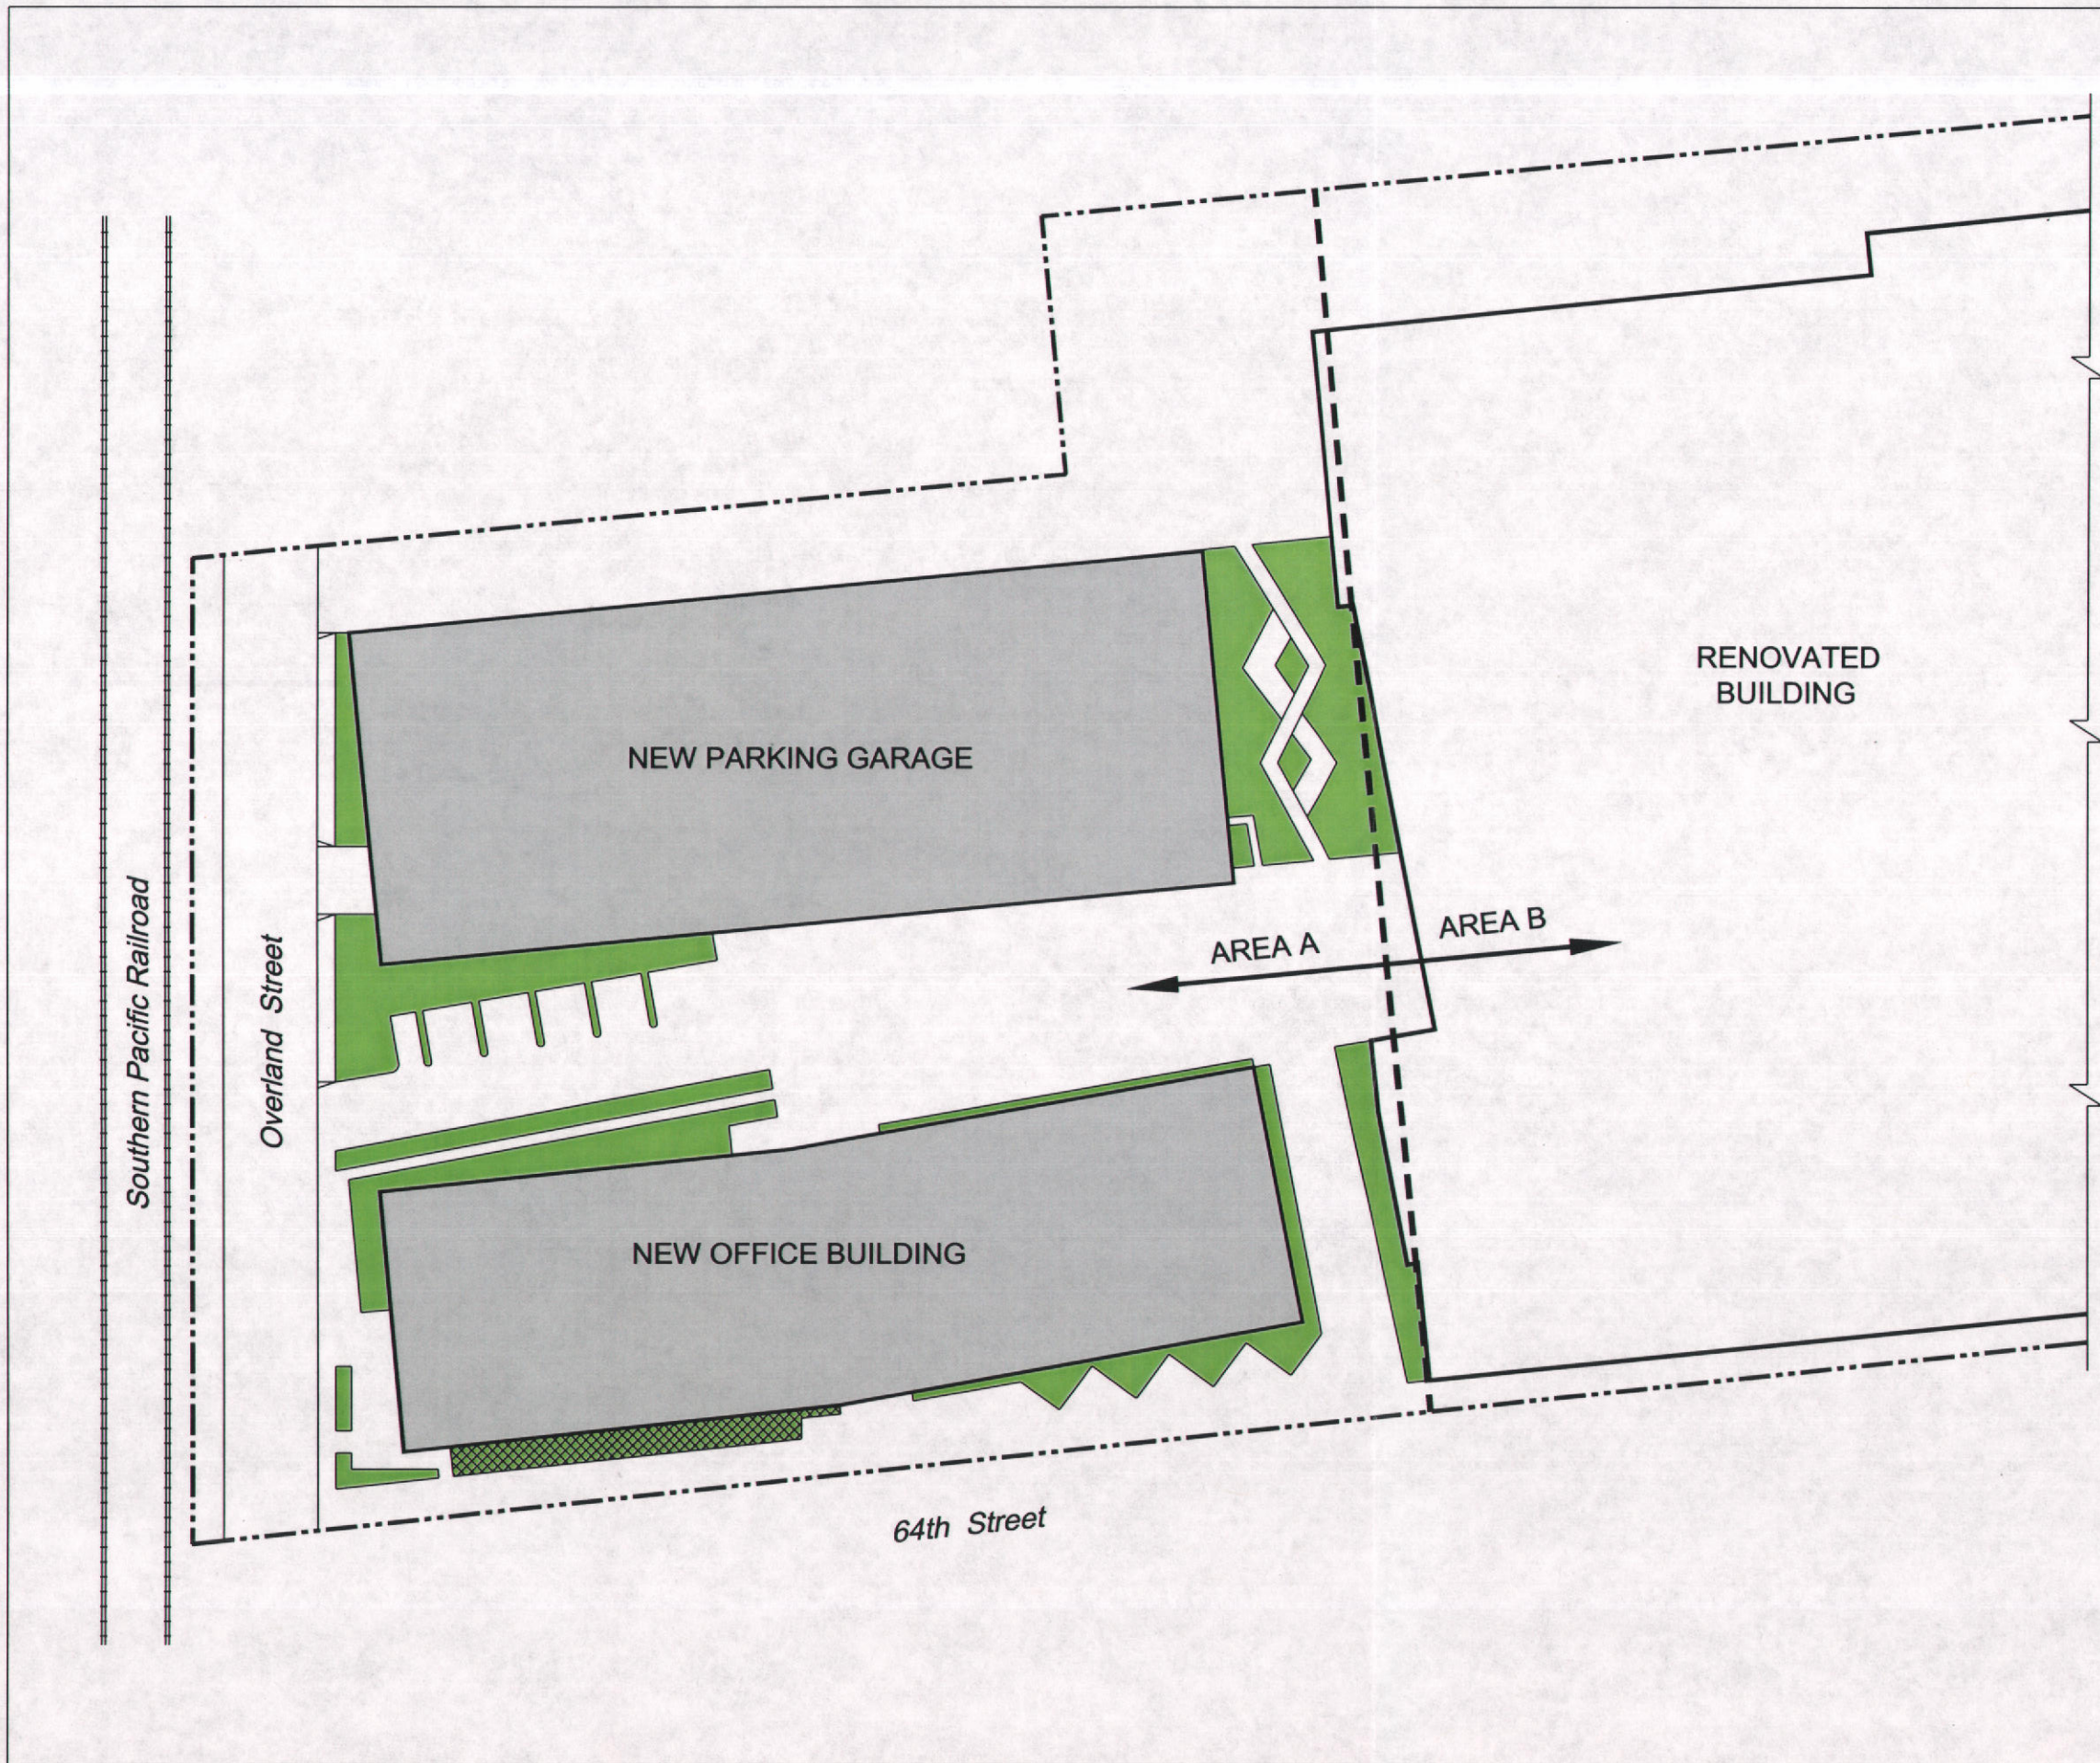
64th Street Properties  
 Emeryville, CA  
 January 2001  
 EKI 990016.00  
 Figure 4

Due to sloping requirements to prevent undermining building foundations and sidewalks, a portion of the landscape areas south of the new building did not achieve the three feet of clean soil cover specified in the RMP. The landscape area of concern is shown on Figure 4. Within this landscape area, the clean soil cover near the edge (i.e., adjacent to the sidewalk and the building) ranges from 1 to 3 feet in thickness. The width of the soil cover less than 3 feet thick is approximately 2 feet. The clean soil cover thickness varies in a roughly linear fashion, with the thinnest portion being closest to the building and sidewalk. To provide a visual warning of the clean fill boundary, the bottom of the clean fill is marked with plastic, orange fence material in the areas where the clean soil cover is less than 3 feet thick.

1. All locations are approximate.
2. Within 2 feet of the edges, clean fill thickness varies between 1 and 3 feet. Clean fill is thinnest at the edge of this landscape area.

Area A Landscape Areas

As required in Section 5.3 of the RMP, a H&SP will be prepared for future subsurface excavation activities in which the cap is removed. The RMP requires that the H&SPs include a description of health and safety training requirements for onsite personnel, the level of personal protective equipment to be used, and any other applicable precautions to be undertaken. These requirements apply to the cap in the landscape area of concern.

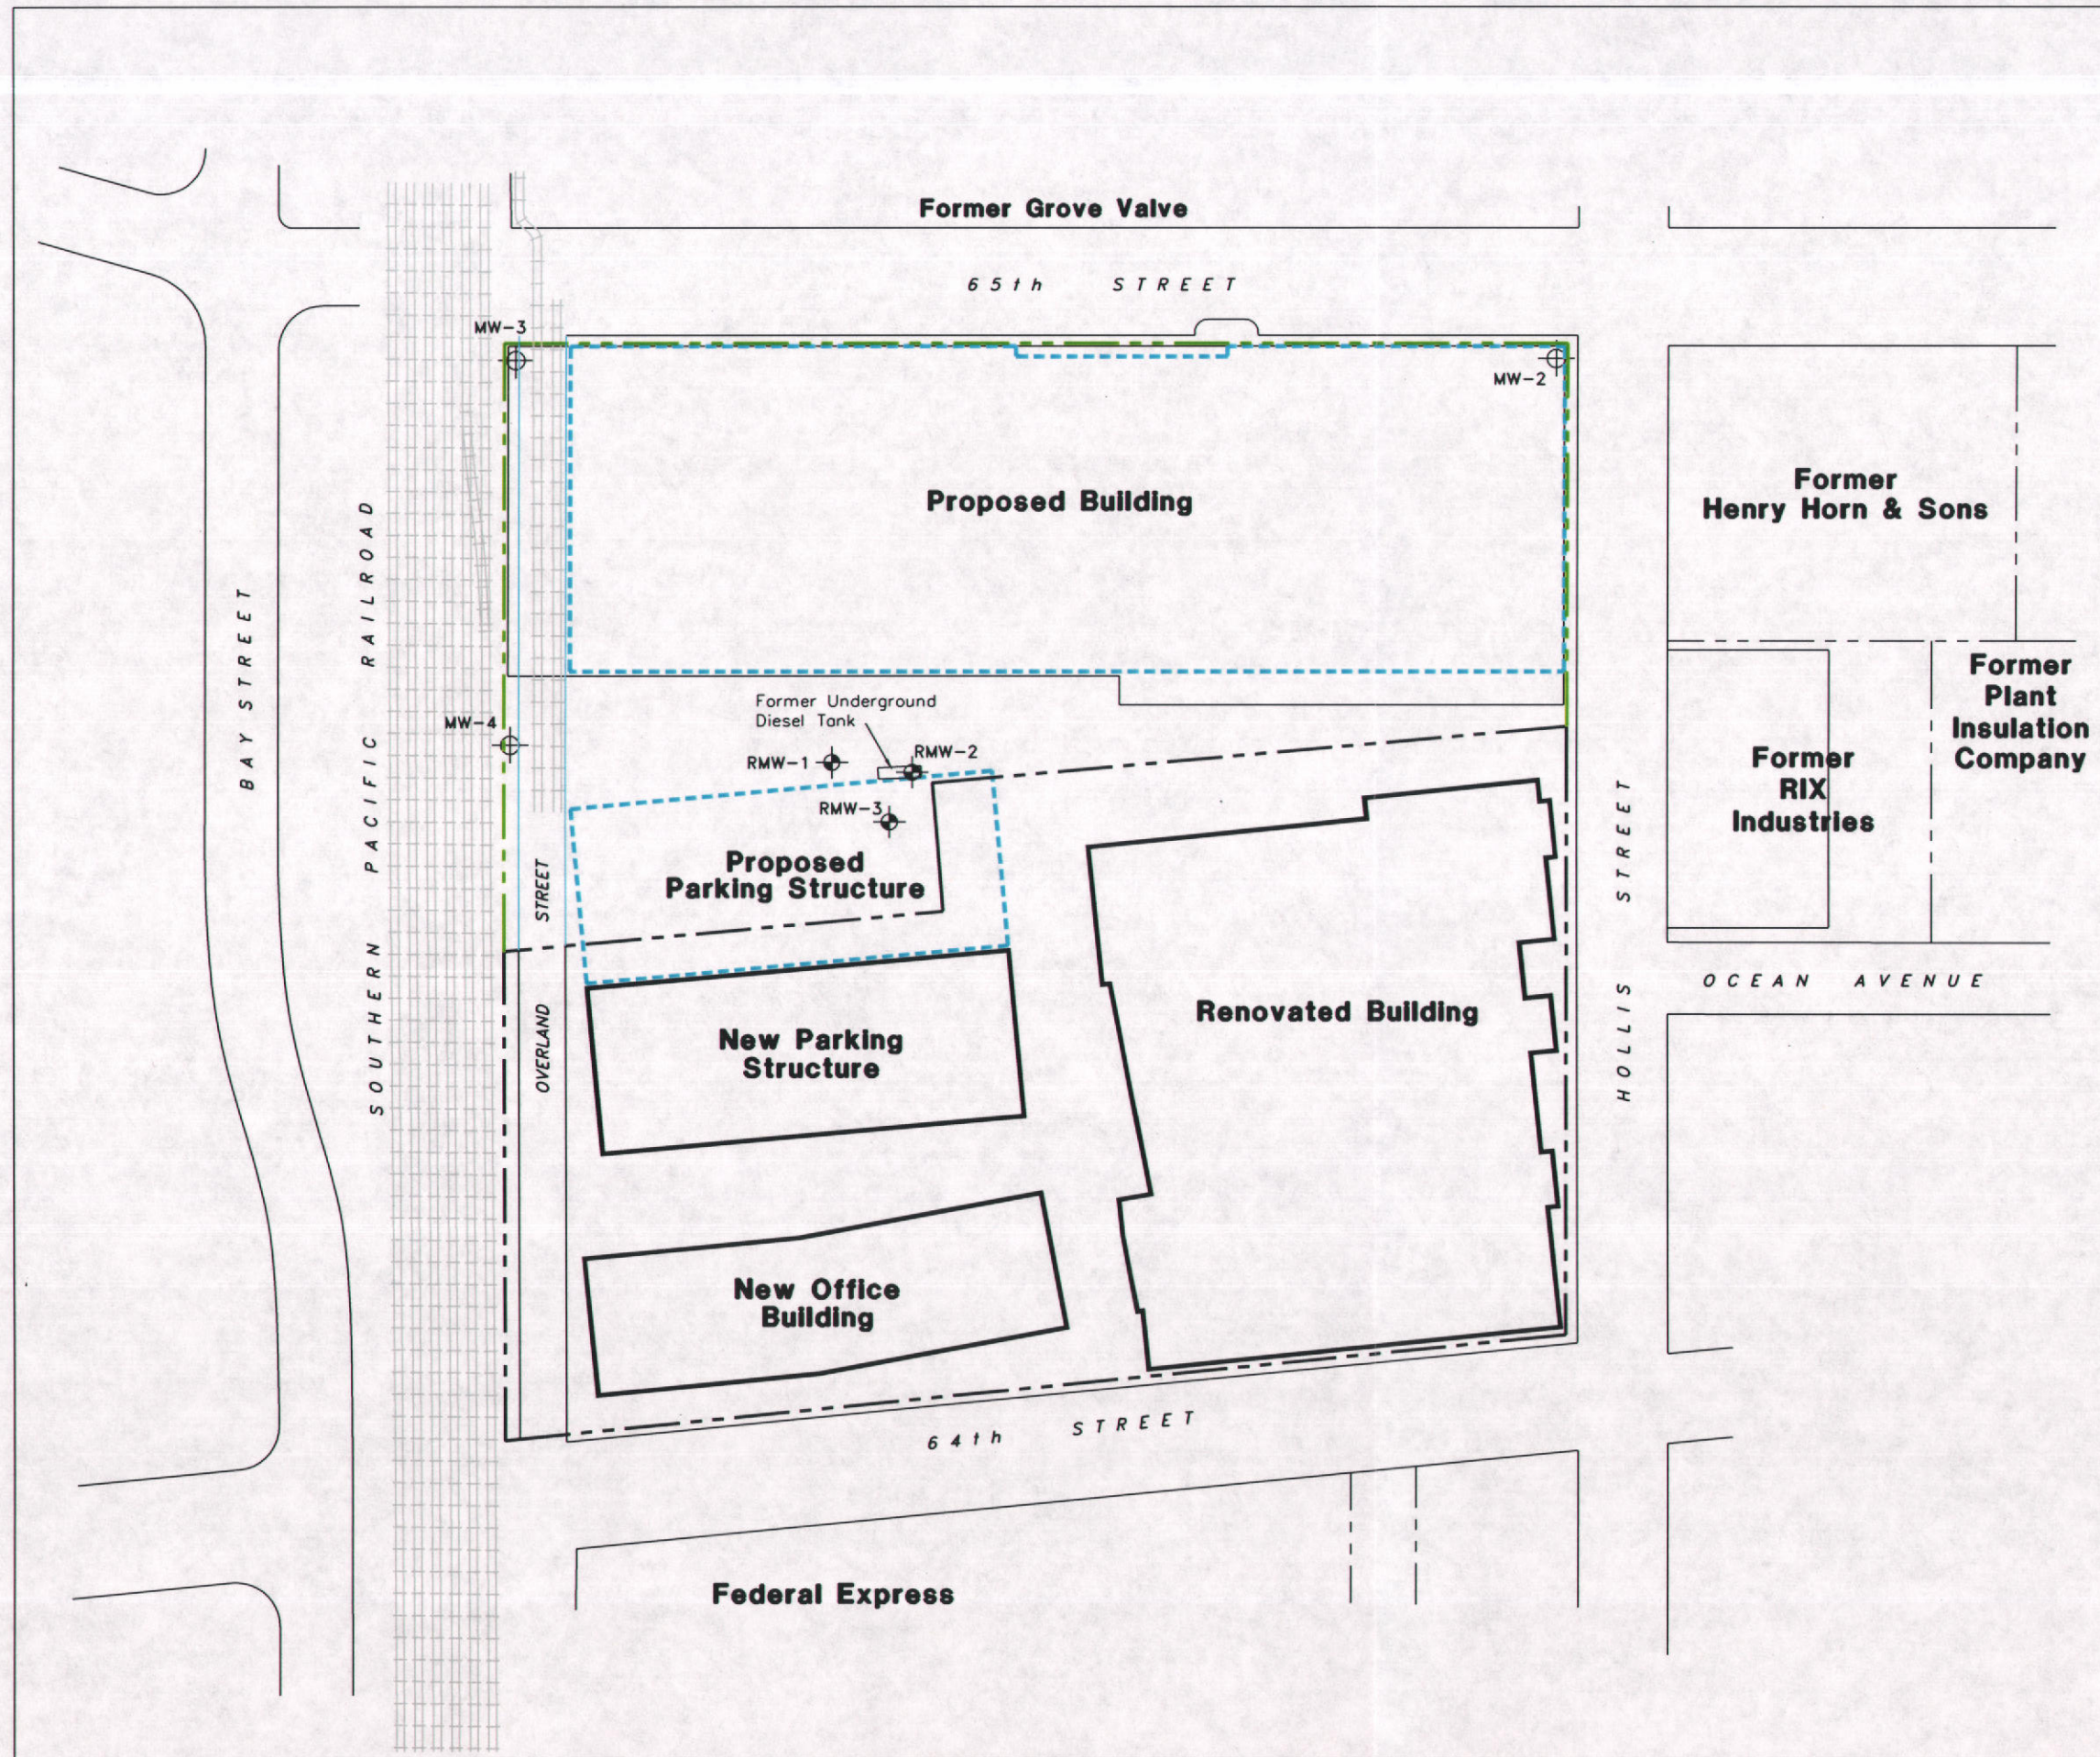
Ryerson Property  
Emeryville, CA  
January 2001  
EKI A00084.00  
Figure 5

On 11 March 1993, a 10,000-gallon underground diesel storage tank was removed from the south central portion of the Ryerson property (see Figure 5) (EKI, 1999a). Shallow groundwater from a well immediately south of the tank (well RMW-3) was found to be impacted by extractable petroleum hydrocarbons, and a hydrocarbon sheen was noted in that well.

Summarized in Table 1 are petroleum hydrocarbon analytical results from groundwater sampled from three wells surrounding the tank removal excavation. Well locations are shown on Figure 5. Benzene, toluene, ethylbenzene, and methyl tertiary butyl ether ("MTBE"), were not detected in any groundwater samples collected during the latest sampling, which was performed in December 2000. Xylenes were only detected in well RMW-3, at a concentration of 2.5 ug/L. Polynuclear aromatic hydrocarbons ("PAHs") were not detected in samples collected March 1995, the last time groundwater was analyzed for PAHs. Groundwater from well RMW-3 in December 2000 contained total extractable petroleum hydrocarbons ("TEPH") at a concentration of 23,000 ug/L, while TEPH was not detected in groundwater collected from wells RMW-1 and RMW-2. Well RMW-2 is located within the backfill of the tank removal excavation. Given the distribution of hydrocarbons in groundwater, it is uncertain whether the former diesel tank is the source of the hydrocarbons detected in well RMW-3. It is possible that the source of these hydrocarbons could be the refinery formerly (i.e., circa 1911) located immediately to the south.
