**REVISED ADDENDUM NUMBER 1  
TO THE FINAL  
RISK MANAGEMENT PLAN FOR  
THE 64<sup>TH</sup> STREET PROPERTIES  
EMERYVILLE, CALIFORNIA**

13 April 2001  
(EKI 990016.00, 990016.03)

# **Erler & Kalinowski, Inc.**

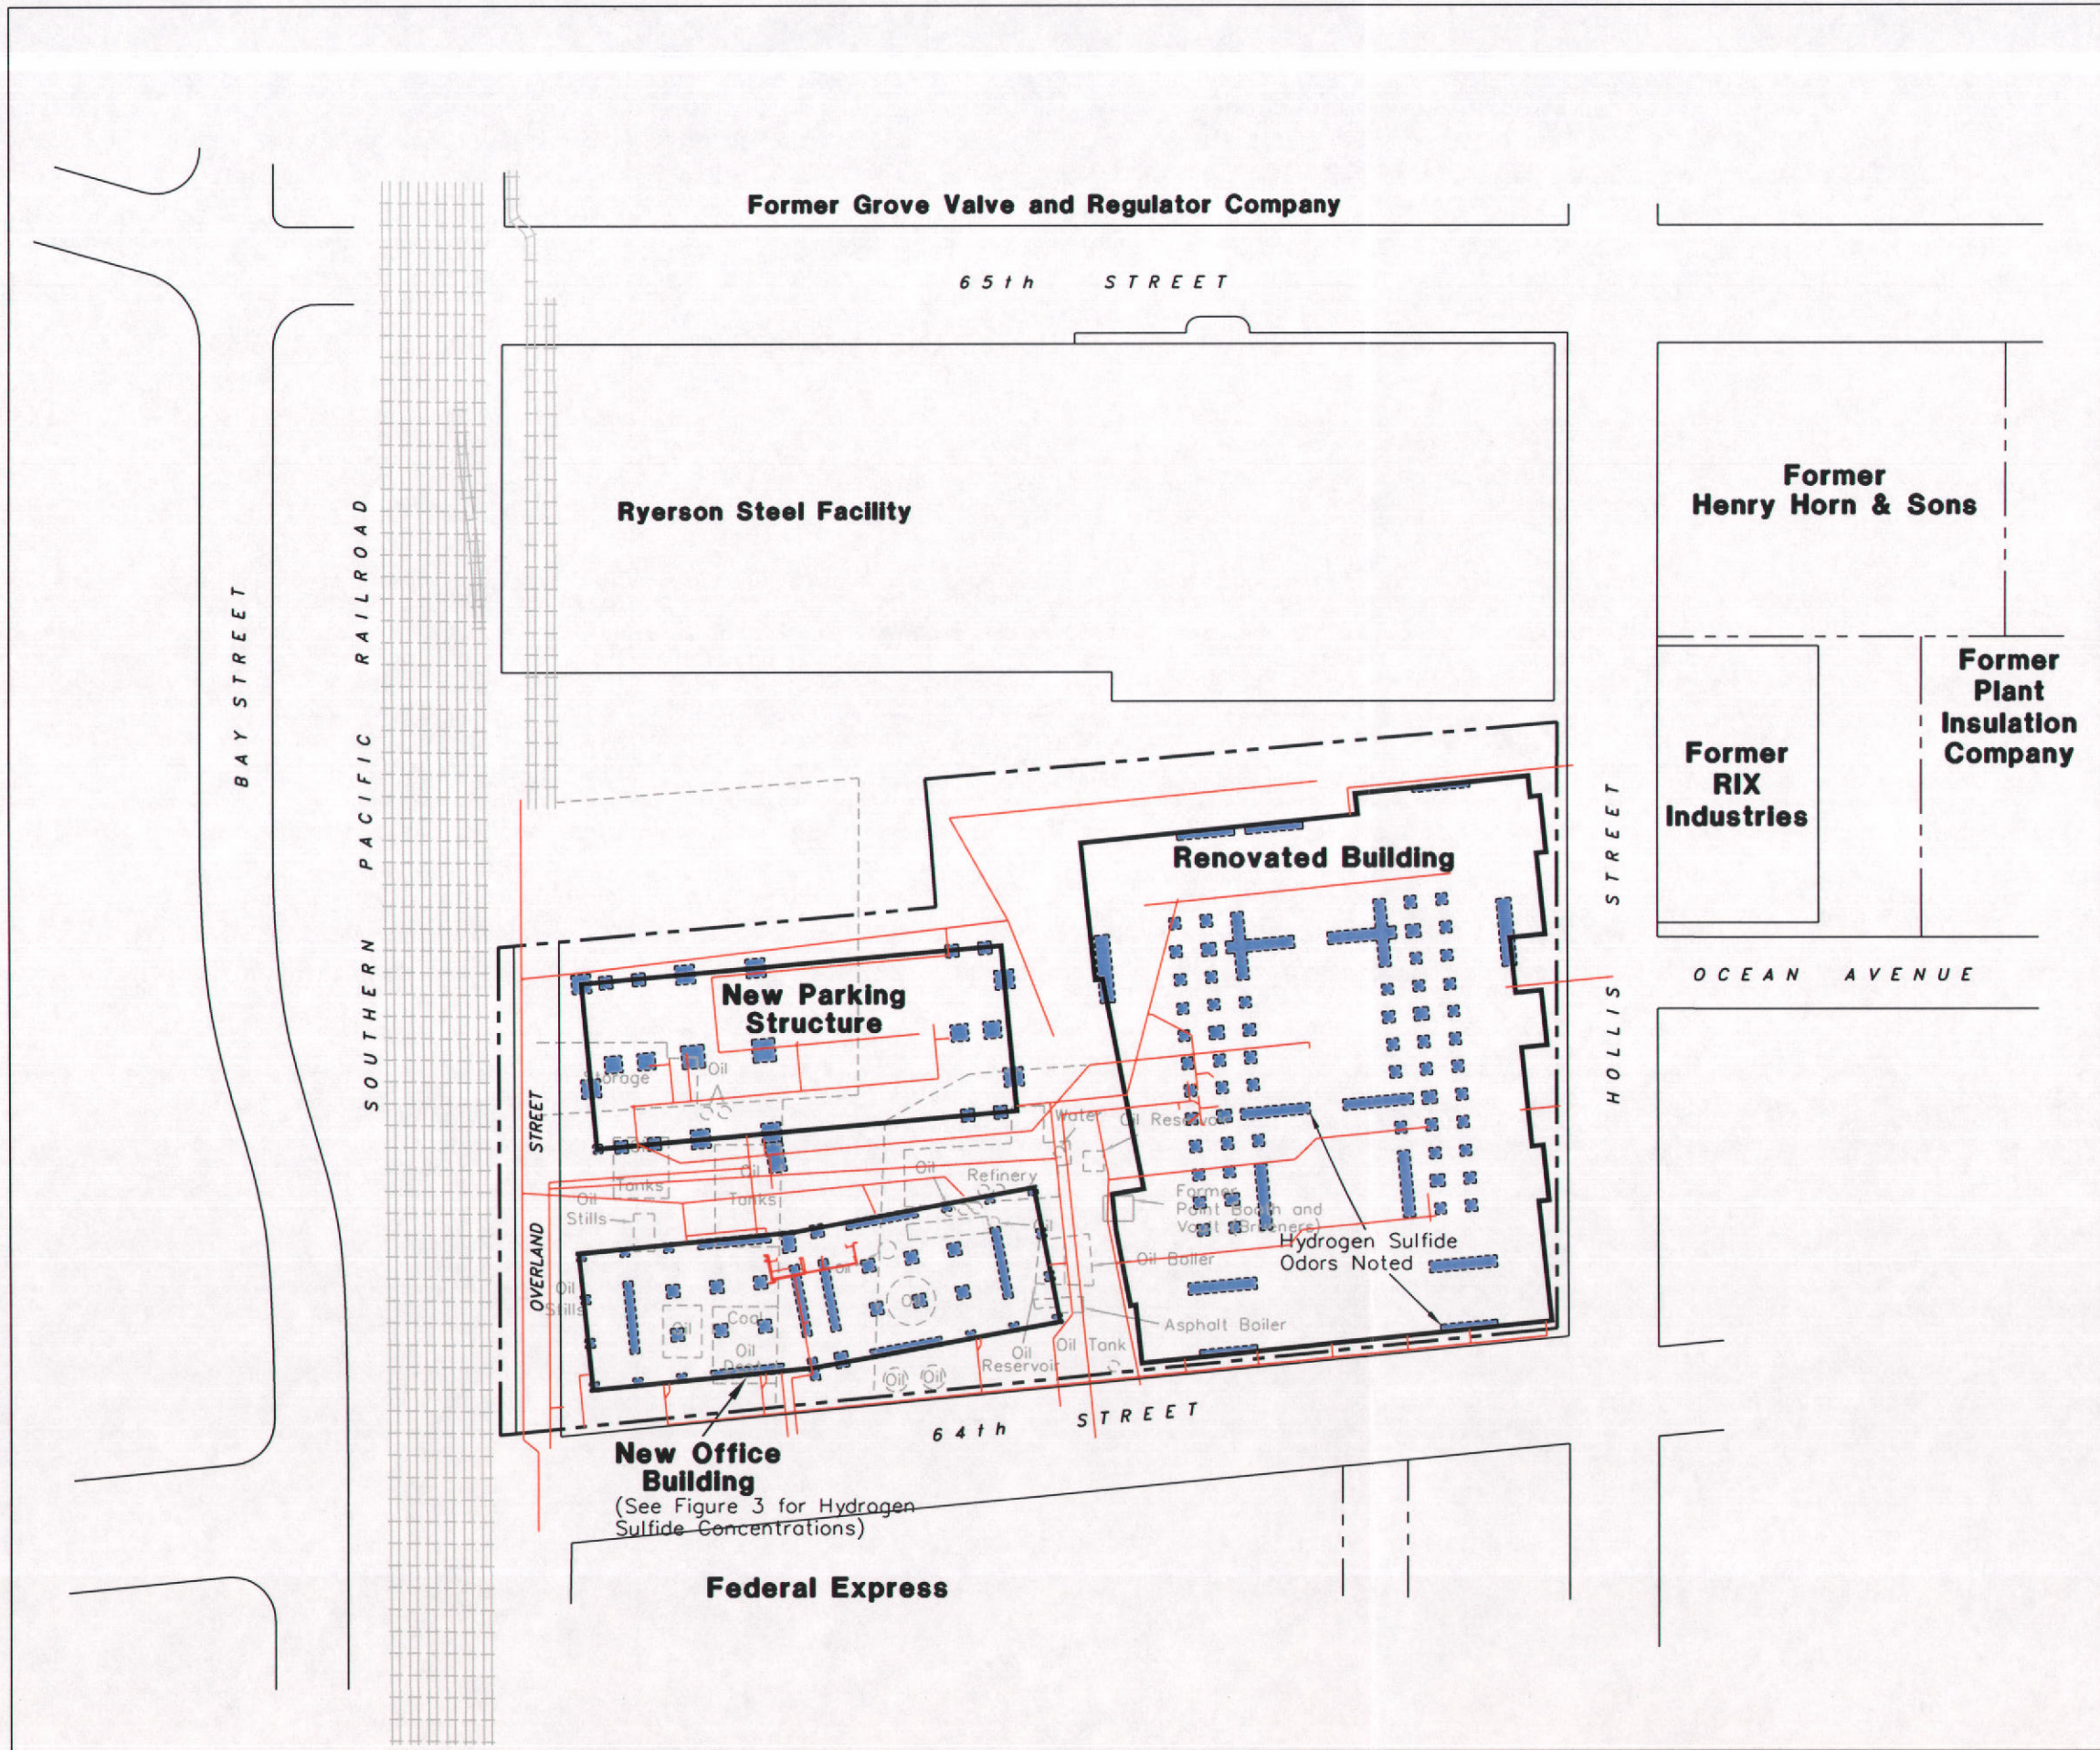
Building Footing Excavations and Underground Utilities

According to SBC, some hydrogen sulfide odors were also noted while performing footing excavations in the central portion and the southeastern corner of the renovated building (see Figure 2). Work was halted when the odors were noted and later resumed while measuring for hydrogen sulfide. However, the odor was no longer present after the resumption of work, and no hydrogen sulfide was detected.

SBC indicated that hydrogen sulfide odors were not noted when excavating trenches for installation of below-grade utilities. The approximate locations of these trenches are shown on Figure 2. In fact, SBC did not note hydrogen sulfide odors after construction of building footings was complete.

The origin of the hydrogen sulfide detected on the 64th Street properties is not known. Given that sustained concentrations of hydrogen sulfide were only encountered in the southwestern portion of the 64<sup>th</sup> Street properties (i.e., in the vicinity of the former refinery, see Figure 2), natural degradation of petroleum residuals from the former refinery is the likely source of the hydrogen sulfide. The southeastern corner of the renovated building, where hydrogen sulfide odors were noted, is in the vicinity of a former underground fuel storage tank. Given that bay mud underlies the fill on the property, sulfate bacteria capable of producing hydrogen sulfide are likely present amongst residual hydrocarbons remaining from this closed tank. Thus, hydrogen sulfide odors in this vicinity may also be the result of natural degradation of petroleum hydrocarbons. It is also possible that natural degradation of organic material within the bay muds underlying the 64th Street properties contributes hydrogen sulfide to the soil gas.

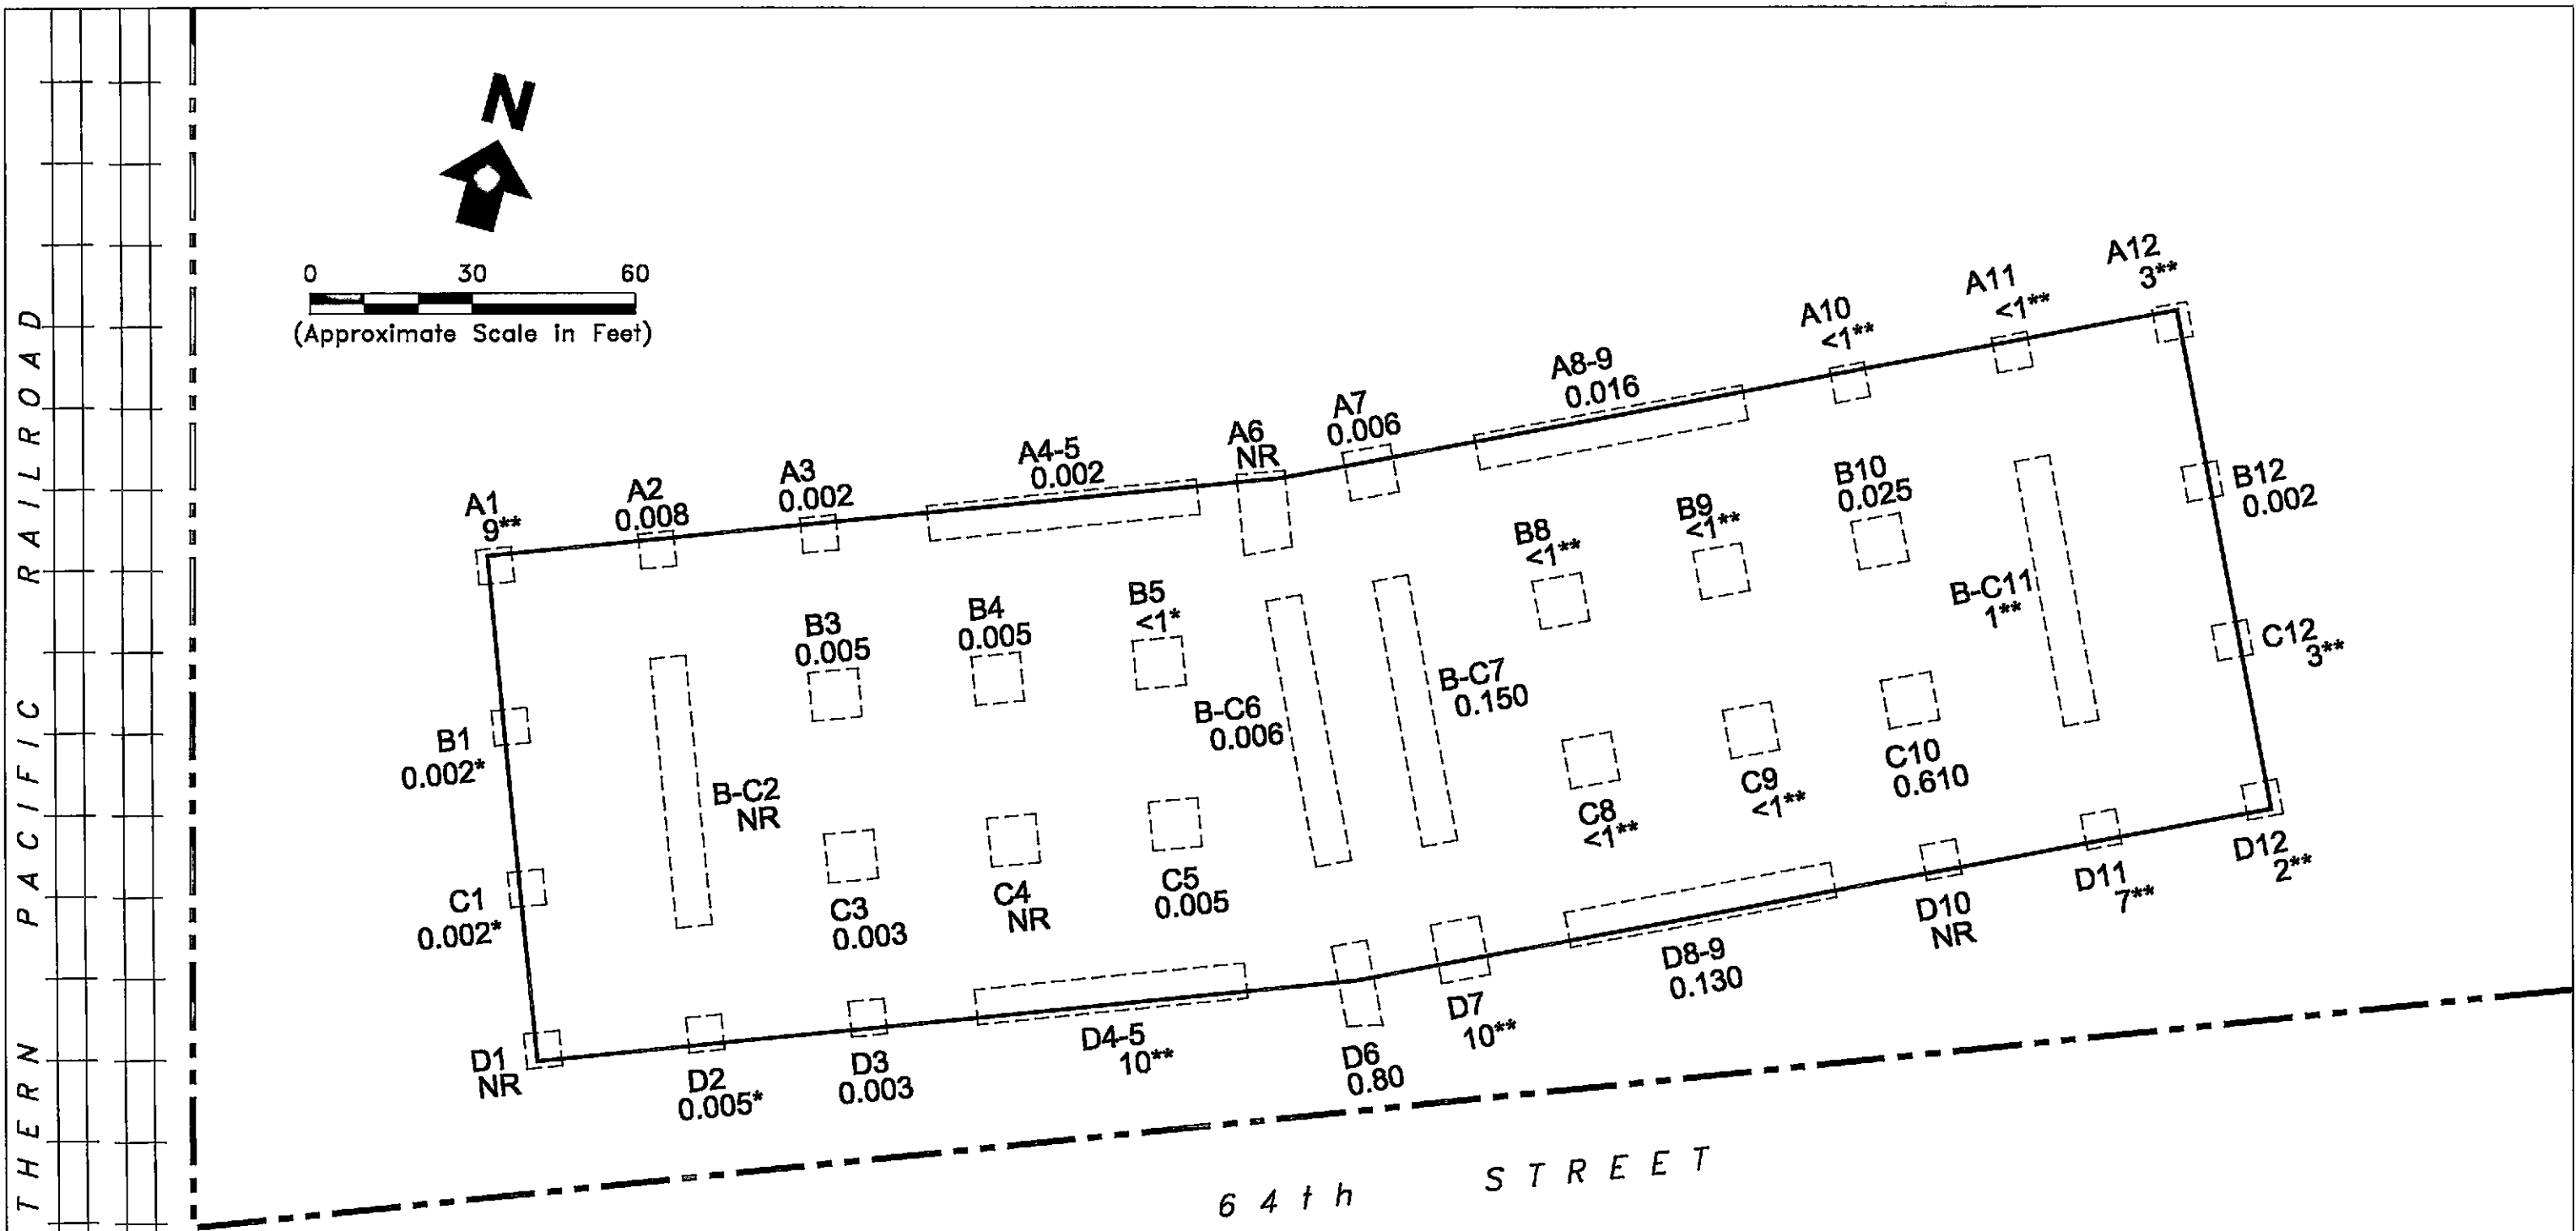
Maximum Breathing Zone Hydrogen Sulfide Concentrations Measured During Construction  
 64th Street Properties  
 Emeryville, CA  
 April 2001  
 EKI 990016.03  
 Figure 3

The maximum breathing zone concentrations of hydrogen sulfide measured at each foundation excavation for the new office building are shown on Figure 3. The highest concentrations were detected at footing excavations A1 (9 parts per million by volume ("ppmv")), D4-5 (10 ppmv), D7 (10 ppmv), and D11 (7 ppmv). As shown on Figure 3, the distribution of hydrogen sulfide is not contiguous; rather, it appears to be concentrated in specific areas.

The concentrations shown on Figure 3 are peak concentrations; sustained concentrations were lower. Hydrogen sulfide concentrations generally decreased to non-detectable levels within 30 minutes of the cessation of excavation activities. Hydrogen sulfide was only detected in the areas shown on Figure 3, and only when soil excavation was being or had recently been performed.

The maximum hydrogen sulfide concentration detected at the site is 10 ppmv. As noted above, the PEL is also 10 ppmv; however, the PEL is an 8-hour time-weighted average, while the maximum hydrogen sulfide concentrations shown on Figure 3 were not

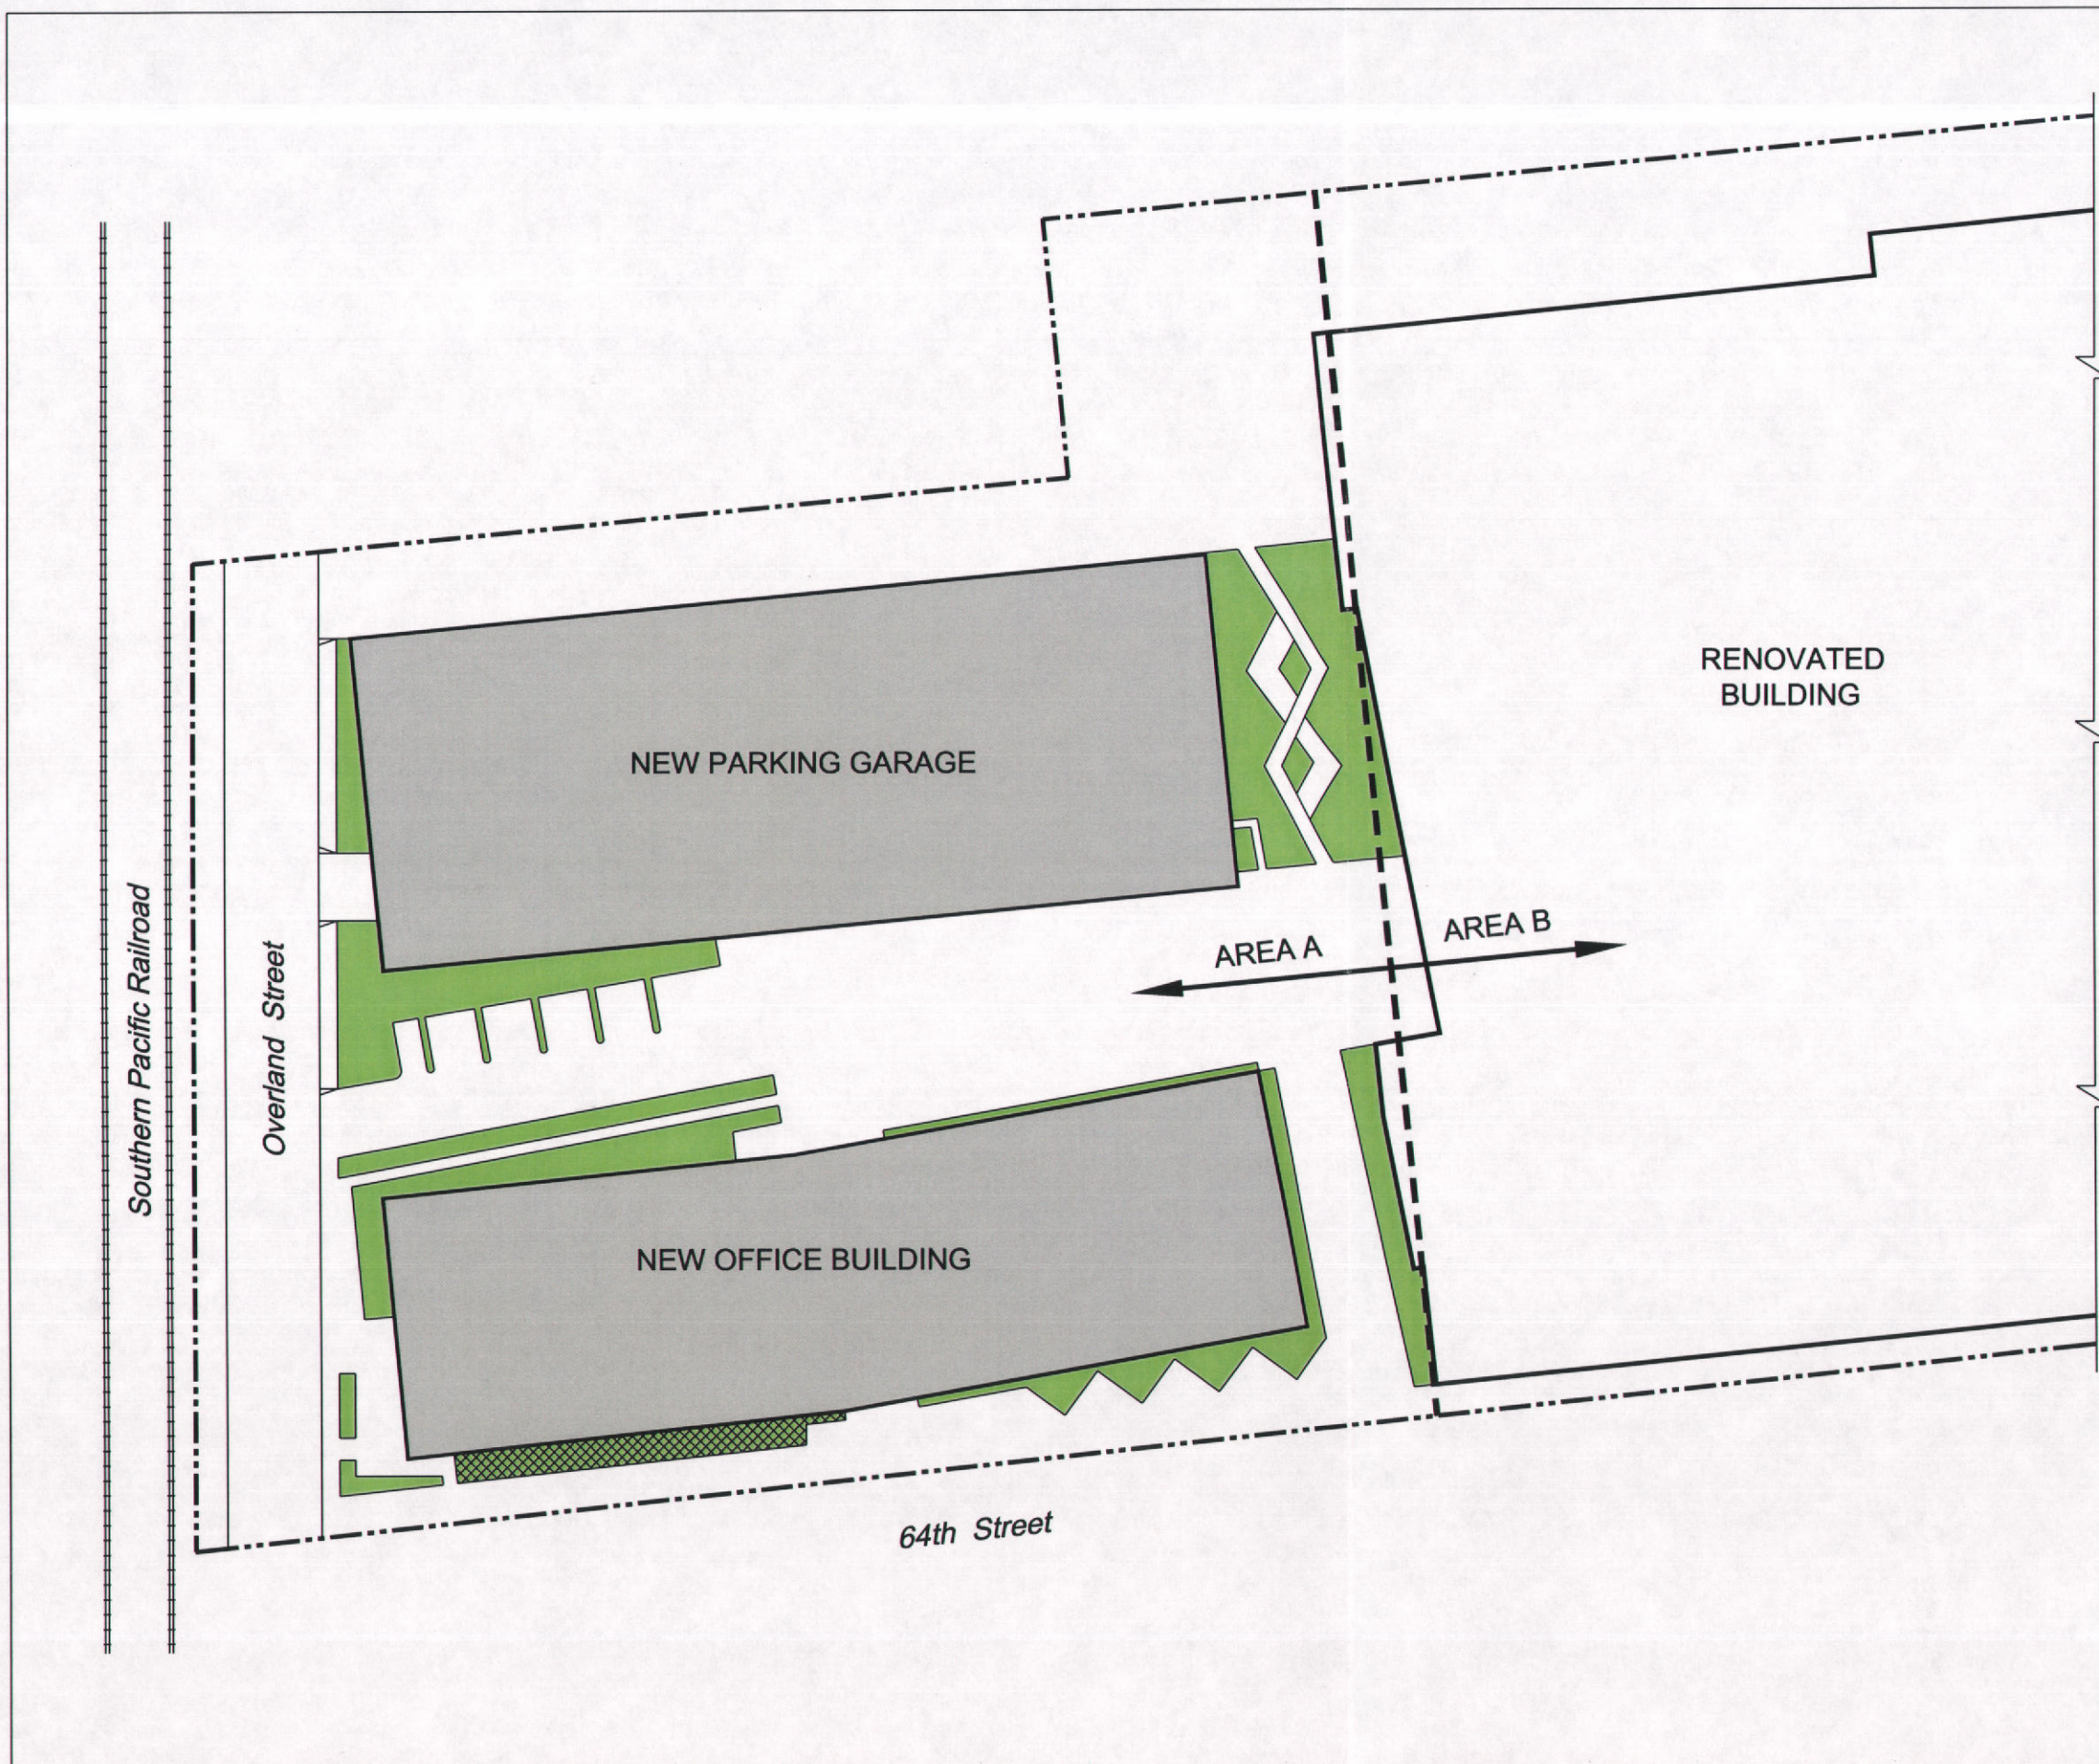
Area A Landscape Areas

Due to sloping requirements to prevent undermining building foundations and sidewalks, a portion of the landscape areas south of the new building did not achieve the three feet of clean soil cover specified in the RMP. The landscape area of concern is shown on Figure 4. Within this landscape area, the clean soil cover near the edge (i.e., adjacent to the sidewalk and the building) ranges from 1 to 3 feet in thickness. The width of the soil cover less than 3 feet thick is approximately 2 feet. The clean soil cover thickness varies in a roughly linear fashion, with the thinnest portion being closest to the building and sidewalk. To provide a visual warning of the clean fill boundary, the bottom of the clean fill is marked with plastic, orange fence material in the areas where the clean soil cover is less than 3 feet thick.

1. All locations are approximate.
2. Within 2 feet of the edges, clean fill thickness varies between 1 and 3 feet. Clean fill is thinnest at the edge of this landscape area.

As required in Section 4.3 of the RMP, a H&SP will be prepared for future subsurface excavation activities in which the cap is removed. The RMP requires that the H&SPs include a description of health and safety training requirements for onsite personnel, the level of personal protective equipment to be used, and any other applicable precautions to be undertaken. These requirements apply to the cap in the landscape area of concern.
