RE: 1315 Court Street, Alameda CA

Subject: Interim Remedial Action Plan (IRAP); Proposed Mercury Removal Action; 1315 Court St., Alameda, California

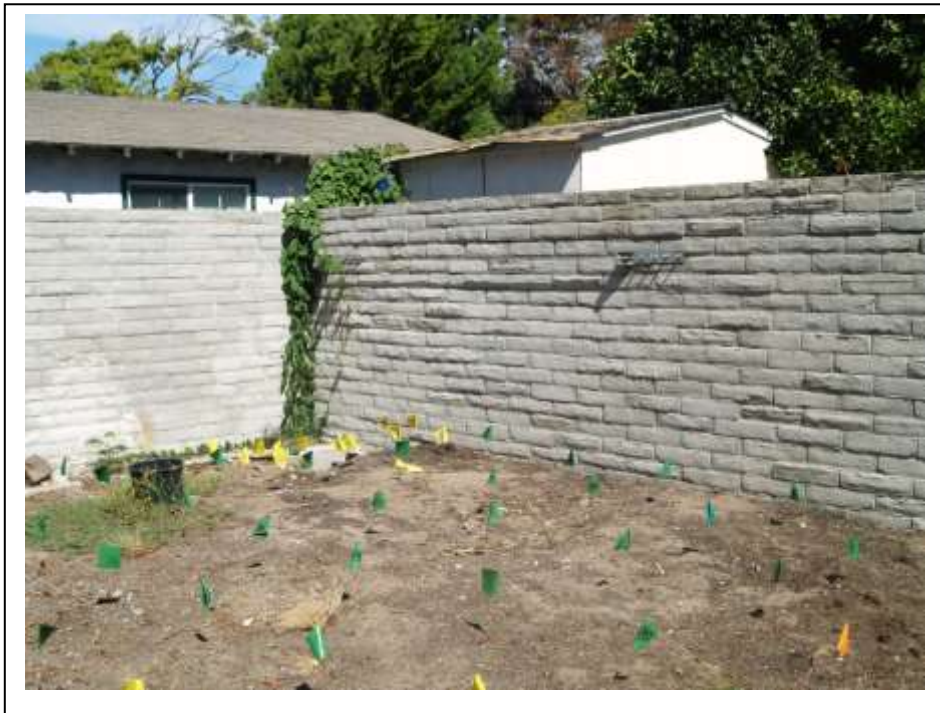
Project No. TM/R: 92105	Description	Concrete Block Wall: Mercury Release Identified Near Corner	Photo #1
	Name	1315 Court Street, Alameda California	Photo Date Sept. 21, 2015

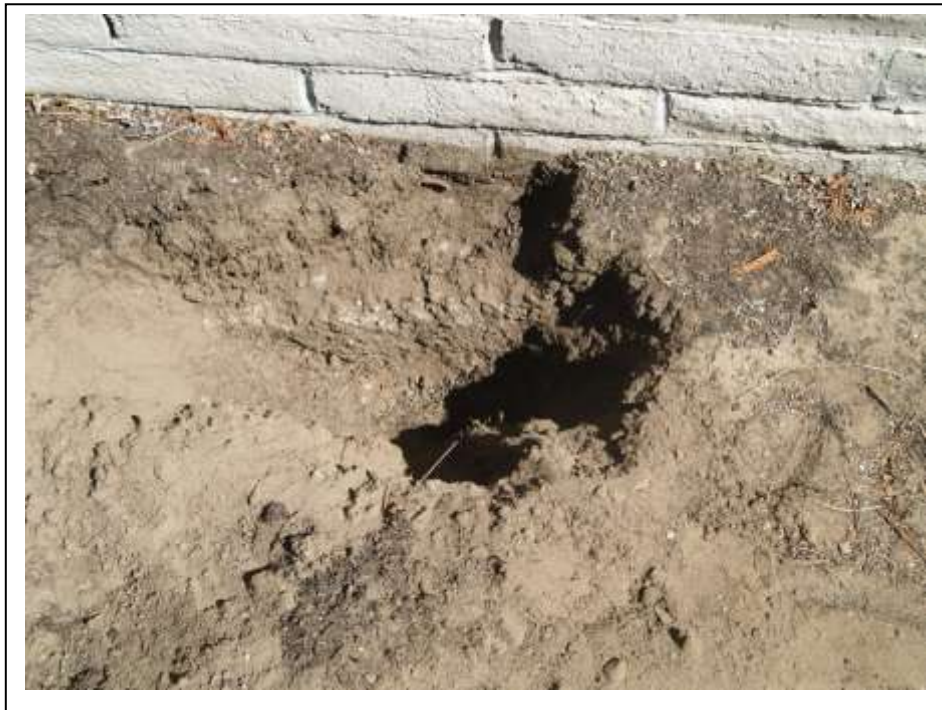
Project No. TM/R:92015	Description	Concrete Block Wall and Exposed Footing Near Release Site	Photo #2
	Name	1315 Court Street, Alameda California	Photo Date Sept 21, 2015

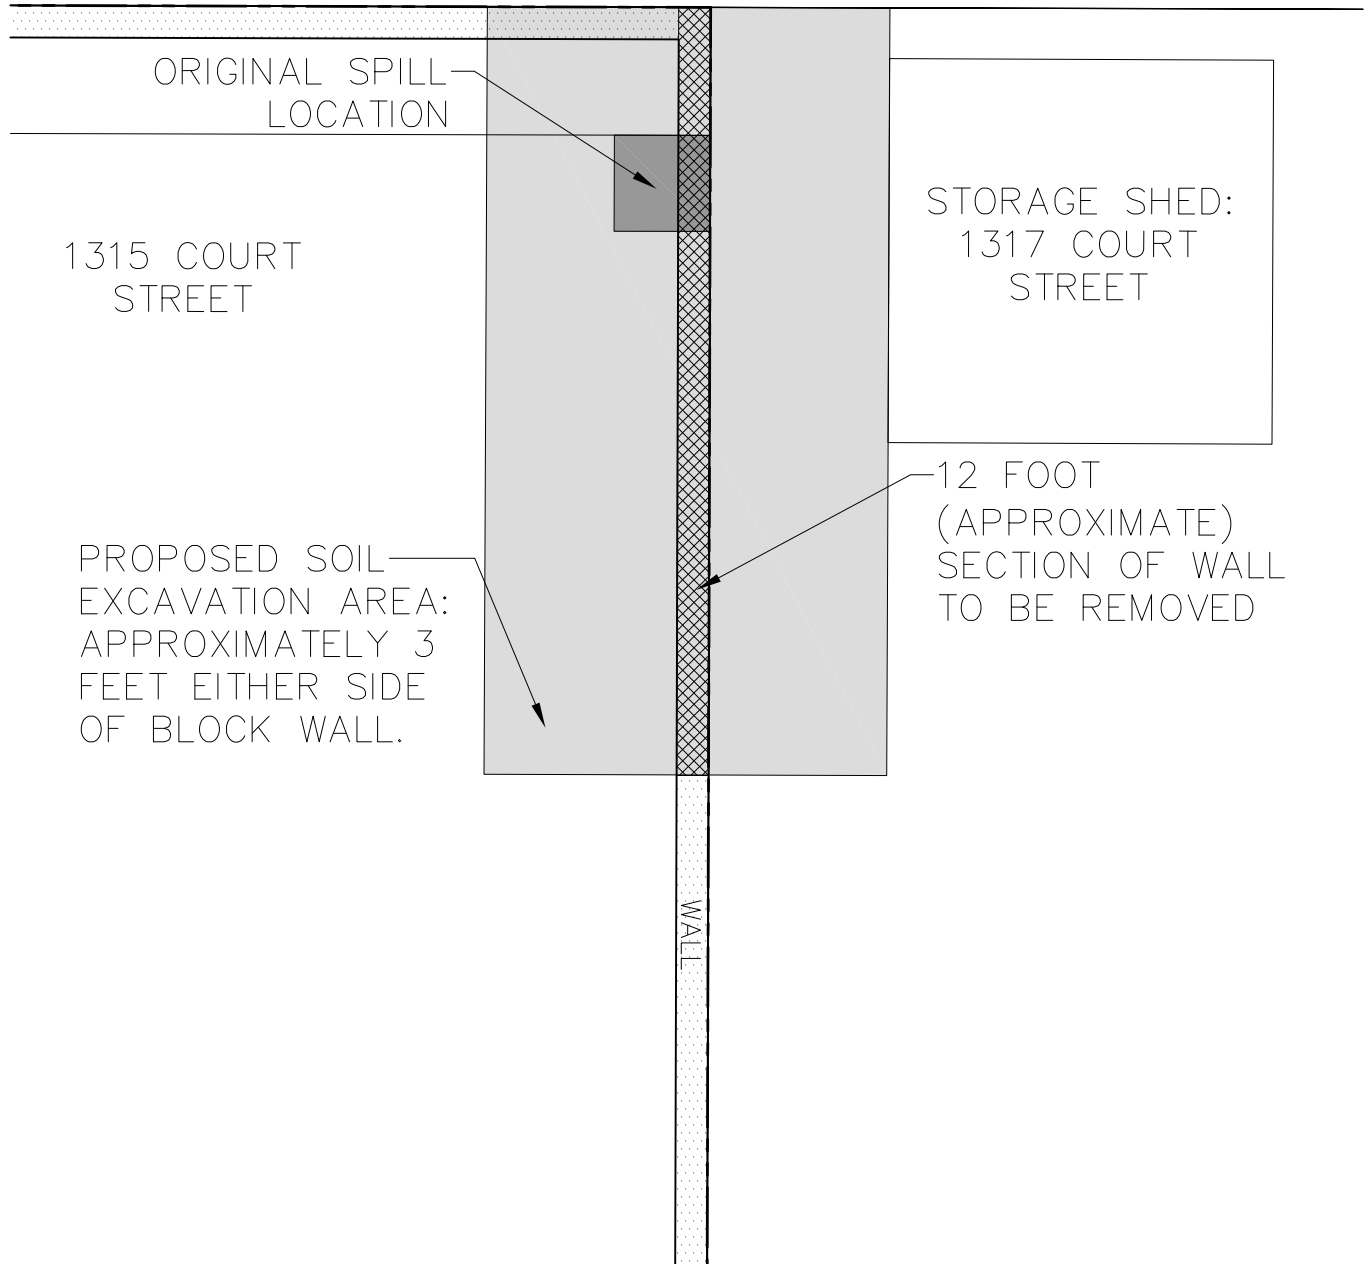
FIGURE #1

Based on direct soil vapor readings and observations of liquid mercury in soil and wall structures, it is apparent that liquid mercury was intentionally disposed to the opening at the top of the cinder block wall at the northern corner of the property (Figure 1).

The observations of mercury, substantiated by vapor and laboratory analytical data, indicate that the area of contamination is localized and has impacted shallow soil at the north corner of the 1315 Court St. and far western corner of 1317 Court St.

1315 COURT STREET, ALAMEDA CA
PROPOSED CONCRETE WALL REMOVAL AND
SOIL EXCAVATION

- Removal and disposal of the affected portions of the concrete wall and associated footings that exceed the ESL.
- Soil removal with disposal at a permitted hazardous waste disposal facility
- Backfill and compaction of clean fill and topsoil.
