**RE: WORK PLAN FOR ADDITIONAL SITE CHARACTERIZATION  
FORMER ROCKRIDGE CLEANERS  
5100 BROADWAY, OAKLAND, CALIFORNIA**

**RE: WORK PLAN FOR ADDITIONAL SITE CHARACTERIZATION  
FORMER ROCKRIDGE CLEANERS  
5100 BROADWAY, OAKLAND, CALIFORNIA  
TETRA TECH PROJECT NO. 117-7429001**

**Photographic Documentation**  
**Former Rockridge Dry Cleaner – 5100 Broadway**  
**(5114 tenant space)**  
**Oakland California**  
**Project No.: 117-7429001**

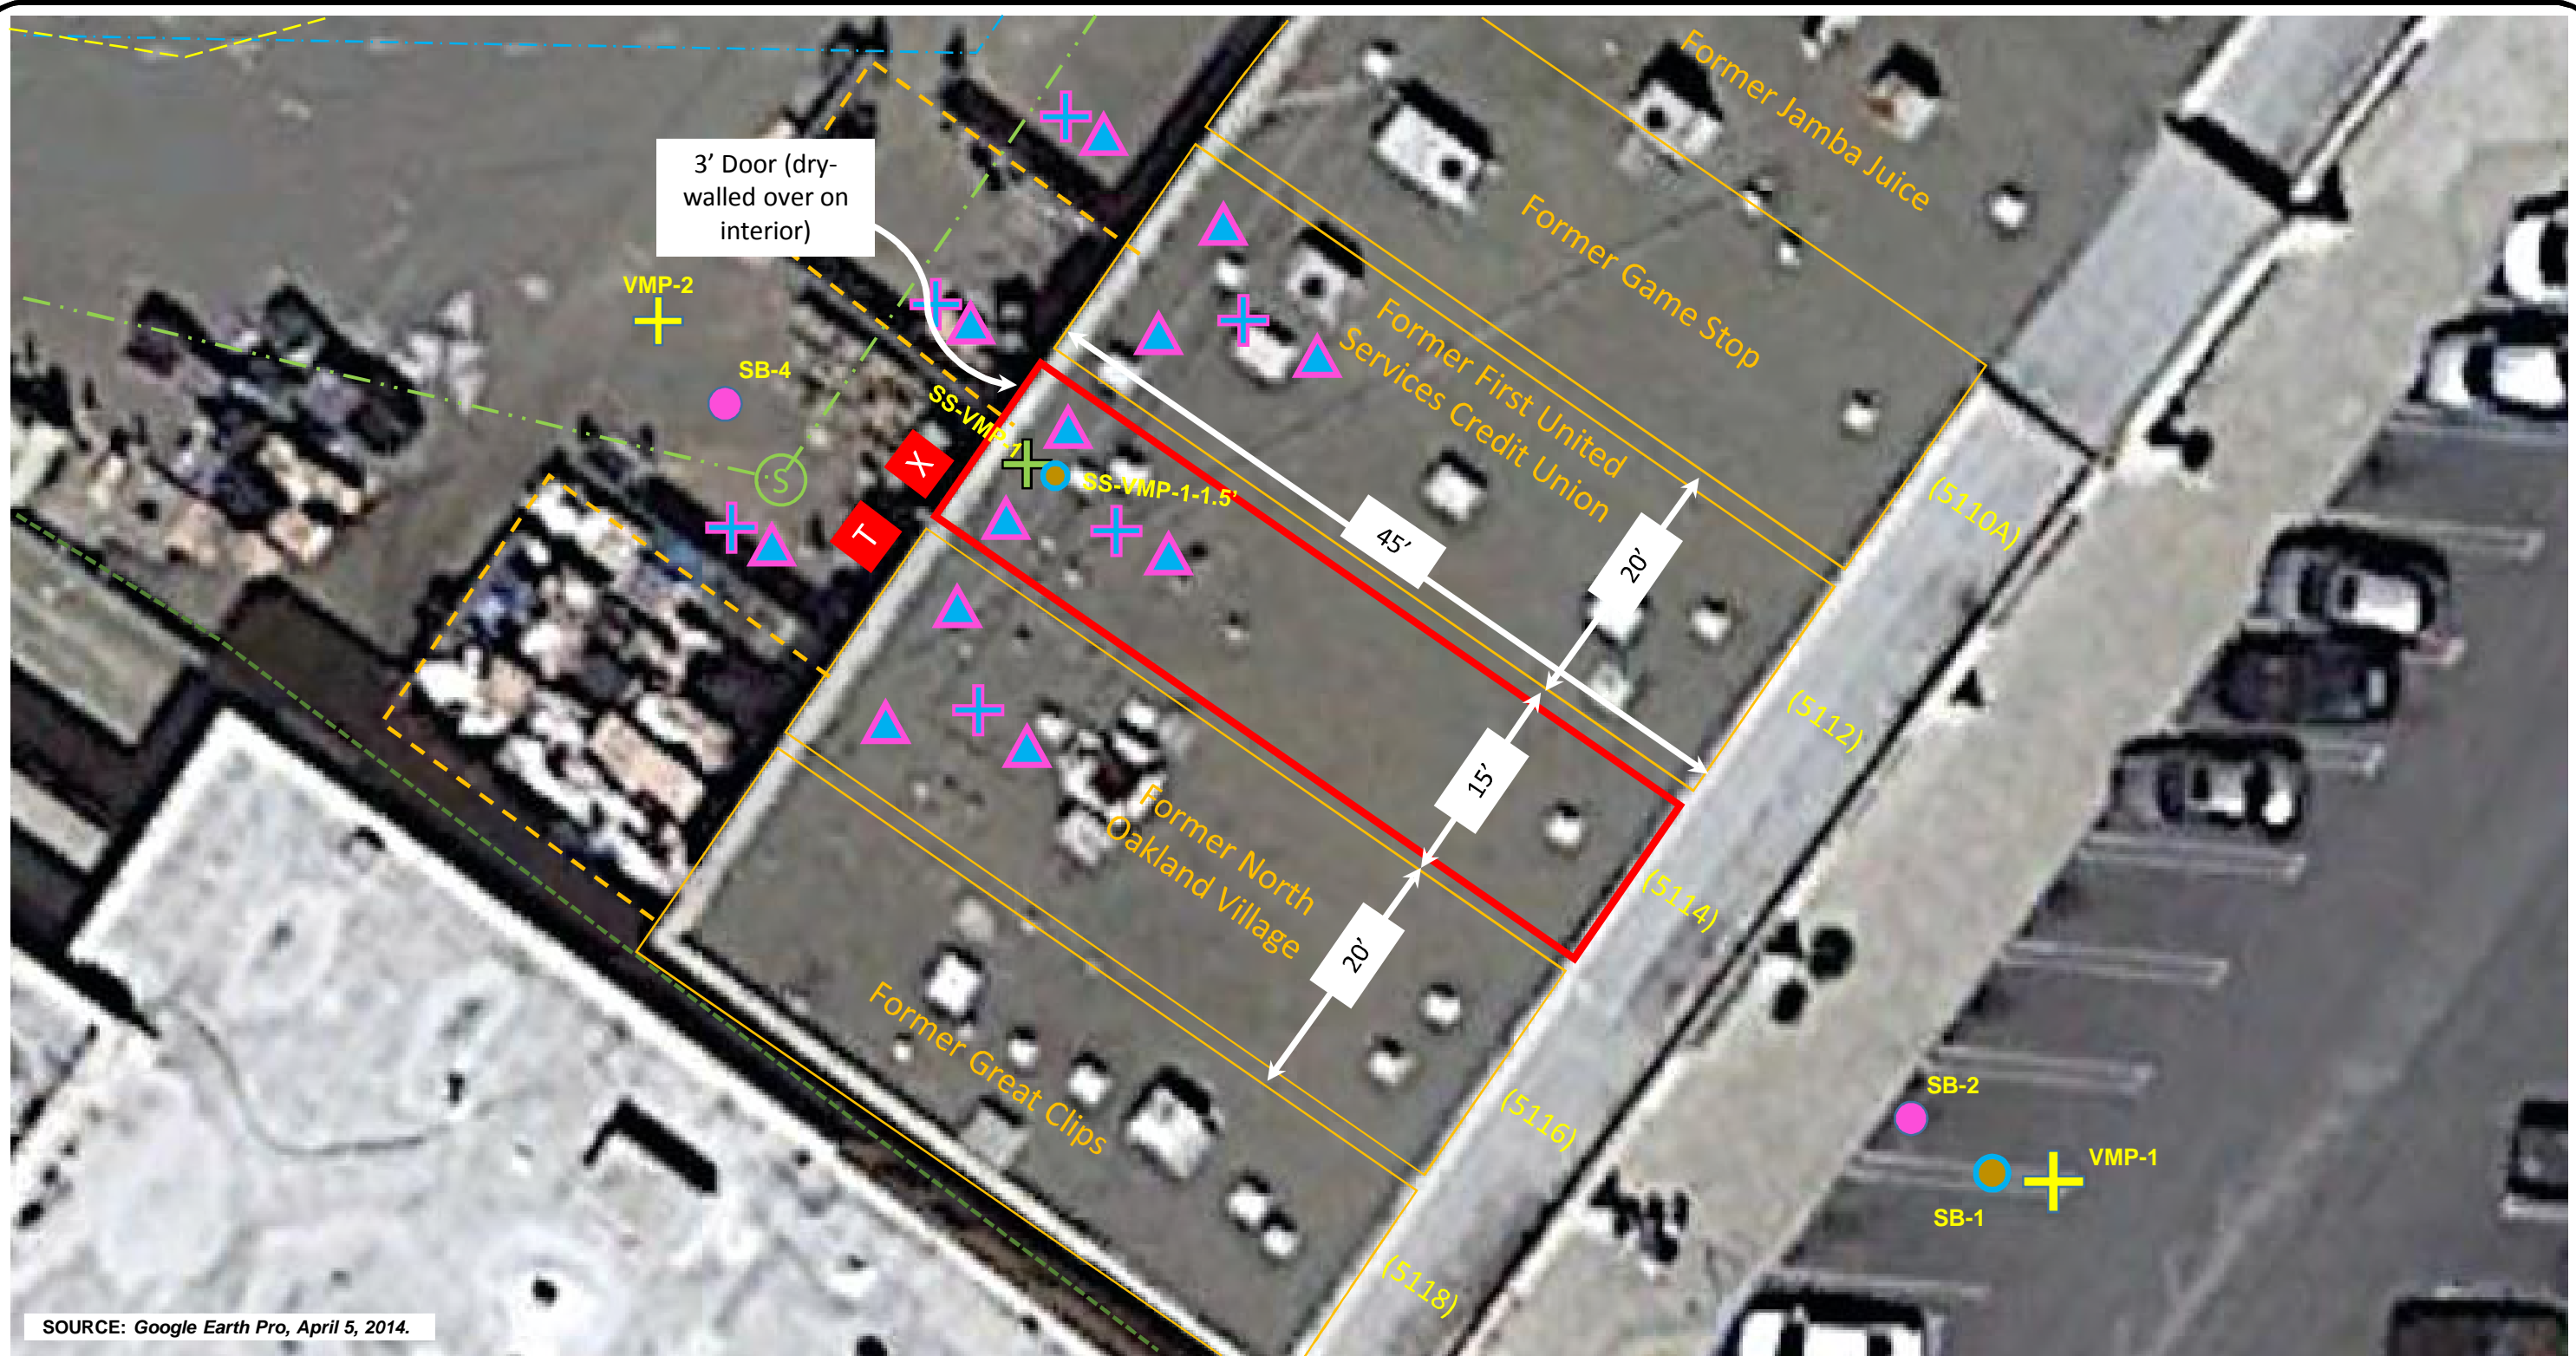
<b>TITLE: Proposed Soil and Soil Vapor Sample Locations Former Rockridge Cleaners</b>			
<b>LOCATION: 5114 Broadway Oakland, California</b>			
<b>TETRA TECH</b>	CHECKED:	TC	<b>FIGURE: 4</b>
	DRAFTED:	KDH	
	FILE:	117-7429001.	
	DATE:	05-19-15

A total of 12 soil borings and six temporary vapor monitoring probes will be advanced to 5 feet below ground surface. The locations of the borings are shown on the attached Figure 4. Three soil borings will be completed in each tenant space, along with one vapor monitoring probe, all biased to the rear of each tenant space where dry cleaning

machinery would have likely been located. The soil borings will be equally spaced in a triangular pattern within the rear 15-feet of each tenant space, with each vapor monitoring probe located near the center of the triangular soil boring pattern. Three paired soil boring/vapor monitoring probes will also be completed behind each of the three tenant spaces, near the exterior northwest wall of the building. The exterior boring locations may need to be adjusted based on utility conflicts (existing electrical transformer and underground electrical), and access restrictions due to stored materials.

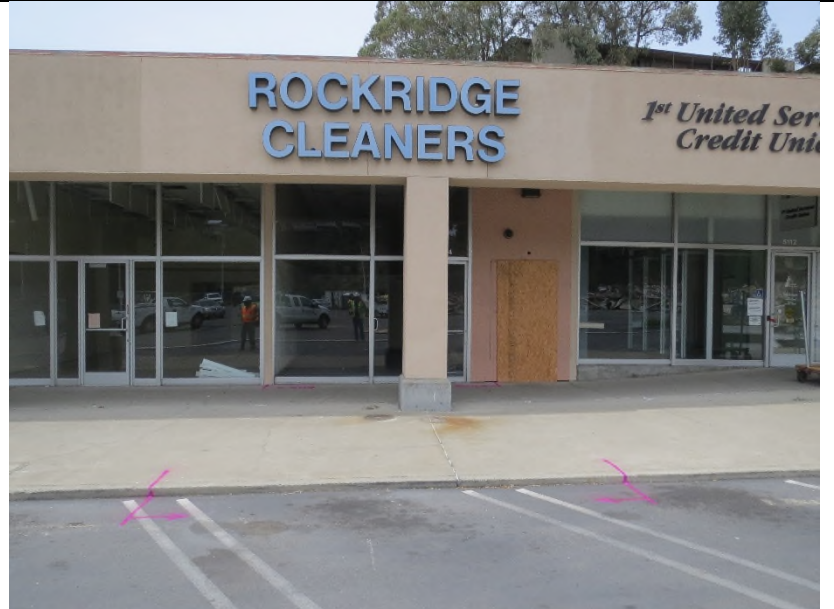
**Photo: 1**

**Description:** Looking toward the front of Building 5, and the former Rockridge Cleaners tenant space

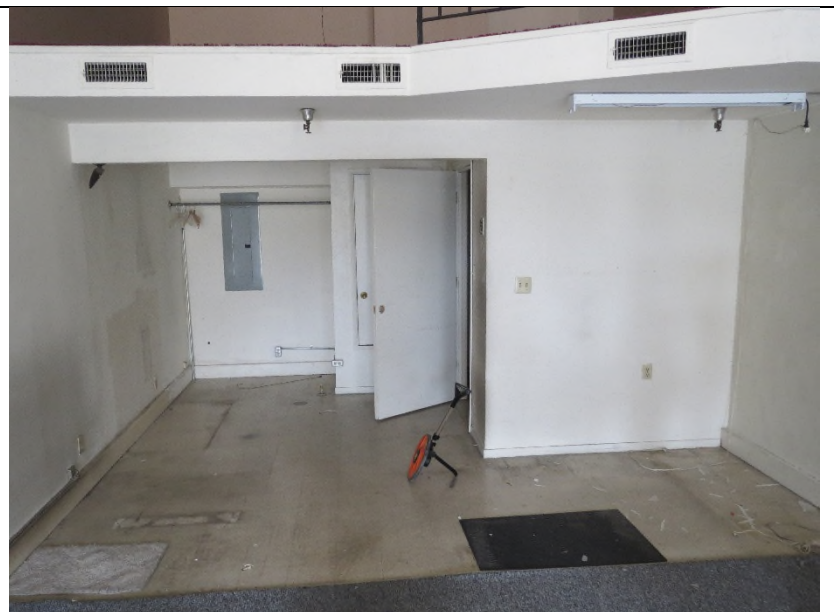
**Photo: 2**

**Description:** Rear (northwest wall) of former Rockridge Cleaners. Bathroom build-out (right) and hotwater heater/natural gas furnace build-out (center). Vinyl floor tile (VFT) area is 15' by 15'.

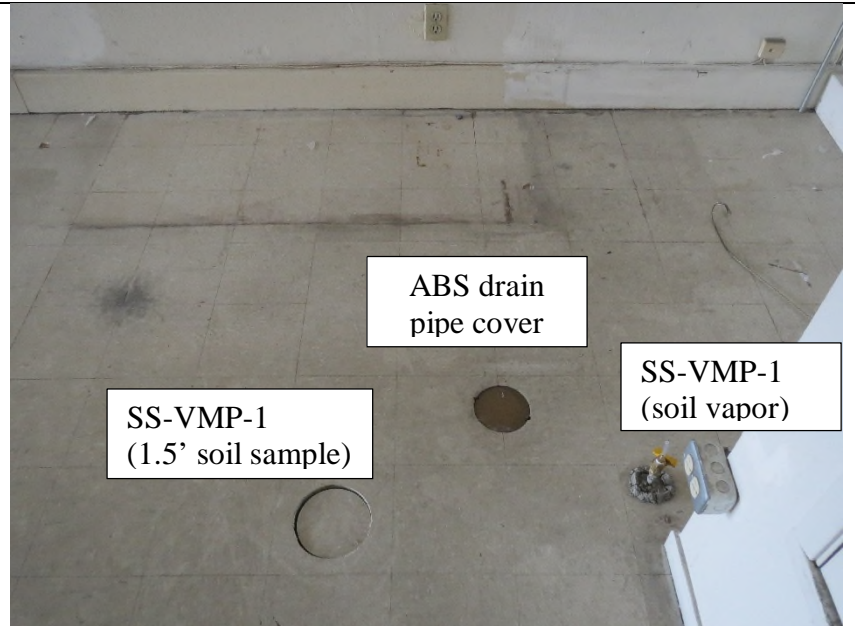
**Photo: 3**

**Description:** Floor drain cleanout (brass plate), and 2014 sub-slab vapor monitoring point (SS-VMP-1) and soil sample location (cored hole – SS-VMP-1-1.5'). Floor covering is 9" x 9" VFT.

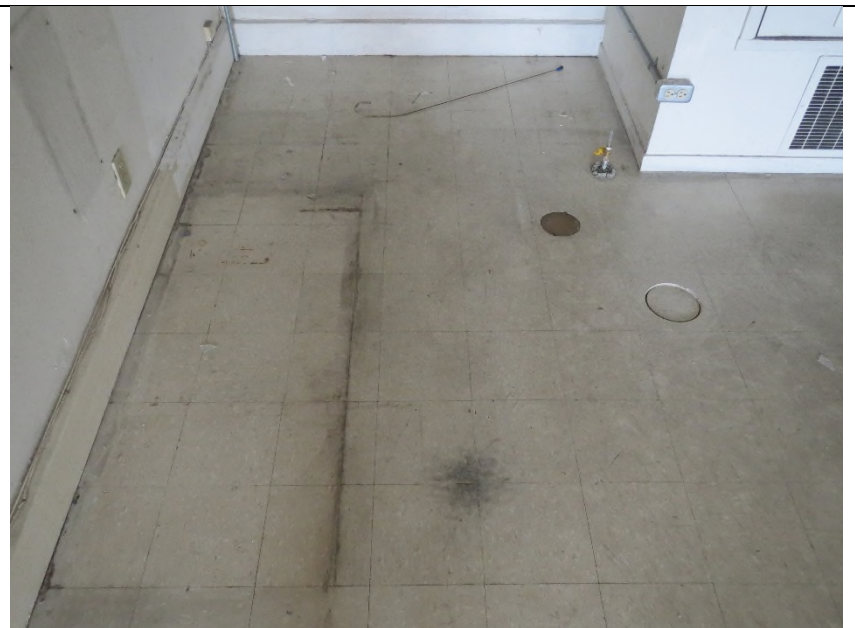
**Photo: 4**

is present on the vinyl floor tile along the southwest wall of the former cleaners, opposite former soil gas and soil sample locations (SS-VMP-1). The dust stain represents a former shelf/bench (observed by Tetra Tech in 2014).

**Description:** Rectangular dust "stain" is location of former shelf/bench, observed by Tetra Tech in 2014. Dust stain measures 2.2' by 4.4'.

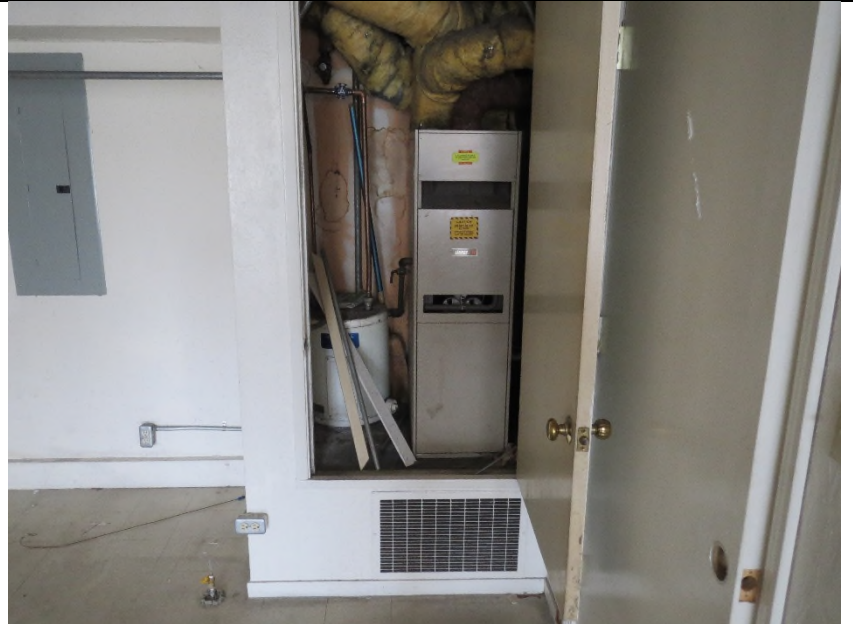
**Photo: 5**

**Description:** Small hot water heater and natural gas furnace closet.

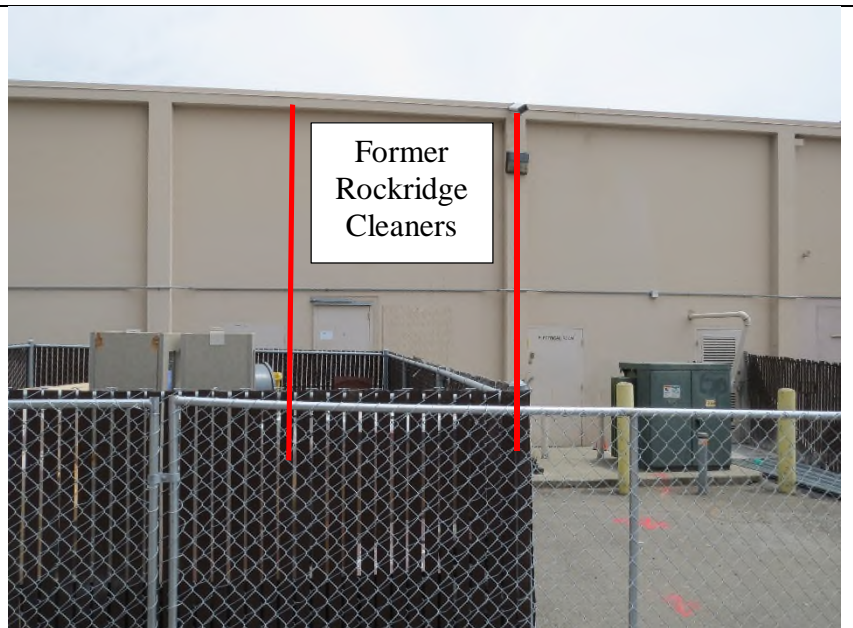
**Photo: 6**

No indication of former PCE storage was observed outside of the three tenant spaces: no drum rings or degraded asphalt was observed. A 3-foot access door is located on the exterior northwest wall of the former Rockridge Cleaners space; however, the doorway has been dry-walled over from the interior of the lease space (bathroom). Deliveries of PCE are expected to have come through this doorway when the dry cleaner equipment was reportedly operational (mid to late 1960s to early 1980s).

**Description:** Rear of former Rockridge Cleaners tenant space (between red lines). Access door is dry-walled over on the interior, inside bathroom. Privacy chain-link enclosure is full of Safeway items.

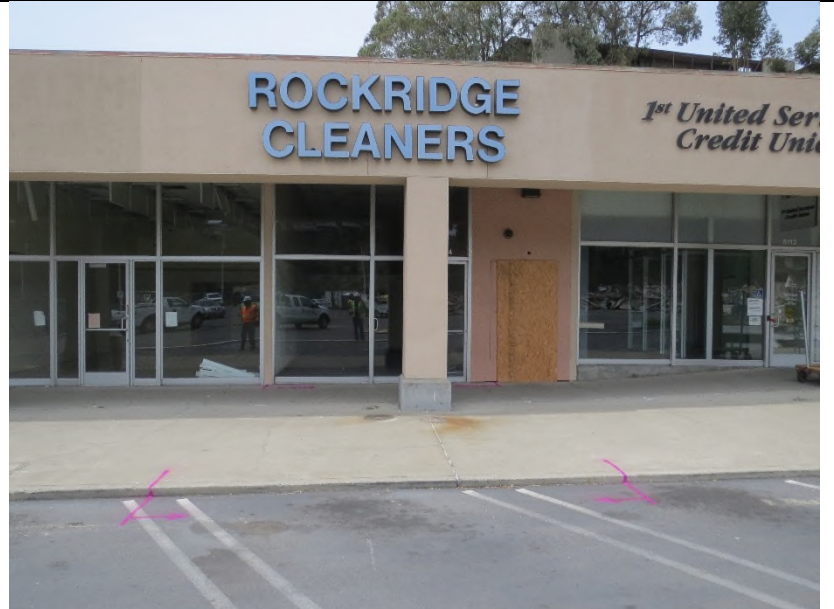
**Photo: 7**

**Description:** Purple paint on curb delineating location of former Rockridge Cleaners.

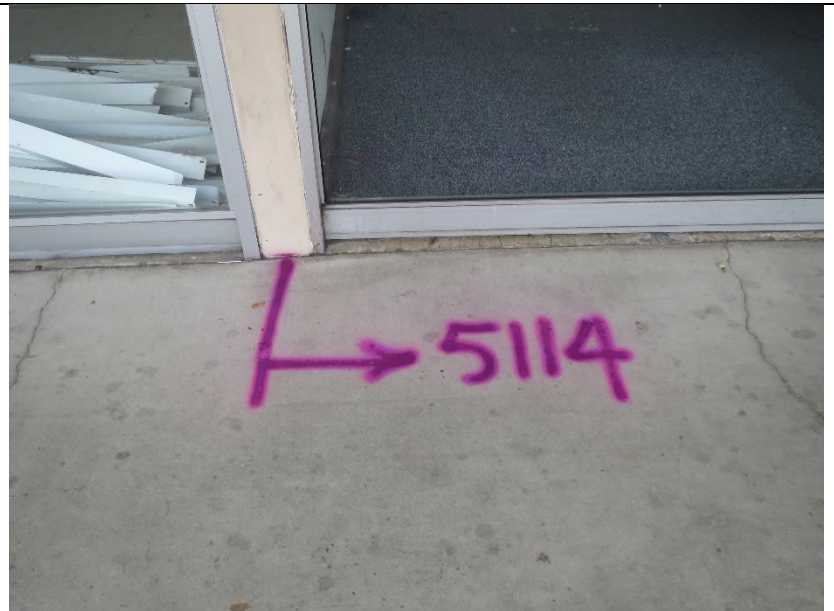
**Photo: 8**

**Description:** Purple paint delineating location of former Rockridge Cleaners, just outside the tenant space.

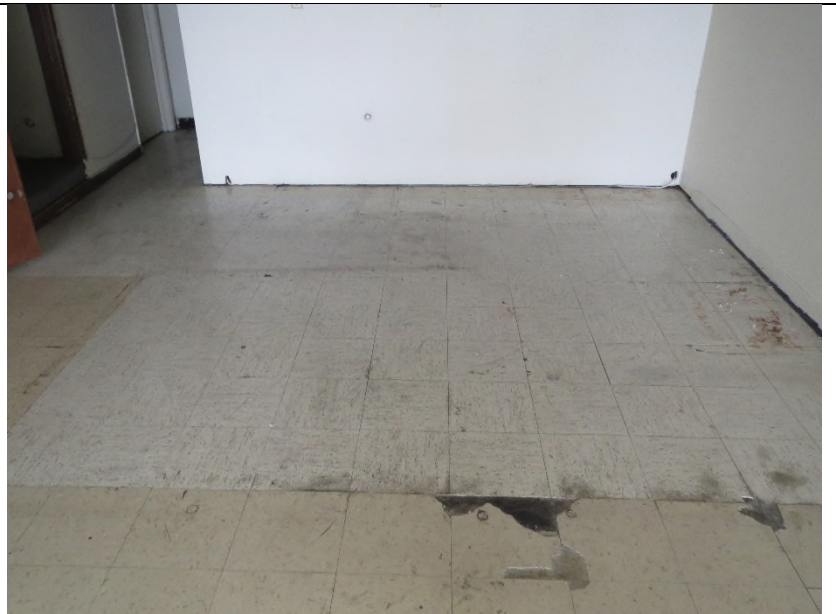
**Photo: 12**

**Description:** Area of mismatched vinyl floor tiles (12" by 12"), towards rear of tenant space.

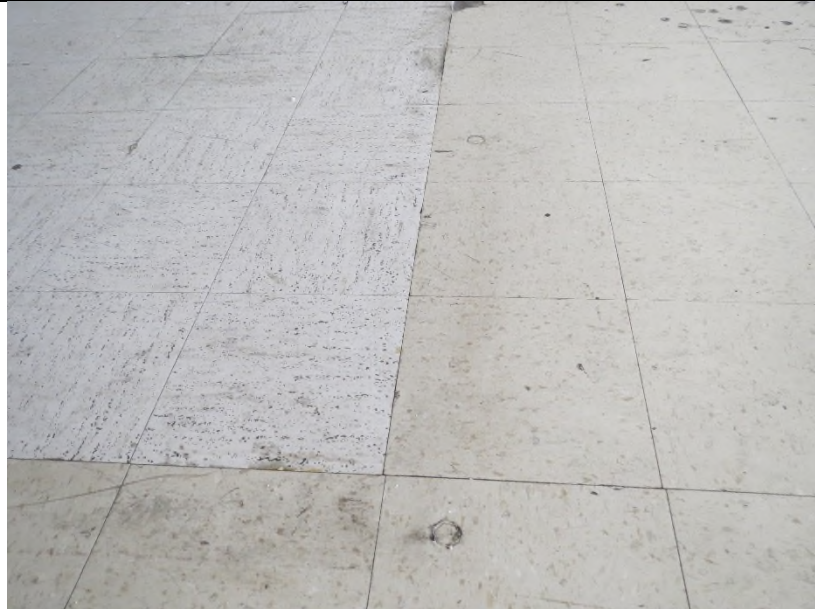
**Photo: 13**

What appear to be patched bolt holes are present in the floor toward the rear of 5116 Broadway (to the south). The patched bolt holes are regularly spaced around an approximate 10' by 10' area where two areas of mismatched vinyl floor tiles meet. The patched bolt holes likely represent lag bolts used to secure a former partition wall to the floor. The floor of 5112 Broadway (to the north) was mostly carpeted toward the front, but vinyl was present in the rear areas.

**Description:** Former bolt holes in floor around mismatched floor tile area (5116). Likely represent former concrete bolts, securing a former partition wall to the floor.

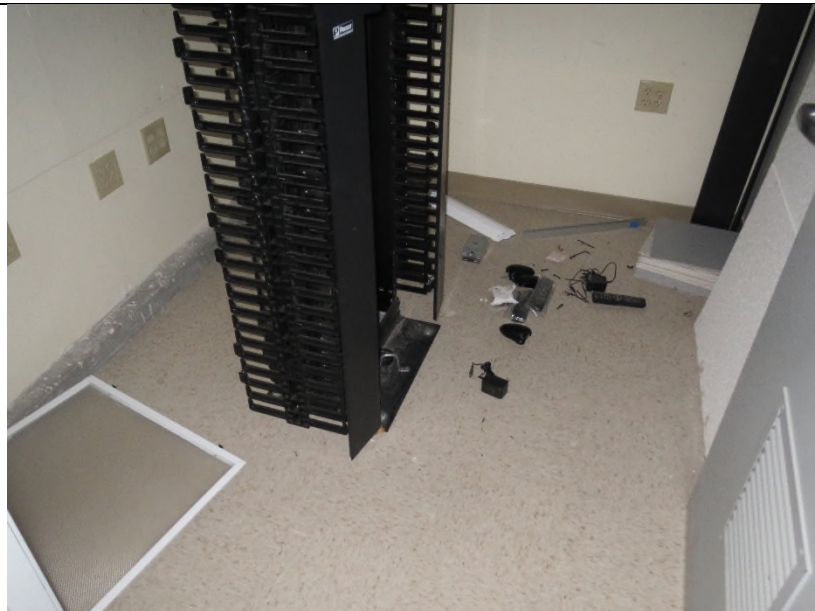
**Photo: 20**

**Description:** Server room sheet vinyl floor (5112).

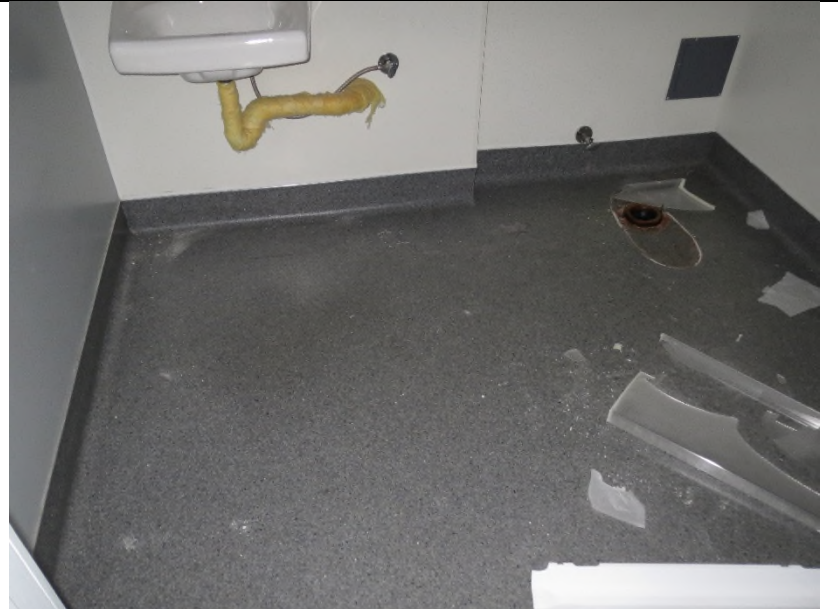
**Photo: 21**

**Description:** Bathroom  
sheet vinyl floor (5112).
