BP OIL

RE: BP Oil Site No. 11116
7197 Village Parkway
Dublin, CA
StID 2043

**Subject: Groundwater Assessment Adjacent to AW-6 at BP #11116,
7197 Village Parkway, Dublin, CA 94568**

7197 Village Parkway, Dublin 94568 * 11116

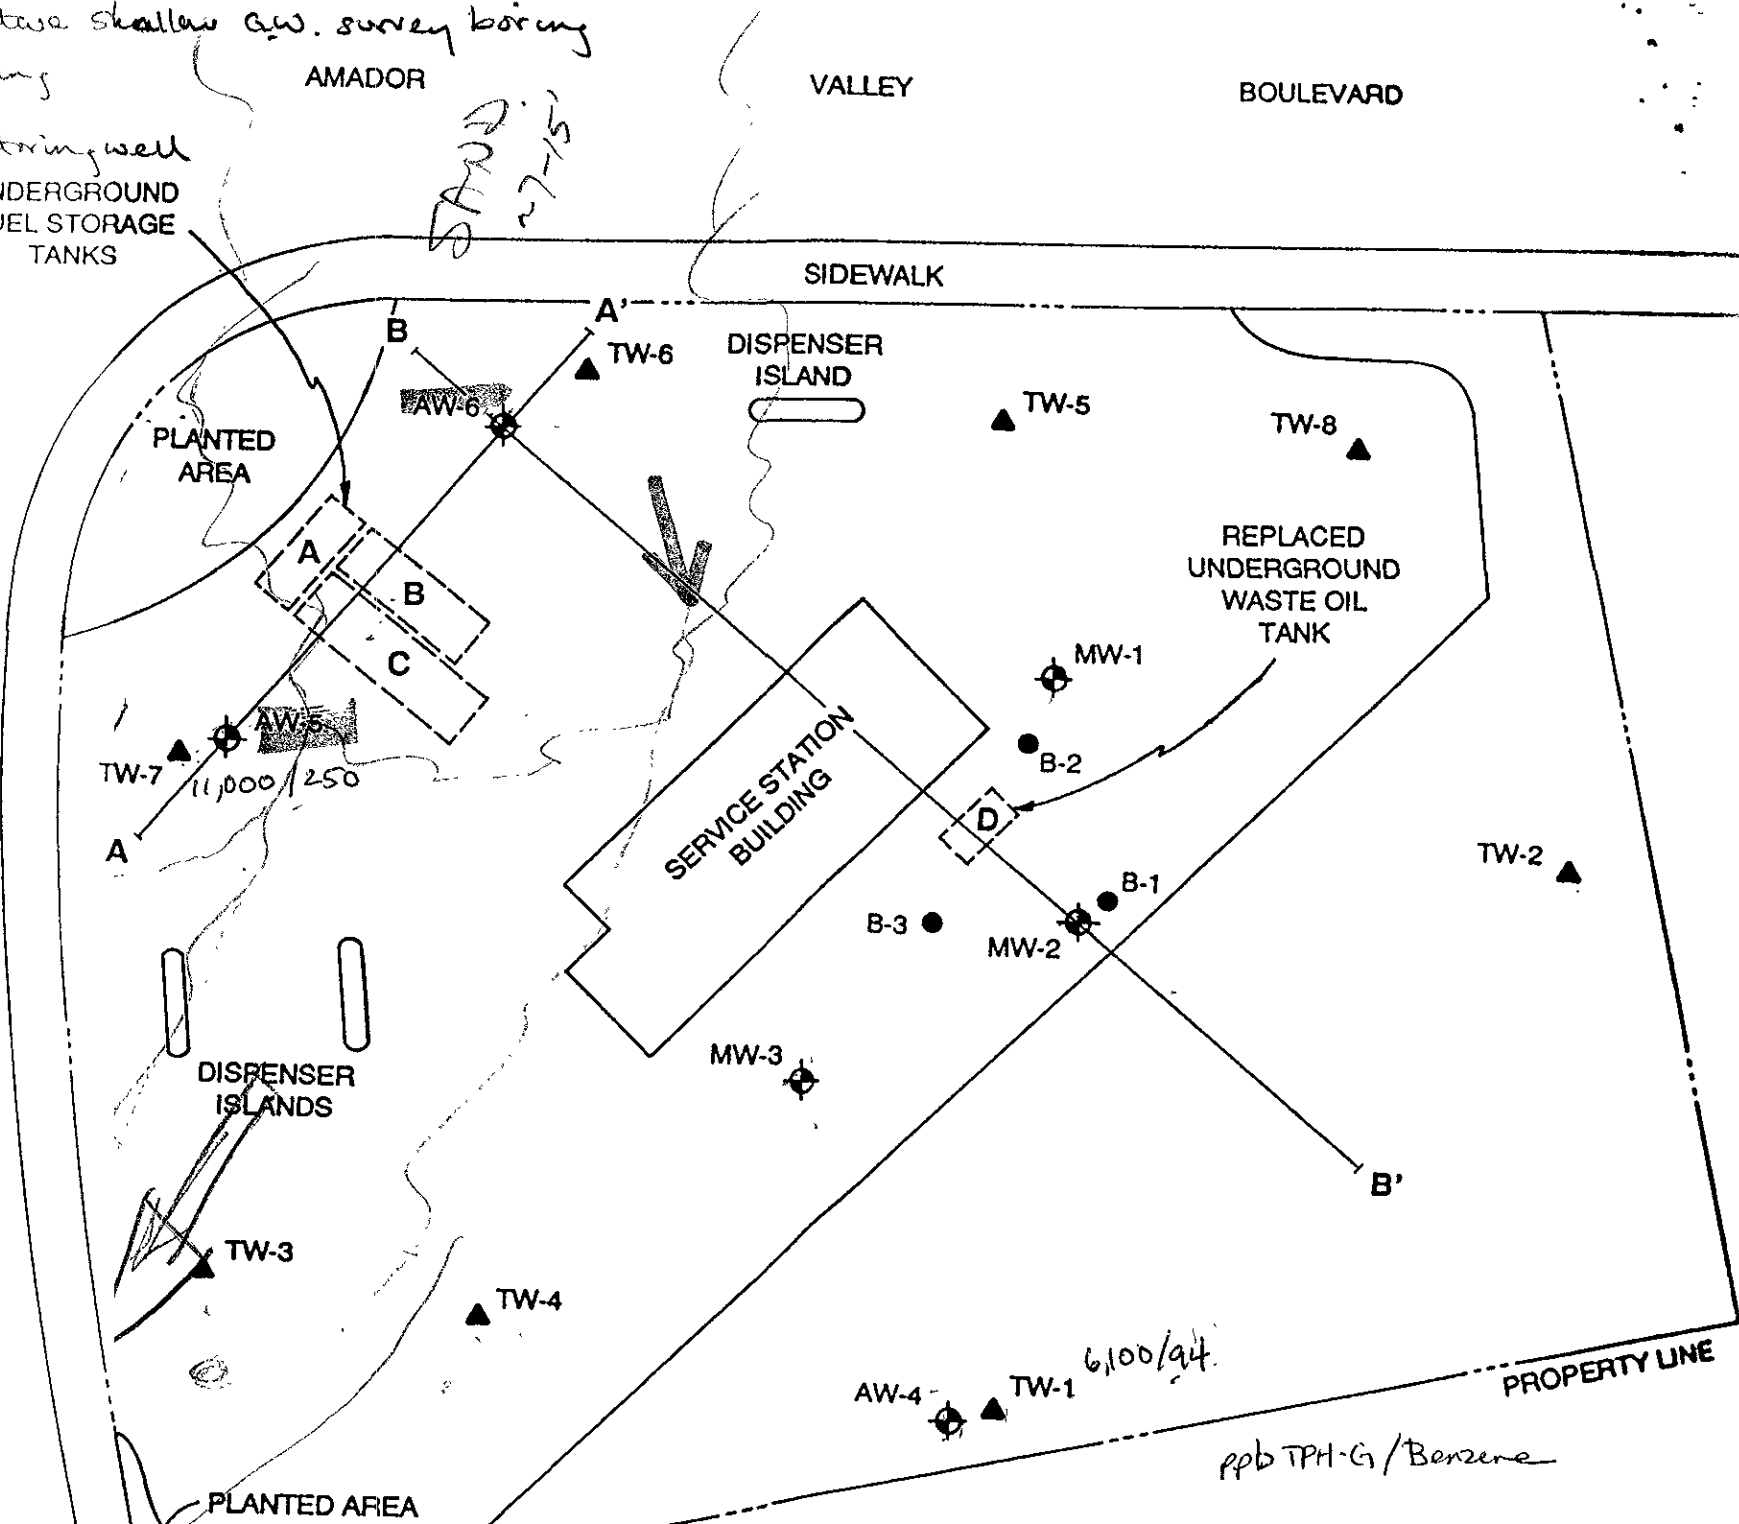
Requested BP to conduct investigations to determine the source of elevated levels of TPH-G and BTEX (as 7,900 ppb TPH-G and 900 ppb benzene) in monitoring well AW-6, and the preferential pathways which may cause the contamination to migrate off-site in the downgradient direction. BP has refused to do this investigation. BP contends that monitoring well AW-5 is downgradient from AW-6 and screened in the same aquifer. Boring logs do not show this to be the case. BP should conduct an aquifer pump test by January 1994 to show the aquifer in AW-5 and 6 are connected.

ppb TPH-G / Benzene
