Alameda County Environmental Health Meeting Sign-In Sheet

Paco Pumps, Inc.
Onsite

9201 San Leandro St, Oakland, CA

Paco Pumps, Oakland: Issues Raised by County March 7, 2014
 Agenda for Discussions at Meeting Scheduled for April 22, 2014

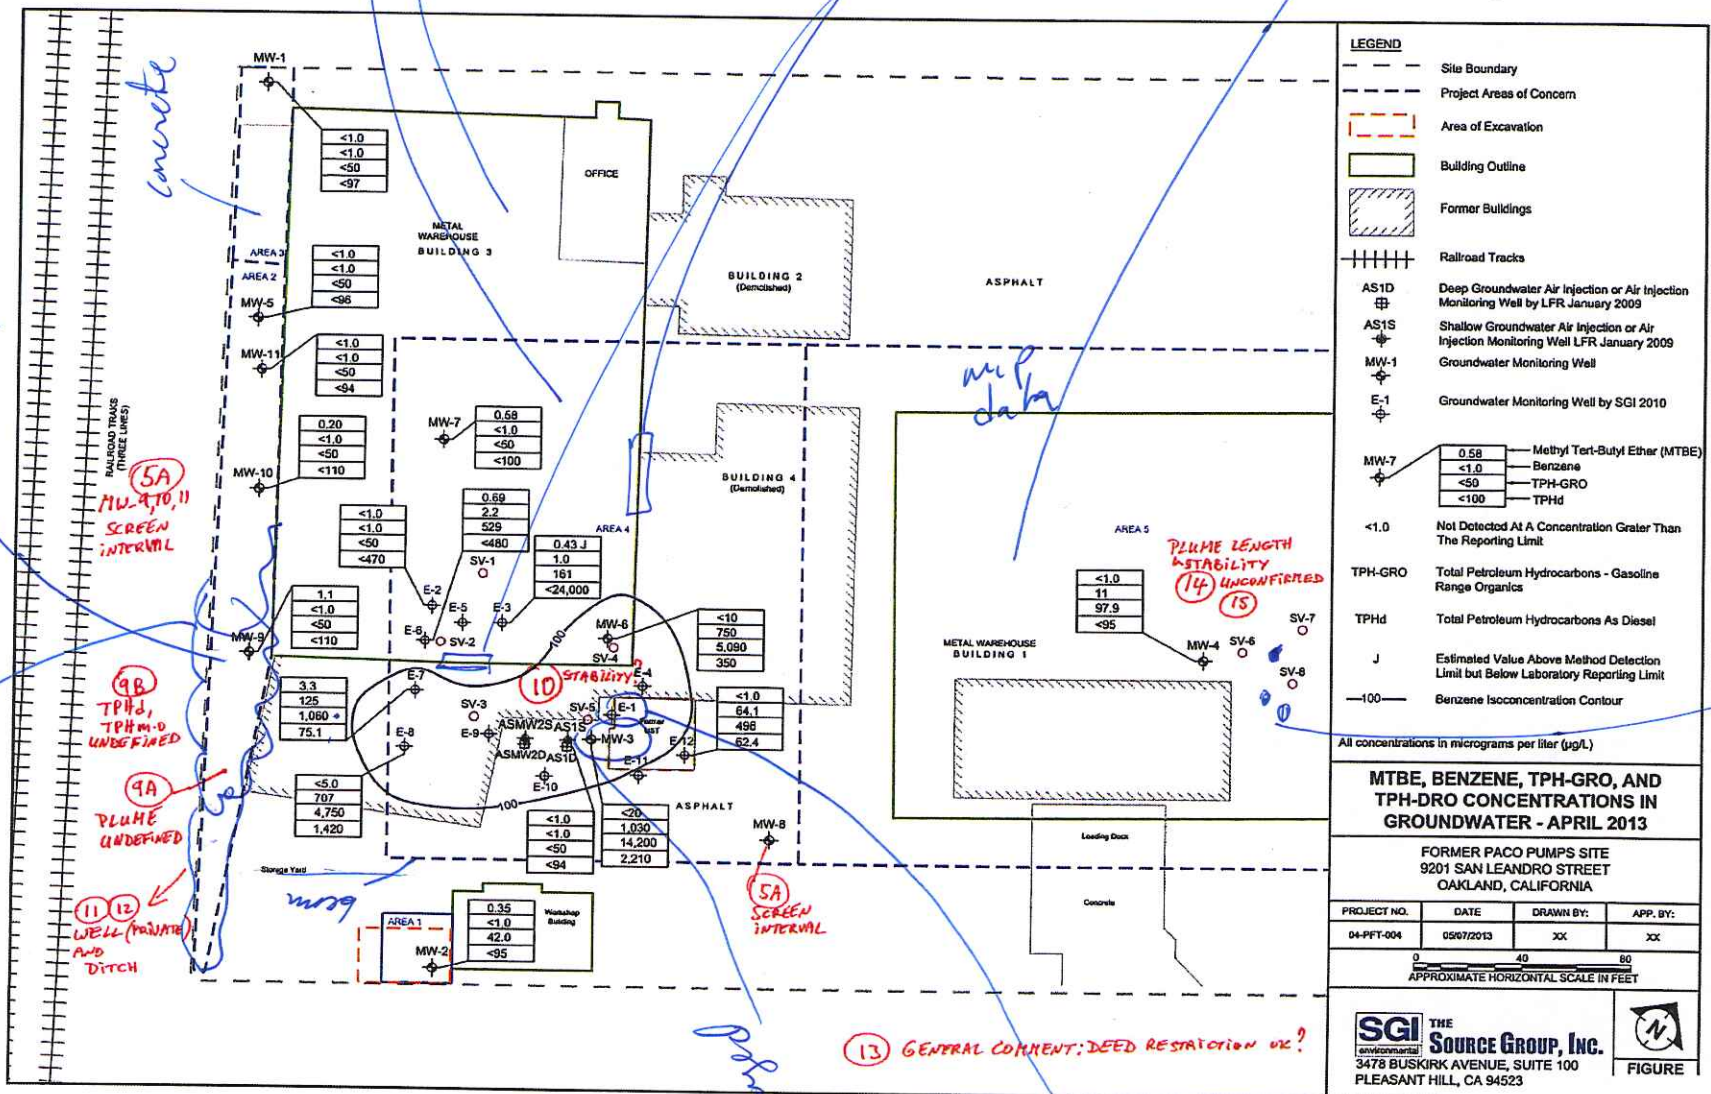
2/12

only cap
 covered w/rotel
 concrete
 only cap
 covered w/rotel
 asphalt
 only cap
 covered w/rotel
 asphalt

(5A) MW-9, 10, 11 SCREEN INTERVAL

(9B) TPHd, TPH-GRO UNDEFINED

(9A) PLUME UNDEFINED

(11) (12) WELL (PAINA) AND DITCH

(10) STABILITY

(13) GENERAL COMMENT: DEED RESTORATION OK?

PLUME LENGTH STABILITY (14) UNCONFIRMED (15)

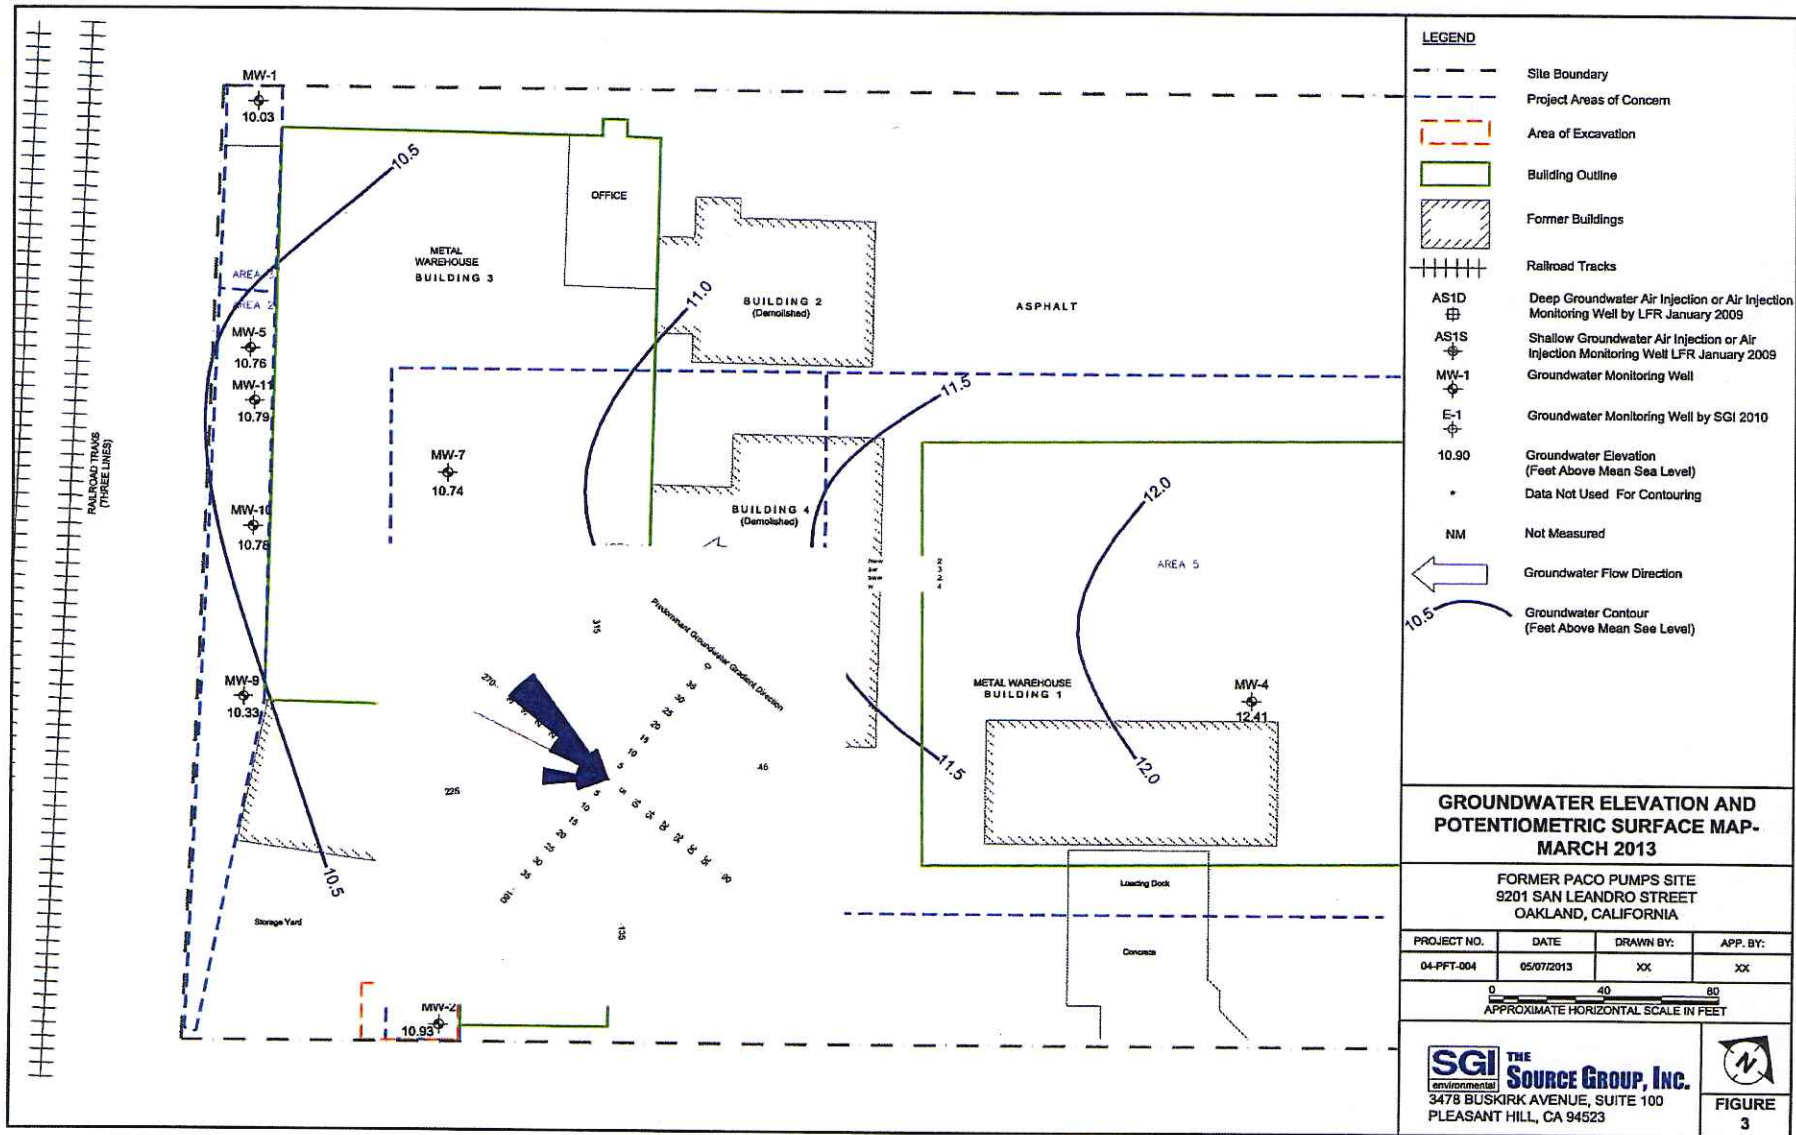
GROUNDWATER GRADIENT ROSE
DIAGRAM (11 AVAILABLE DATA)

9A	5 Area 4-a Groundwater contamination to southwest undefined	As shown in rose diagram of previous gradient directions, historical data indicate groundwater gradient to the northwest, and downgradient wells in that direction are ND.	Benzene plume is small and groundwater gradient historically points to the location of the new wells. Conduct one year of quarterly groundwater monitoring with silica gel, then request closure with deed restriction for potential hydrocarbons in future excavations.	
9B	5 Area 4-a TPHd, TPH mo Not evaluated	Not significant, but future rounds of sampling will be conducted with silica gel		
10	5 Area 4-b Plume stability not demonstrated	Collect additional data including silica gel testing		
11	5 Area 4-c Private well 620 ft to the southwest	Noted: CSM will be updated		
12	5 Area 4-d unlined ditch 360 ft to the southwest	Noted: CSM will be updated		
13	5 Area 4-e general comment: is deed restriction applicable?	Deed Restriction is applicable
