Ground Water Investigation 19051 Lake Chabot Road Castro Valley, California

REPORT
ENVIRONMENTAL SERVICES
19051 LAKE CHABOT ROAD
CASTRO VALLEY, CALIFORNIA

JCH&A Job Number 650.1

October 27, 1989

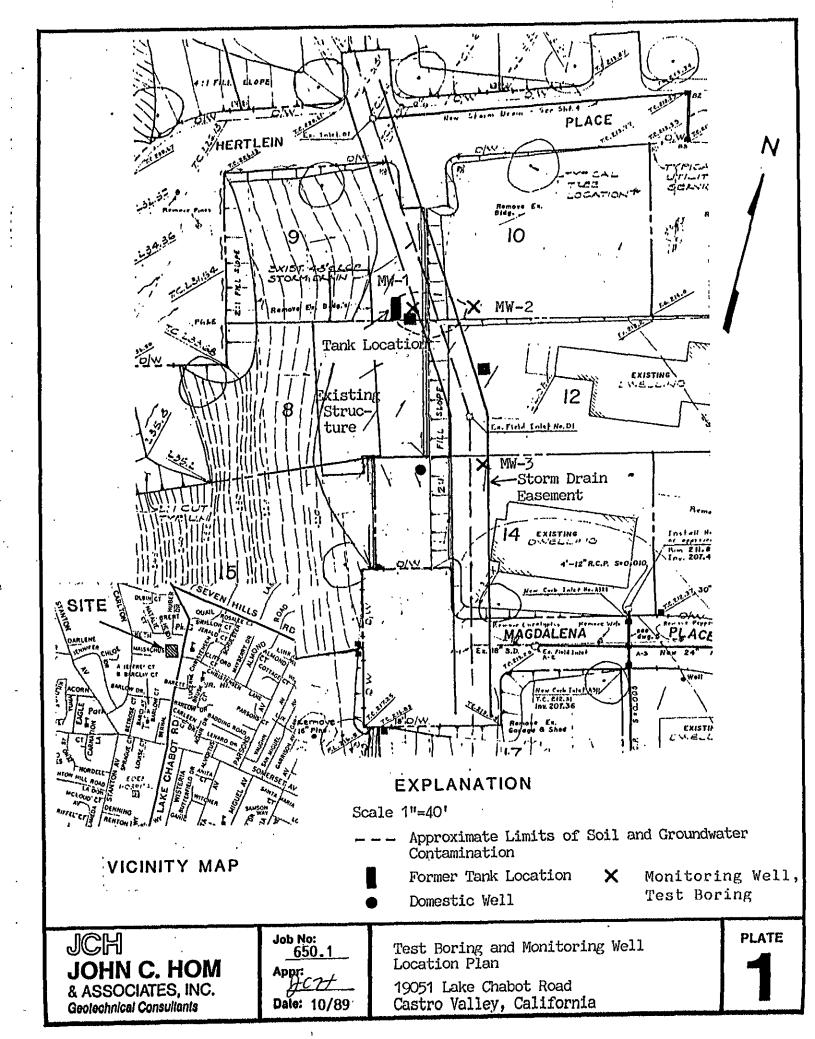
We recommended and observed removal of contaminated soil and groundwater in the areas outlined on Plate 1. Soil in this area was removed and bedrock exposed at the bottom of the ex-The excavation was sloped back to about 2-horizontal cavation. to 1-vertical (2:1). Excavated soil below 3-feet was stockpiled on the site and allowed to aerate. The groundwater was at the bottom of the excavation and was pumped into the soil stockpile. Some amounts of water seeped into the excavation after the initial pumping. This excavation was then pumped dry. We sampled and tested the water and soil at the bottom of the excavation. The results of the tests are shown on Plate 10. The excavation was then filled with "clean" soil, not excavated material. was placed in lifts, moisture-conditioned to near optimum, and compacted to at least 90-percent relative compaction.

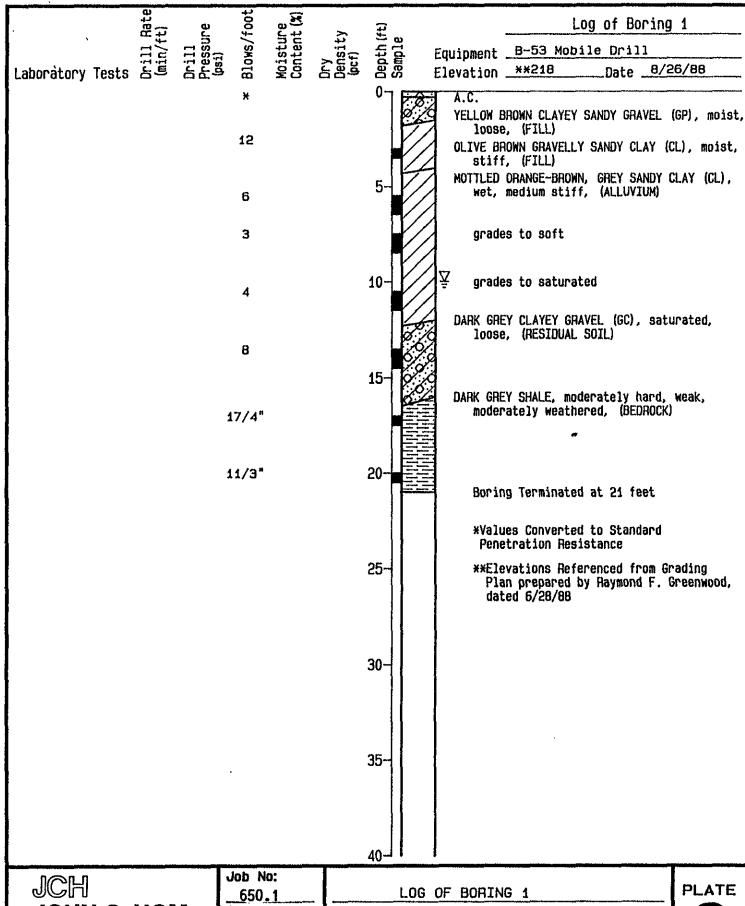
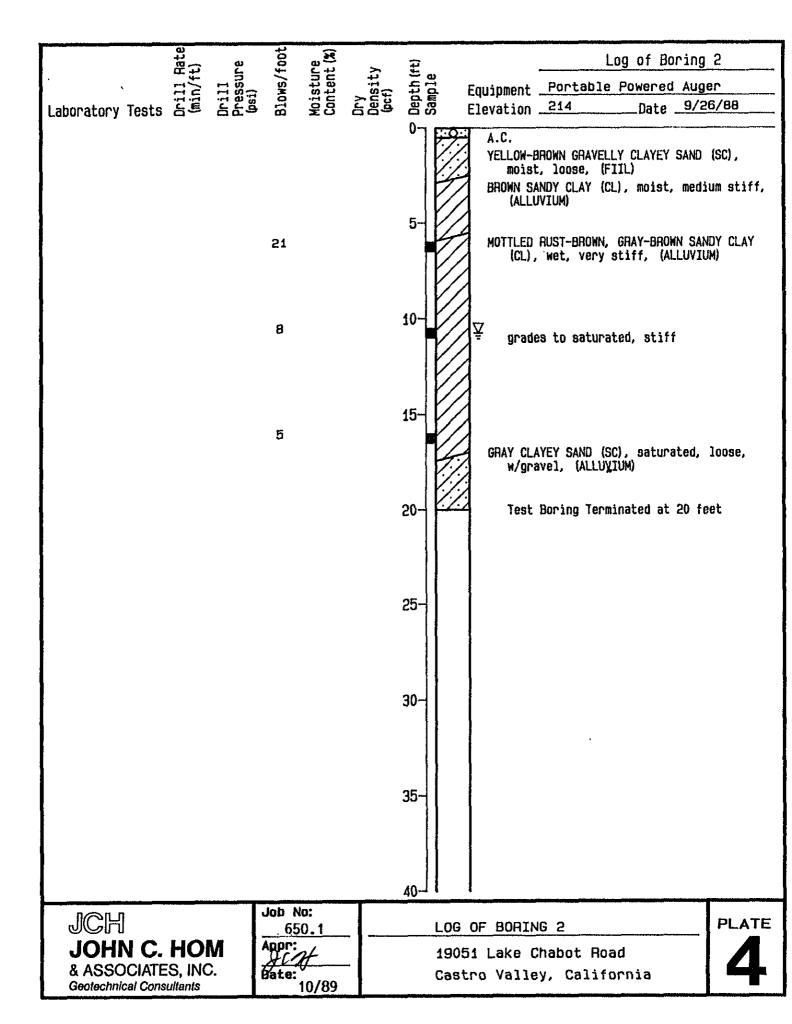
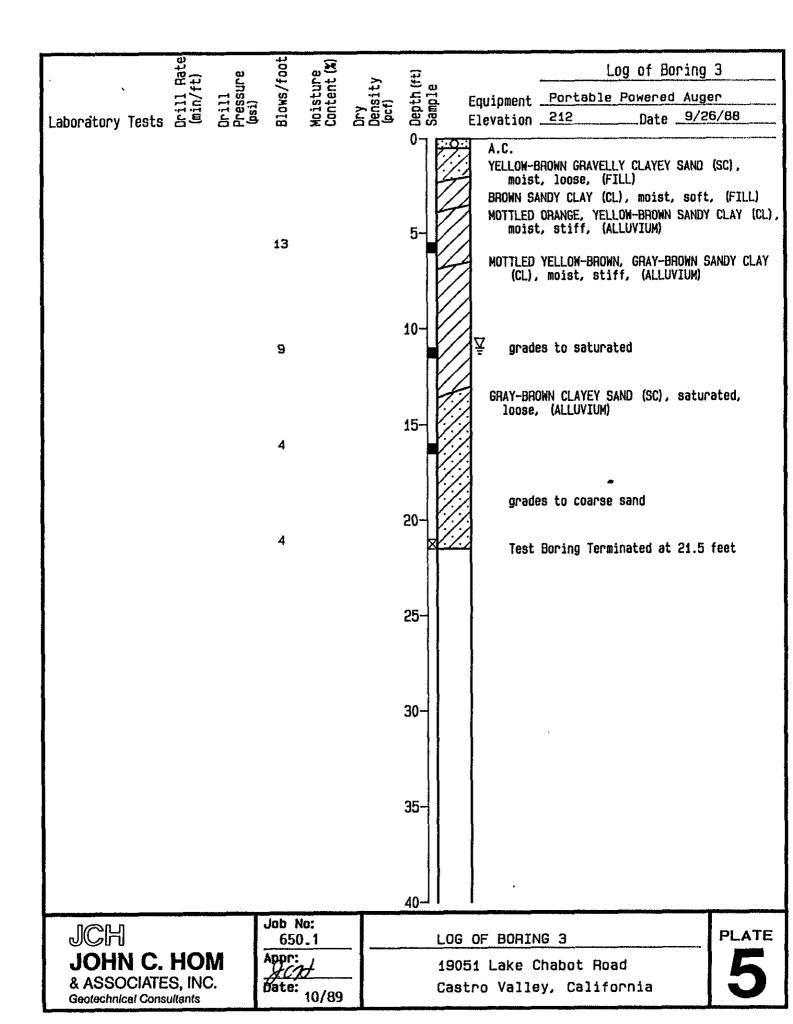
19051 Lake Chabot Road Castro Valley, California 3

The test borings encountered fill soils and alluvium over bedrock. The fills encountered varied in thickness and composition. Generally, they ranged from 1/2- up to 4-feet below the existing grade. The fills consisted of a random mixture of sands, clays and gravels, and existed in a medium dense or stiff state. Underlying the fill soils, the test borings encountered alluvial soils. The alluvial soils consisted primarily of clay material with significant amounts of sand and gravels. Bedrock was only encountered in Test Boring 1 at a depth of 16-feet.

In Test Borings 2 and 3, the alluvial soils extended up to 20feet below the existing ground surface.

Ground water was encountered in three of the test borings. The depths are indicated on the boring logs. The ground water probably varies with seasonal rainfall.
