**PHASE I
ENVIRONMENTAL SITE ASSESSMENT**

1285 66th Street
Emeryville, California

Project No. 3102

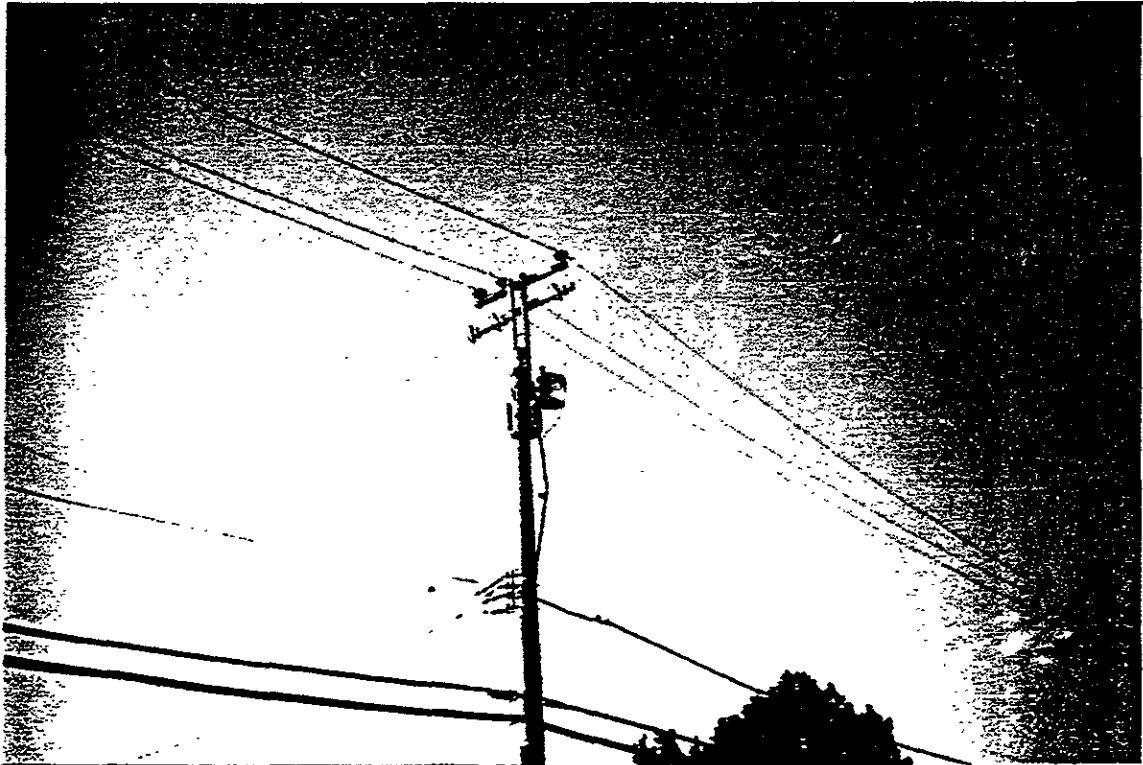
One pole-mounted transformer was observed on the subject property during the site inspection.

No spills, staining or leaks were observed on or around the transformer.

PHOTO 4
POLE-MOUNTED TRANSFORMERS LOCATED ALONG 66TH STREET
