#### 1001 42<sup>nd</sup> Street Property, Emeryville/Oakland, California Initial Site Conceptual Model (11-14-08)

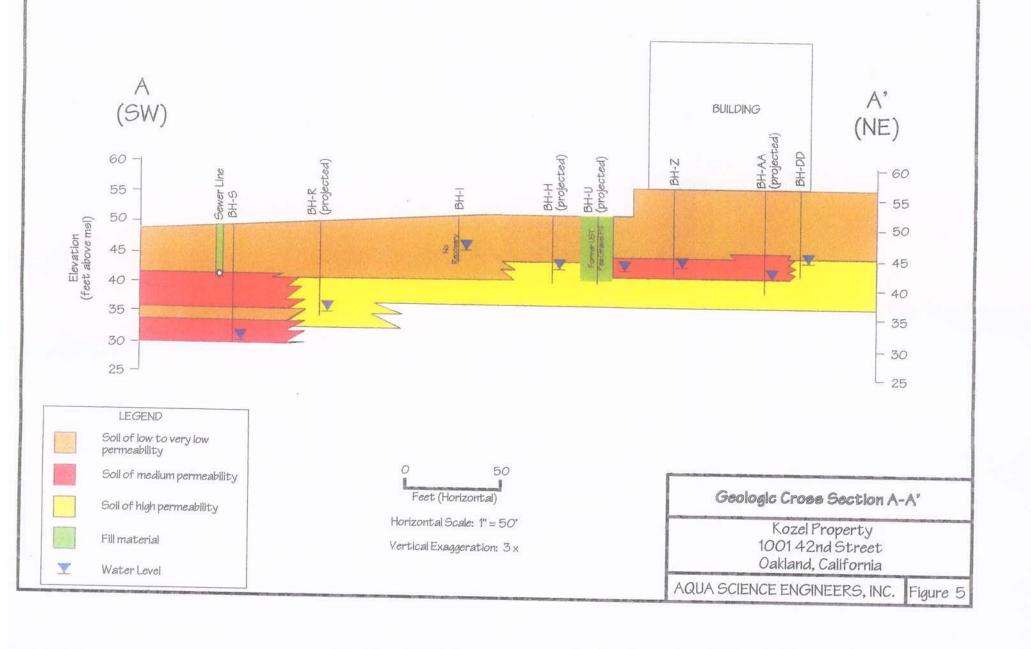
## GEOLOGIC CROSS-SECTION A- A'

DESCRIPTION	Data Tables	Graphics	Reference	Data Gaps	Work Necessary to fill data gap	Comments
Subject	Site Geology		SCHUTZE	ERM Draft CAP			See
Site	The sediments across much of the site		Section A-A'	for Subject Site			paleochannel
Geology	within the uppermost 30 feet bgs tended to			Geology			map in
Geology	be relatively low permeability sediments		<u>SCHUTZE</u>	Section			Preferrential
	(i.e., clayey silt and silty clay). Soils at		Section B-B'				Pathway
	depths from 3 to 8 ft bgs (beneath asphalt						Section
	paving or concrete) were dark brown sandy		SCHUTZE				
	silts (ML), with variable sand content and		Section C-C'				
	occasional areas of increased clay content.						
	Beneath this uppermost fill layer, clay		SCHUTZE				
	(CH/CL) was typically encountered, with		Section D-D'				
	variable sand and silt content, and		001111775				
	occasional stringers (layers less than 2 feet		SCHUTZE

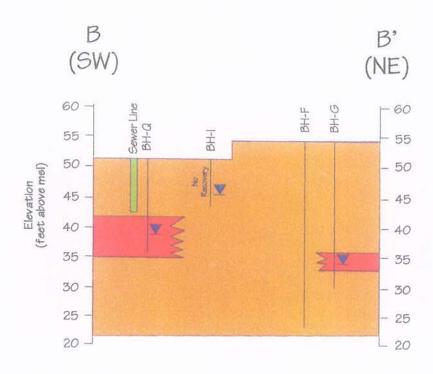
## GEOLOGIC CROSS-SECTION B-B'

# Geologic Cross Section B-B° Kozel Property 1001 42nd Street Oakland, California

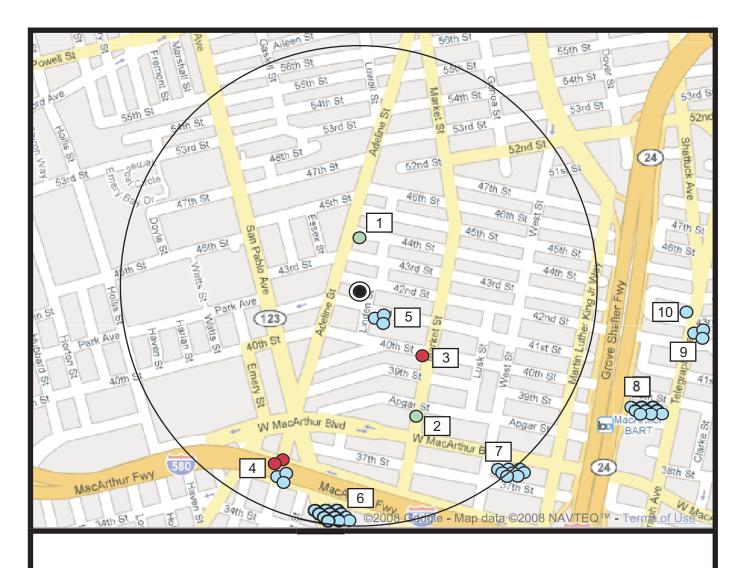
# 1/2 Mile Radius Well Survey 1001 - 42nd Street, Oakland, California

Data provided by the California Department of Water Resources

DESCRIPTION	Data Tables	Graphics	Reference	Data Gaps	Work Necessary to fill data gap	Comments
Preferential	Well Survey: A 1/2-mile well survey identified	SCHUTZE,	SCHUTZE,	SCHUTZE, Well		•	Impact to
Pathways:	two cathodic protection wells, three industrial wells and 28 monitoring wells. Cathodic Protection Well: One of these wells	Well Survey Summary	Well Location Map	Survey Letter report			nearby wells unlikely
Well		<u>Table</u>		DWD Wall Los			
Well Survey	is located approximately 750 feet to the north of the subject site at the intersection of 44th Street and Adeline Street, and the other is located approximately 1,500 feet to the southeast at the intersection of Market Street and Apgar Street.  Industrial Wells: One of these wells is located approximately 1,000 ft to the southeast of the subject site at 899 40th Street, and the other two are approximately 2,200 feet to the southwest at 3516 Adeline Street.  Monitoring Wells (MWs): The well survey identified 28 monitoring wells. The mws identified are at the following locations:  3 MWs are located approximately 500 ft to the SE of the subject site at 989 41st St.  8 MWs are located approximately 2,500 ft to the SE at 731 West MacArthur Blvd.  12 MWs are located approximately 2,500 ft to the S at 3420 San Pablo Ave.  3 MWs are located approximately 2,200 ft to the SW at 3516 Adeline St.  Conclusion of Well Survey: The industrial wells at 899 40th St. was installed in 1928, one year before the Mokelumne Aqueduct started to provide water to the East Bay. It is likely that other, unrecorded commercial wells existed. Boysen Paint operated from the 1930s to 1980			DWR, Well Log Images 01s/04w sec 23, 5/19/08	The onsite well logs are missing in the SCHUTZE cross-sections and in the	Obtain on-site well records, include in SCHUTZE cross-sections and submit to
