**UNDERGROUND STORAGE TANK CLOSURE AND
SUPPLEMENTAL SOIL AND
GROUNDWATER INVESTIGATION REPORT
FORMER BOYSEN PAINT FACILITY, 41ST STREET
EMERYVILLE, CALIFORNIA**

08/16/93

**ALAMEDA COUNTY DEPARTMENT OF ENVIRONMENTAL HEALTH
HAZARDOUS MATERIALS DIVISION**

**CALIFORNIA REGIONAL WATER QUALITY CONTROL BOARD
SAN FRANCISCO BAY REGION**

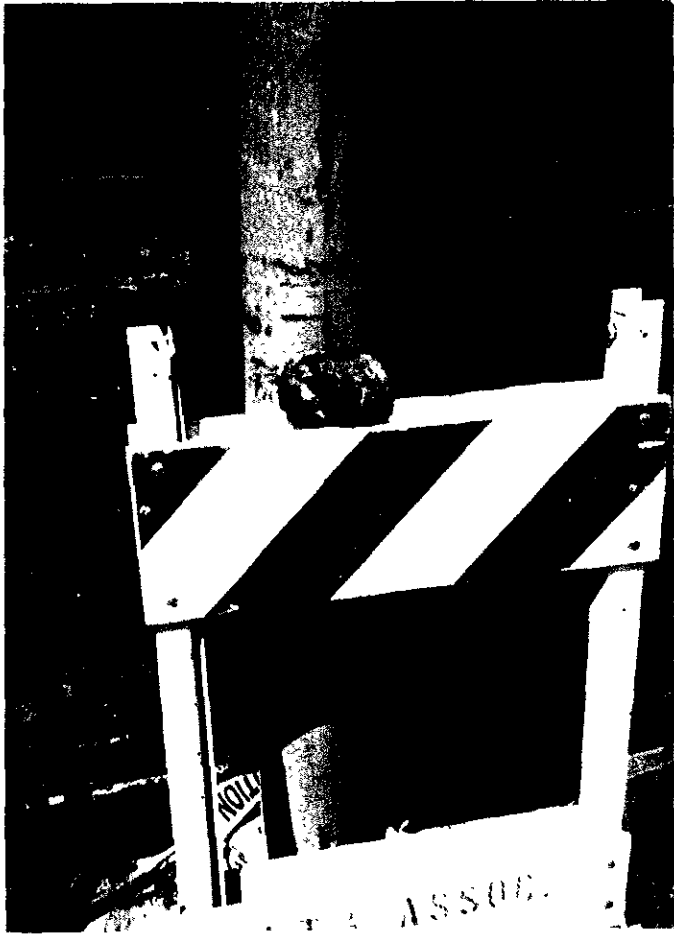
ESC examined the top of the tank surface and the connected lines for signs of leaks. Signs of weakness and holes were found in the connected lines and soil discoloration in the product-line trench was observed (Appendix A).

Photo 2: Hole located in product line fitting.
41st Street, Emeryville, CA
