Subject: Corrective Action Plan Implementation Status Update

Pacific Gas and Electric Company
Oakland General Construction Yard
4930 Coliseum Way
Oakland, California

Cap Inspection 2012 and 2013 Photo Comparison PG&E Oakland General Construction Yard Oakland, California

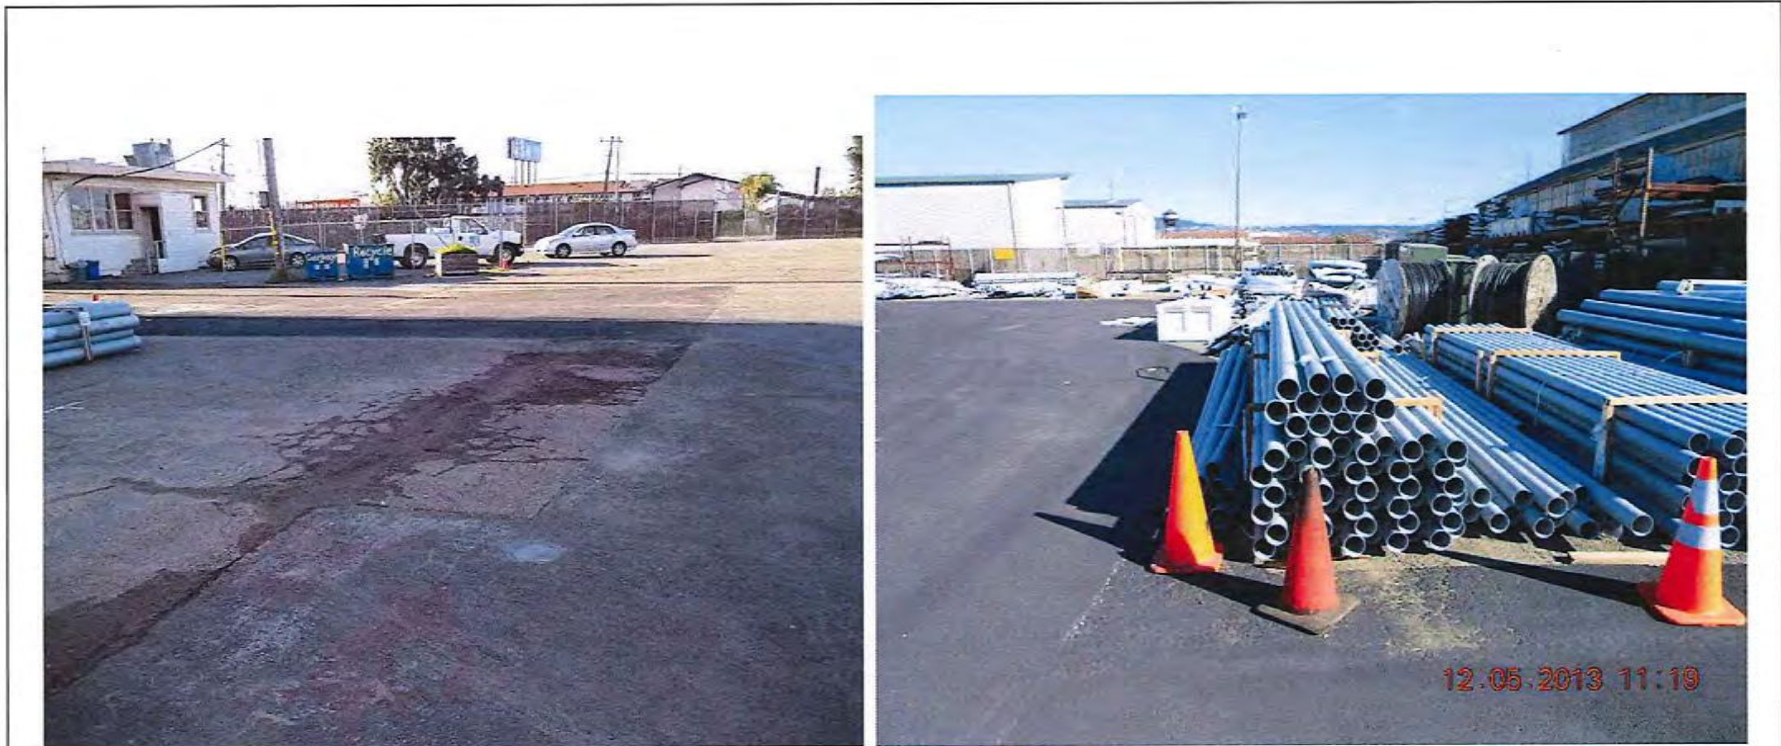
Photographs 1A and 1B: Pavement failure in Area A, 2012 on the left. The area was not visible due to materials storage in 2013 (the 2013 photo was taken facing east).

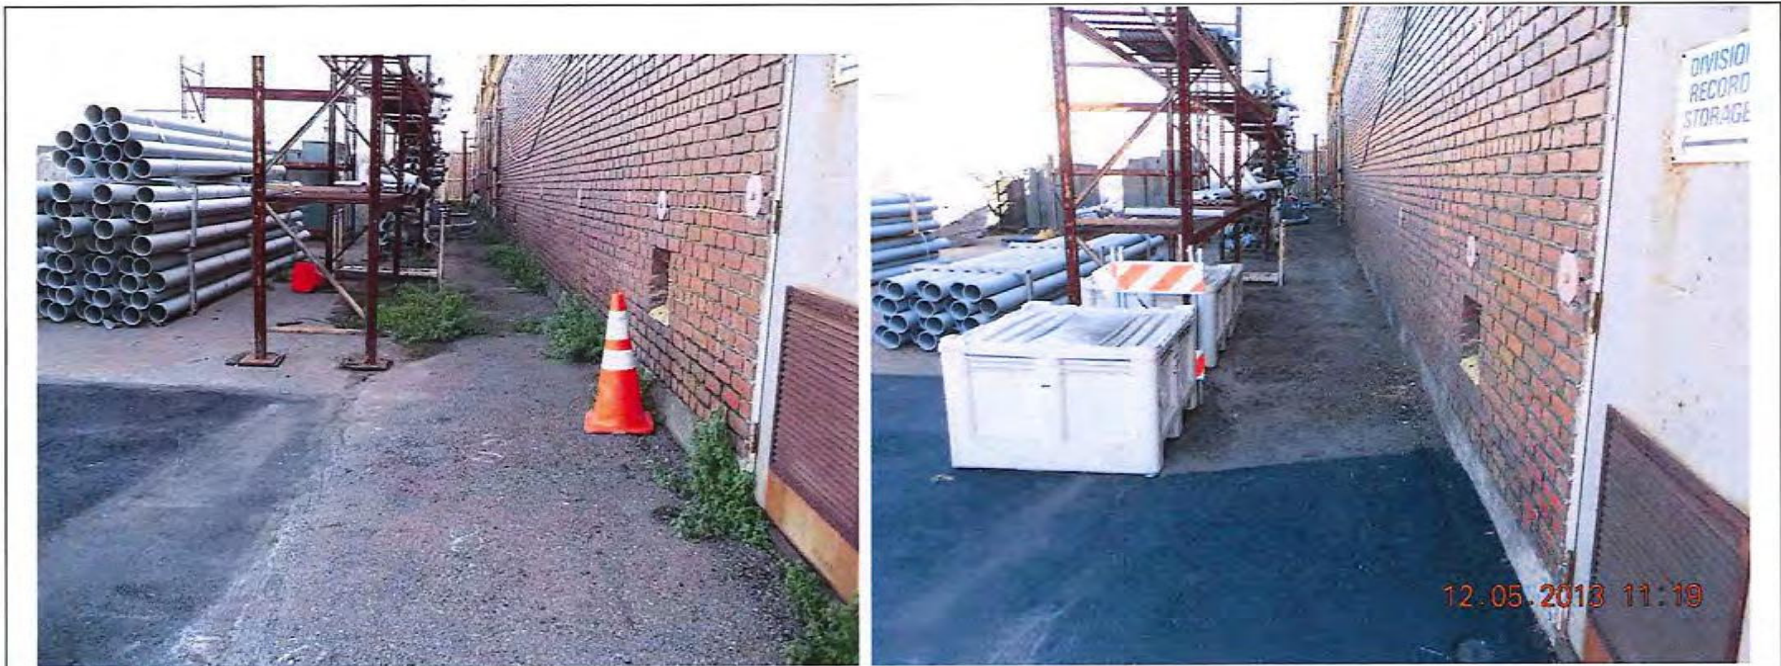
Photographs 2A and 2B: Vegetation along the southeastern side of the cap. In 2013, the foreground has been slurry sealed. Dead vegetation is present along the brick building and under the storage rack.

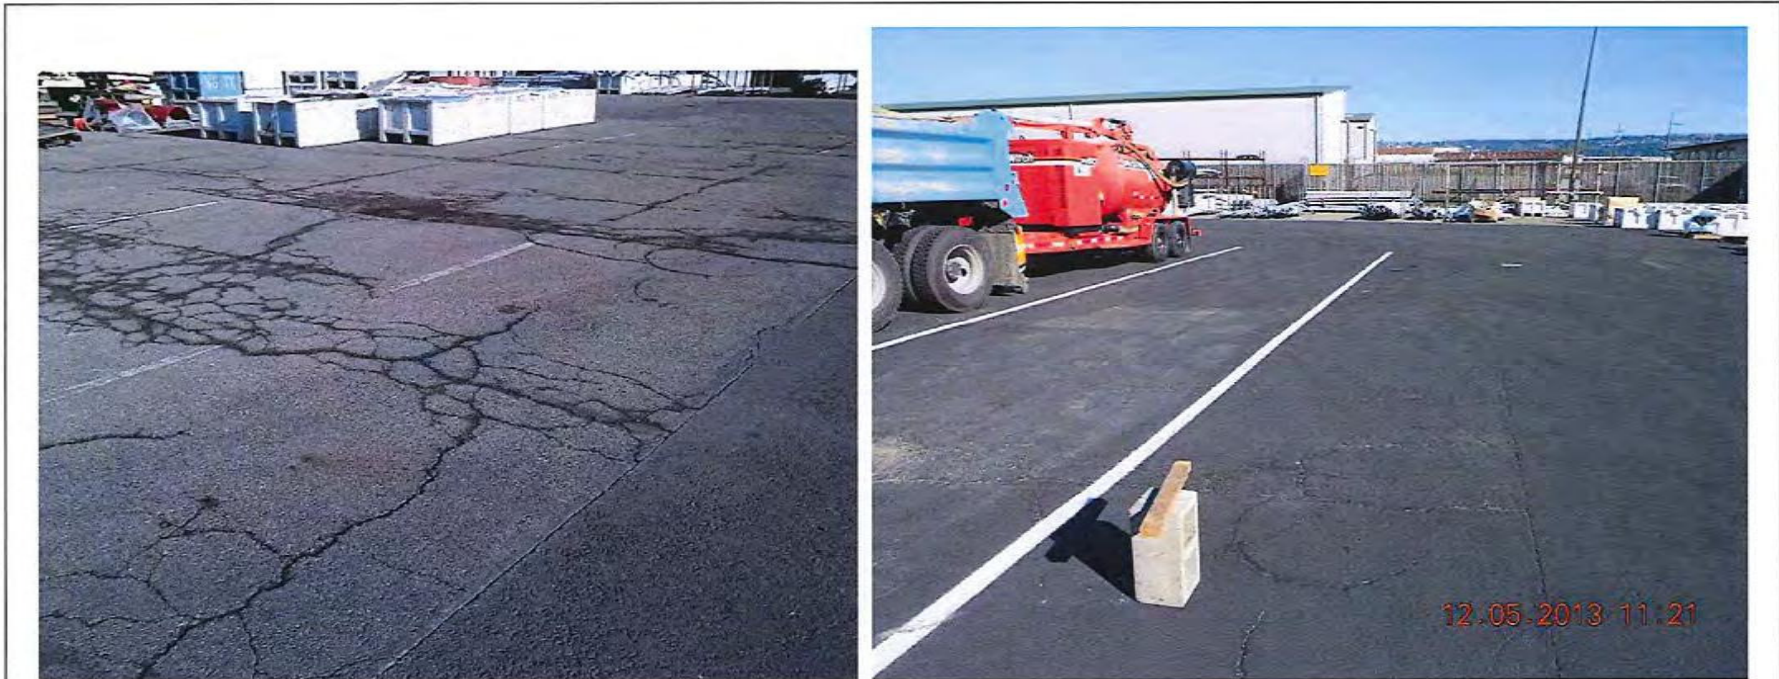
Photographs 3A and 3B: Cracking and pavement failure in Areas B and C of the 2012 report. In 2013, the area has been sealed.

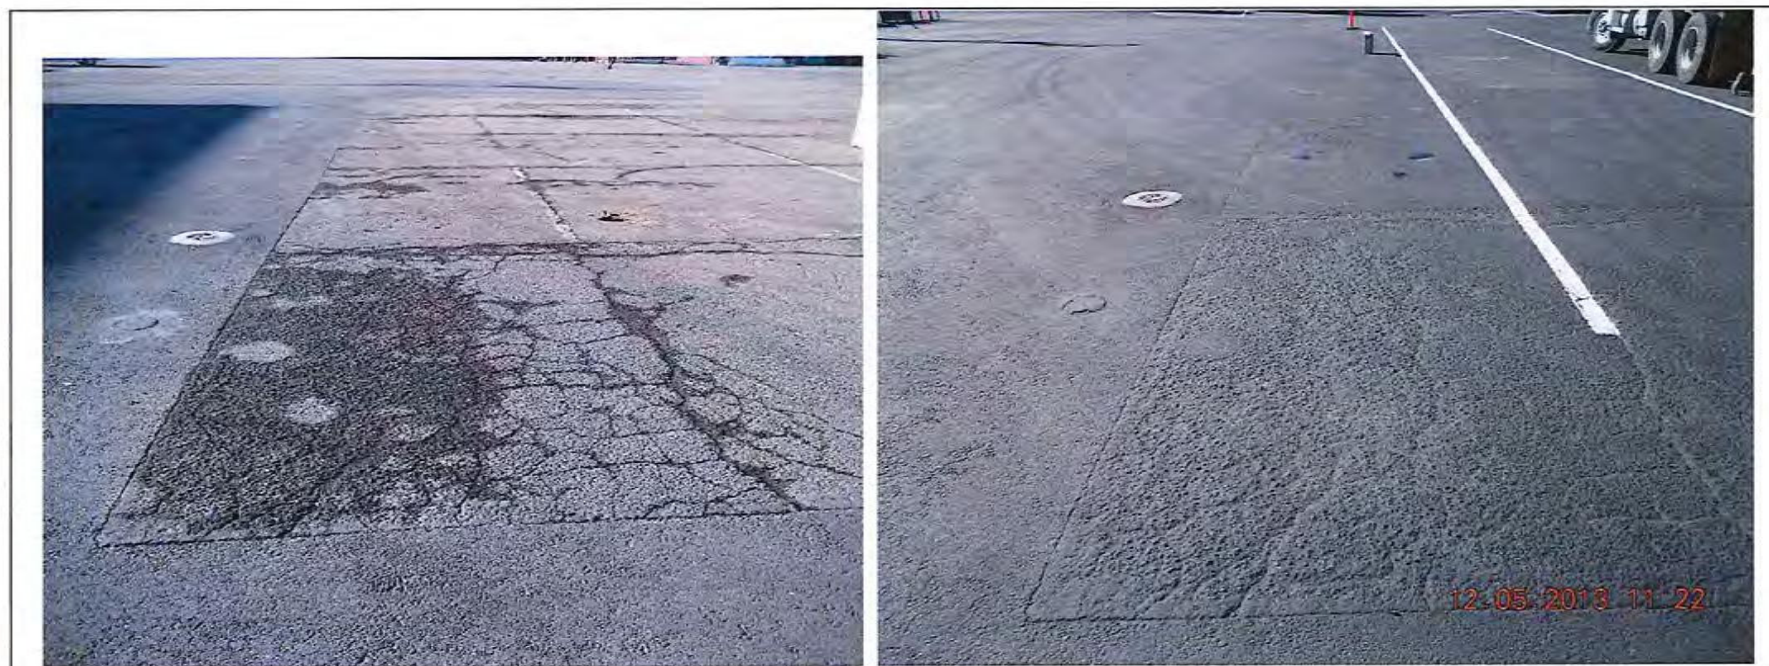
Photographs 4A and 4B: Pavement failure in Area D of the 2012 report. In 2013, the area has been sealed.

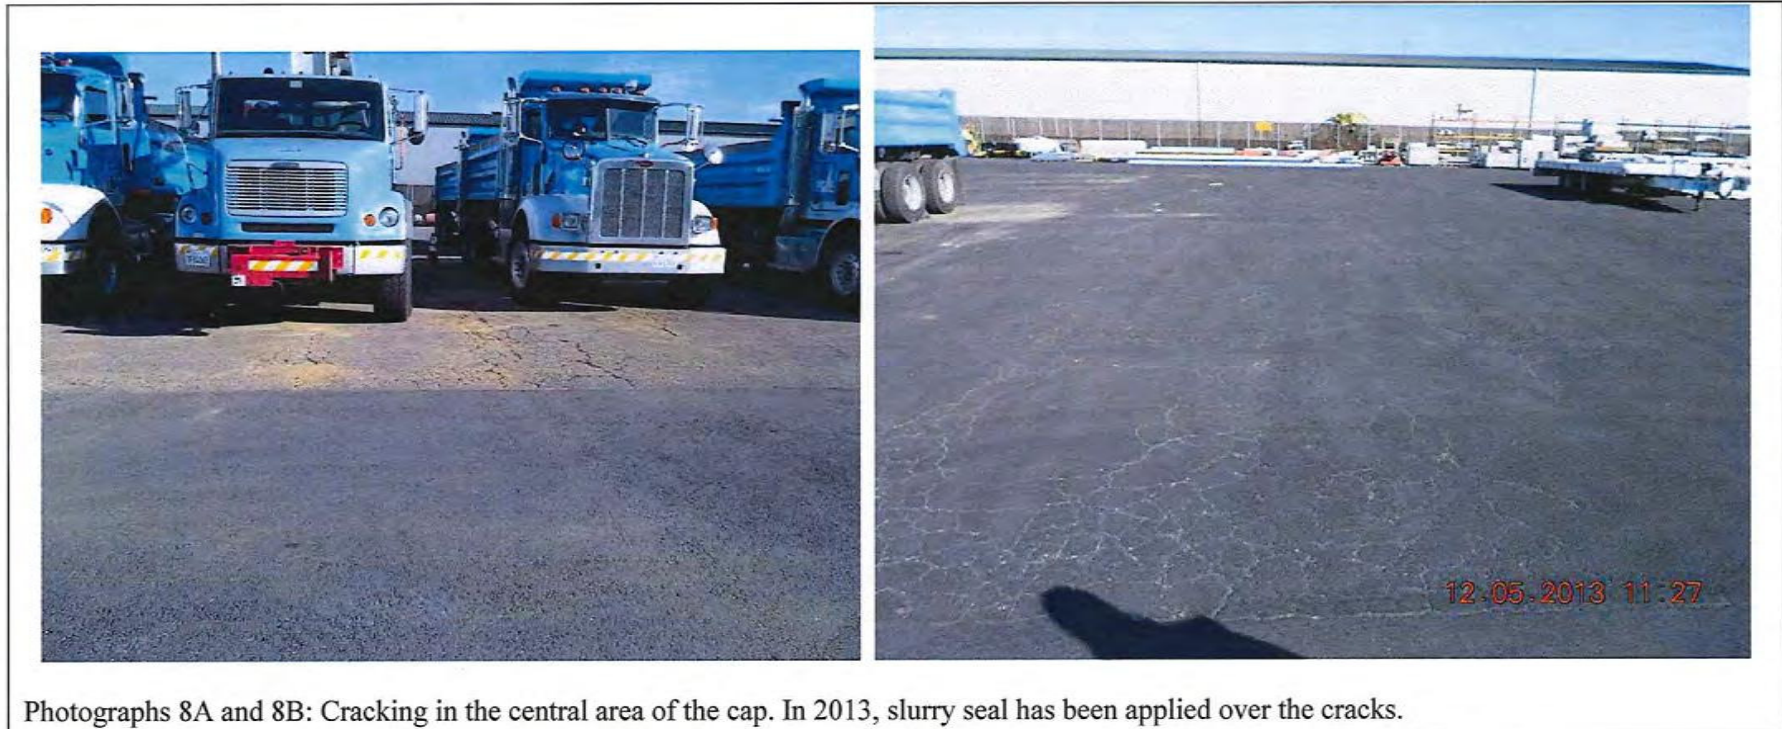
Photographs 8A and 8B: Cracking in the central area of the cap. In 2013, slurry seal has been applied over the cracks.

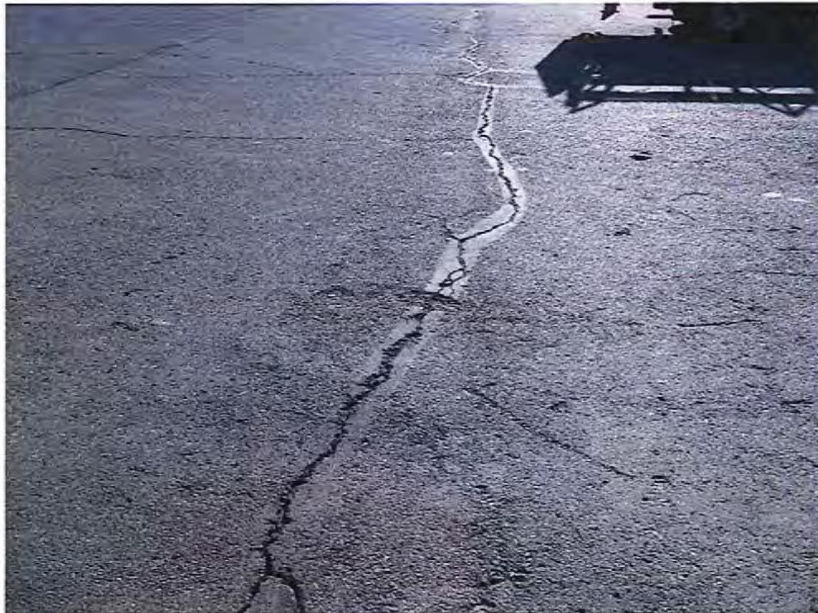
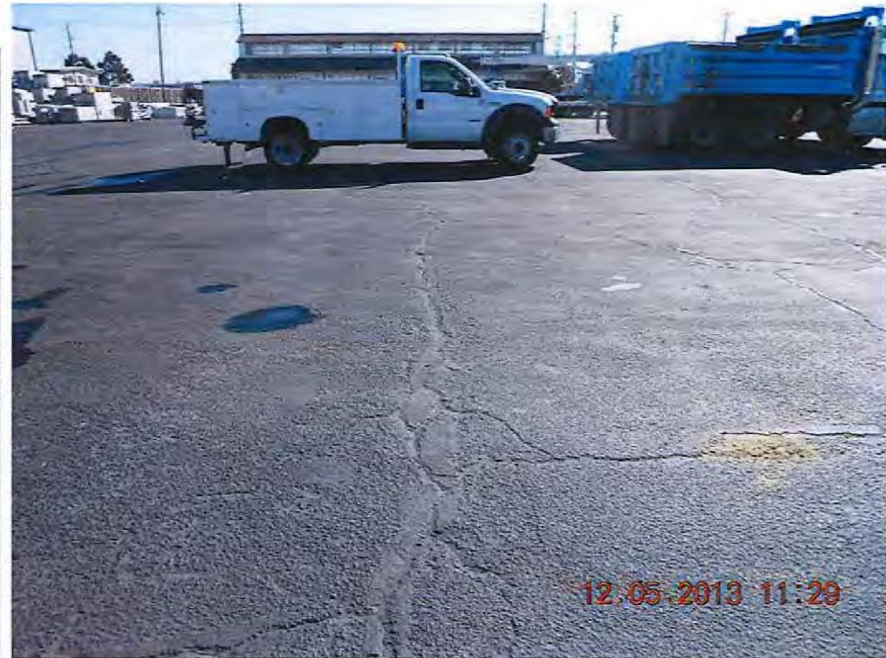
Photographs 9A and 9B: Cracking in Area K of the 2012 report. In 2013, the area has been sealed.

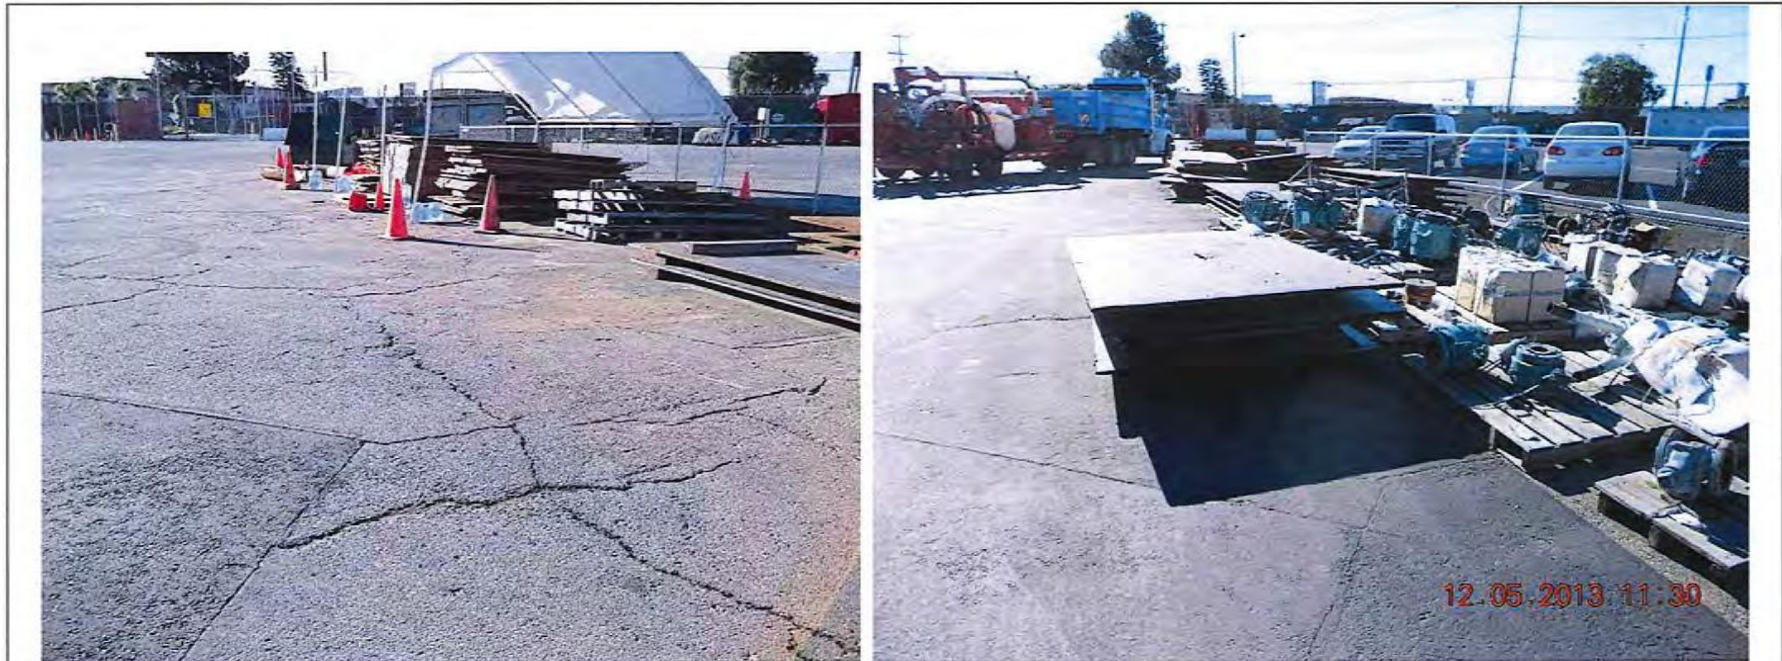
Photographs 11A and 11B: Cracking and weathered surface in Area M of the 2012 report. In 2013 some of the area has been sealed.

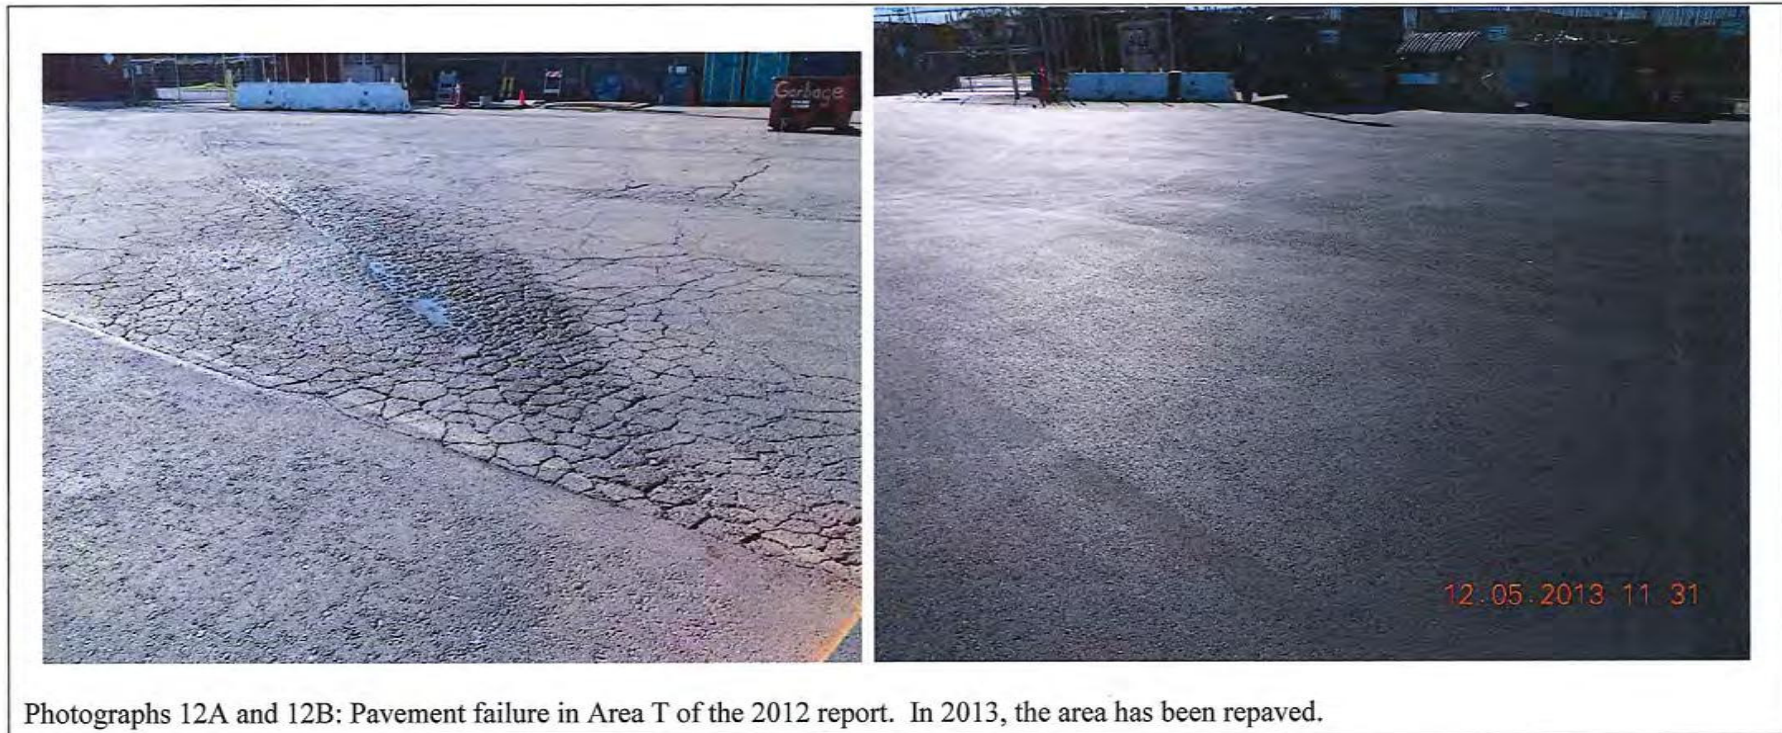
Photographs 12A and 12B: Pavement failure in Area T of the 2012 report. In 2013, the area has been repaved.

In September 2013, PG&E conducted maintenance of the asphalt surface. The majority of the inspected asphalt cap area was slurry sealed and pavement was replaced in an area outside of the asphalt cap boundary. Attachment B (attached) of the December 2013 Asphaltic Concrete Cap Inspection Report presents the Site figure for the 2013 inspection results with before and after photographs from the 2012 and 2013 inspection to demonstrate the changes over the year and the condition of the sealed areas. In one area where substantial pavement failure (alligator cracking) had been noted in 2012, the asphalt surface has been removed and replaced with new pavement (see photographs 12A and 12B, Attachment B).

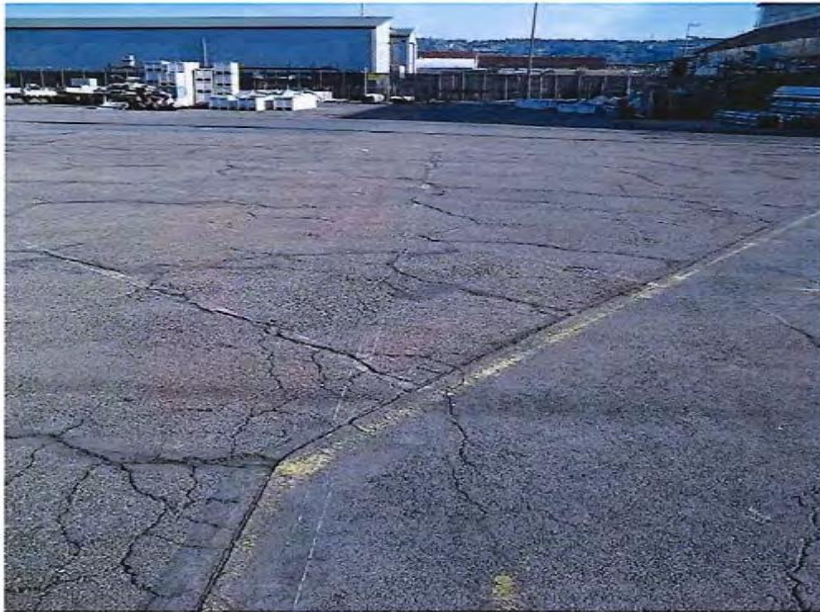
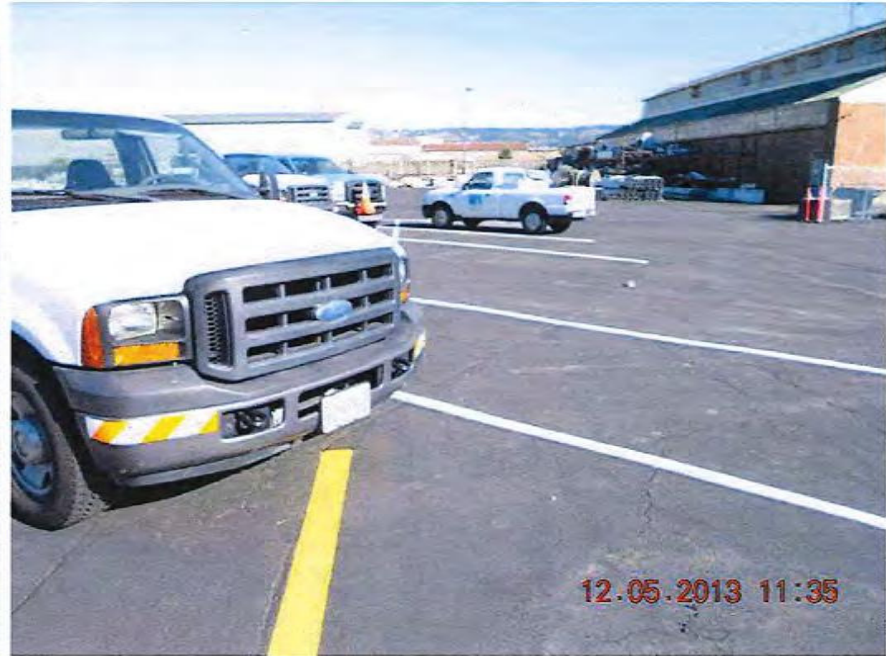
Photographs 13A and 13B: Cracking in Area P of the 2012 report. In 2013, the area has been sealed.
