## **Corrective Action Plan Addendum**

Former Chevron 97127  
10 W. Grant Line Road  
Mountain House, California 95377  
Alameda County Environmental  
Health Case No. RO185

Former Chevron 97127, 10 W Grant Line Road, Mountain House, California  
January 20, 2017

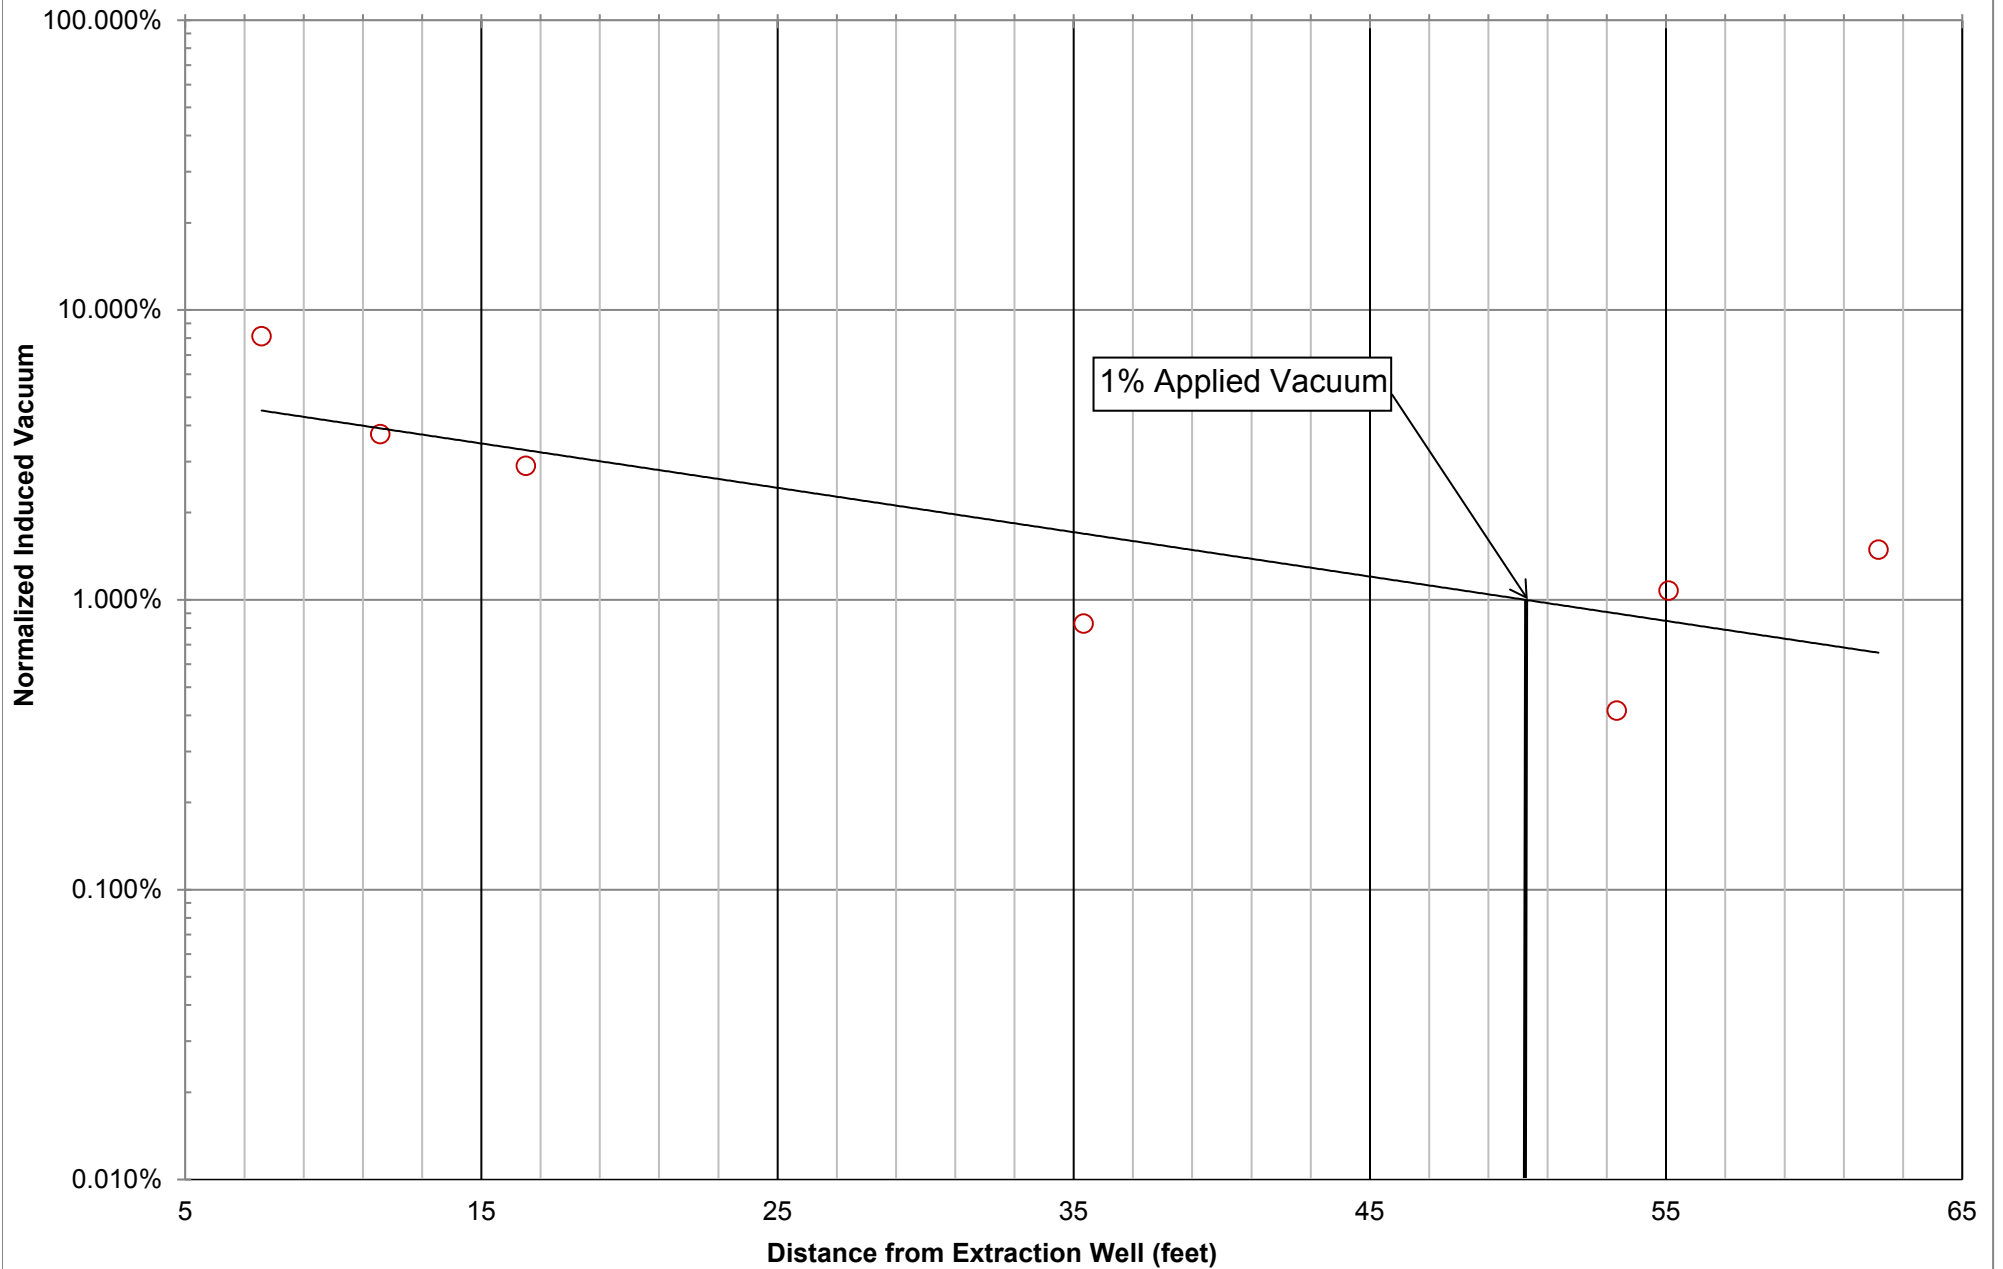
**FIGURE 4**  
**MW-1 - Normalized Radius of Influence**  
**Applied Vacuum of 8.8 in Hg**  
Former Chevron Service Station No. 9-7127  
10 Grant Line Road  
Mountain House, California

A straight line was fitted to the constant-rate testing data using linear regression for applied vacuums of 8.8 in Hg for MW-1 (shown on **Figure 4**). The radial distance corresponding to a normalized vacuum value of 1% represents the observed ROI.

The observed ROI for the MW-1 test could be approximated to approximately 50 feet at average applied vacuum of 8.8 in Hg based on constant rate conditions during the AS/SVE tests.

A straight line was fitted to the constant-rate testing data using linear regression for applied vacuums of 8.8 in Hg for MW-1 (**Figure 4**). The radial distance corresponding to a normalized vacuum value of 1% represents the observed ROI. The observed ROI for the MW-1 test could be approximated to approximately 50 feet at average applied vacuum of 8.8 in Hg based on constant rate conditions during the SVE test. The constant rate conditions were observed at the end of the SVE step testing.

- The observed ROI for the MW-1 test could be approximated to 50 feet at an average applied vacuum of 8.9 in Hg.
- The average injection pressure at AS-1 was 9.1 psi with an average flow of 19.8 scfm.

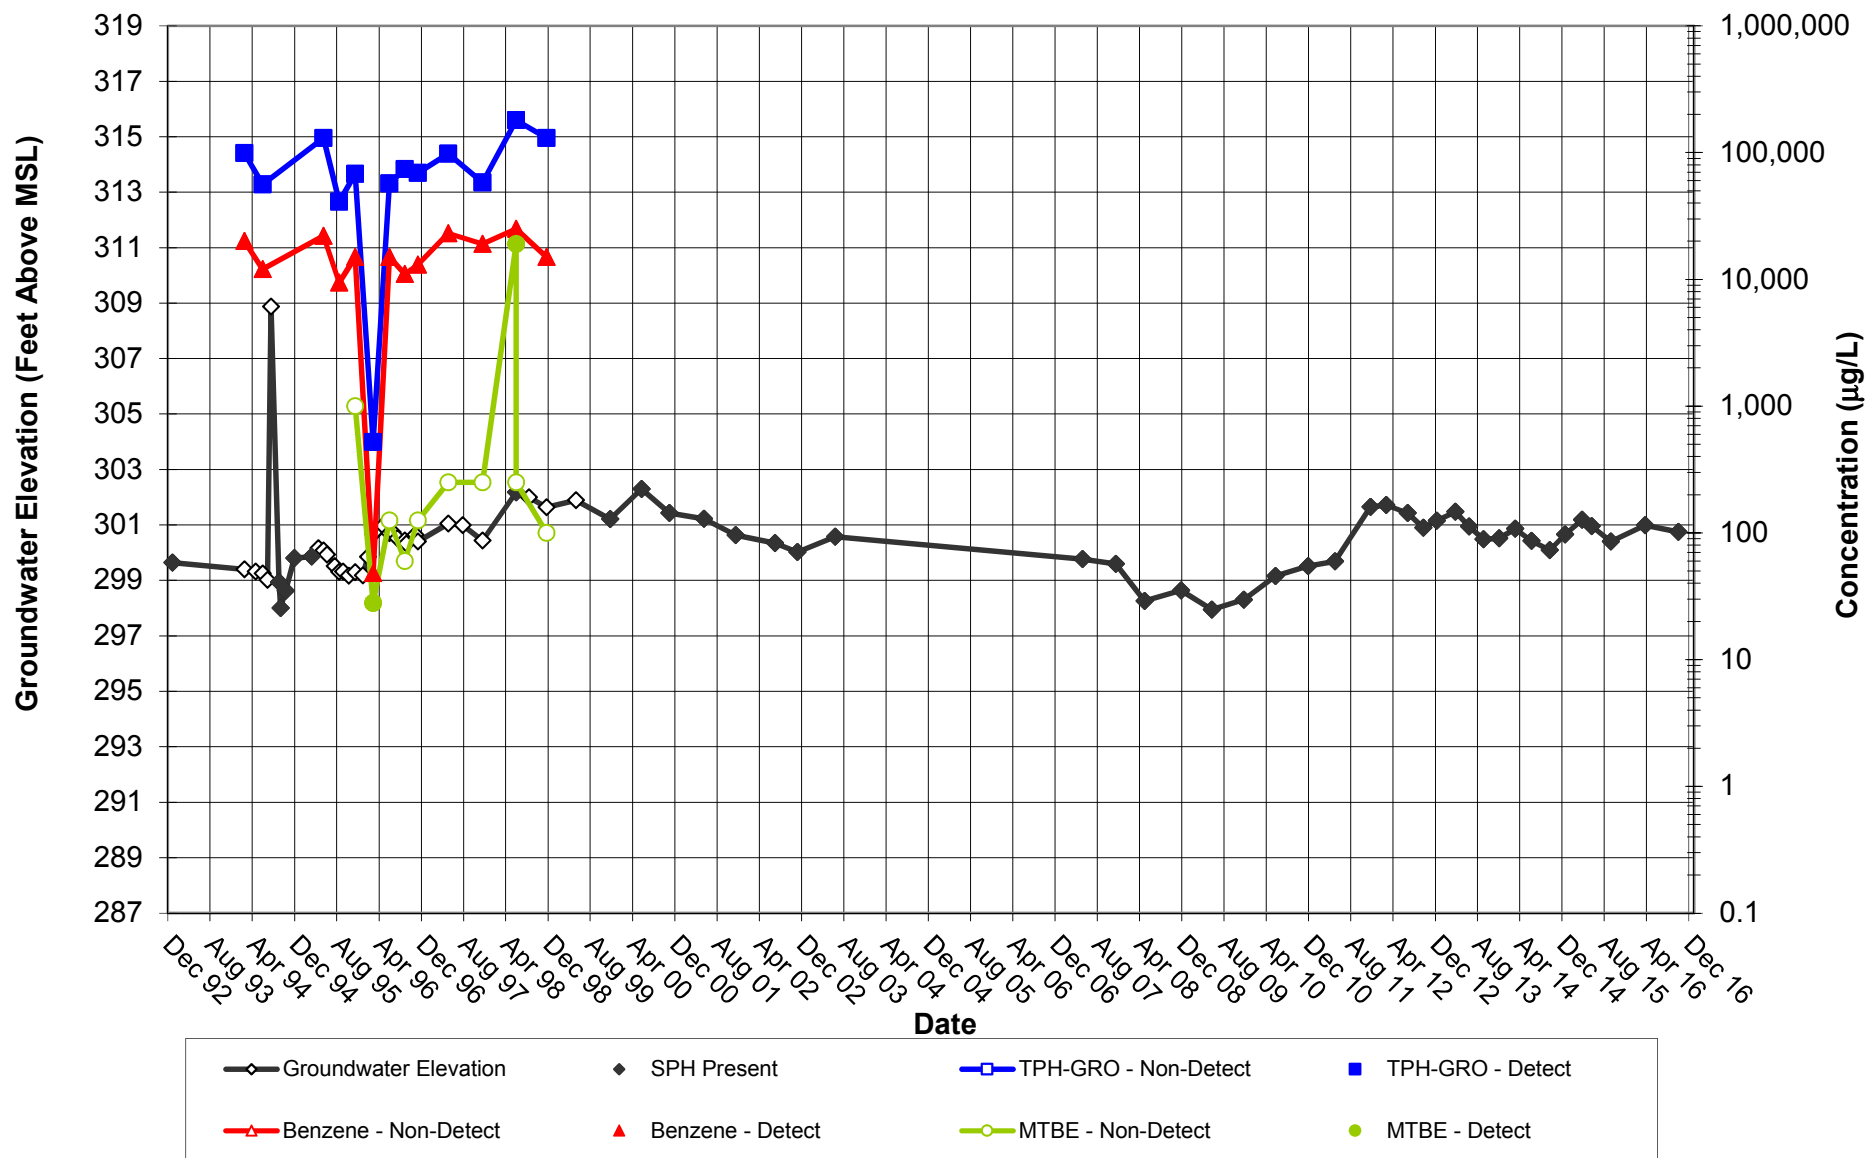
## Former Chevron Service Station No. 97127 MW-1 Hydrograph

1. No analytical samples were collected if SPH (separate phase hydrocarbons) was present in the well during the sampling event.
2. Non-detected analytical results are graphed at a concentration of one-half of the laboratory reporting limit.
3. Trend lines are presented for reference purposes only and do not represent professional interpretation.
4. For additional information about data for a given sampling event (such as no data plotted), refer to Table 1.
