**SOIL REMOVAL AND CONFIRMATION
SOIL SAMPLING REPORT**

BP Oil Company Service Station No. 11116
7197 Village Parkway
Dublin, California

Alisto Project No. 10-017

March 1999

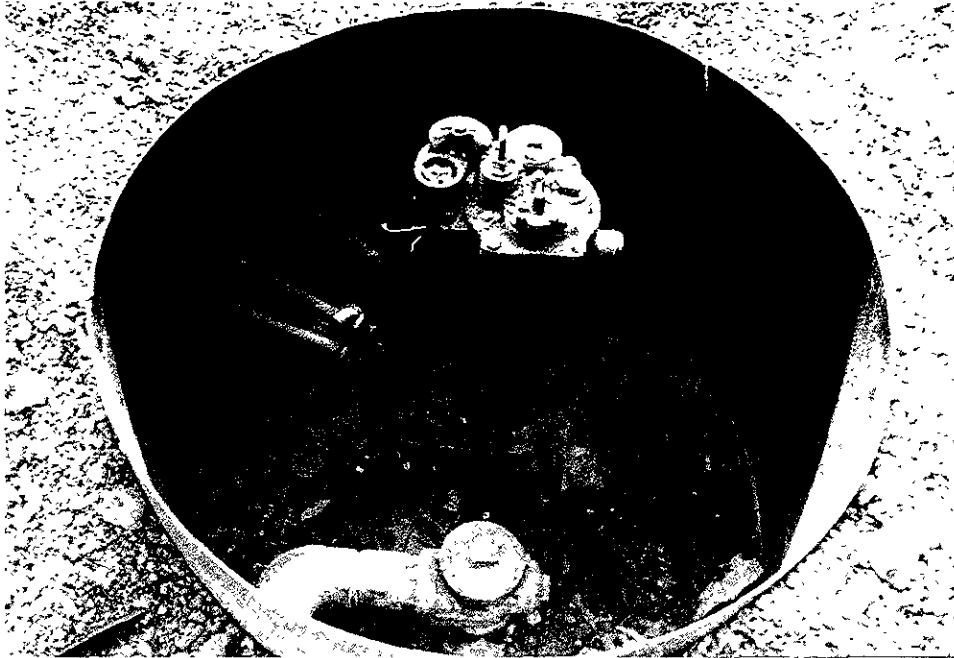
Photograph A1

July 27, 1998 - Tank sump containing turbine pump, vent piping and electrical conduit.

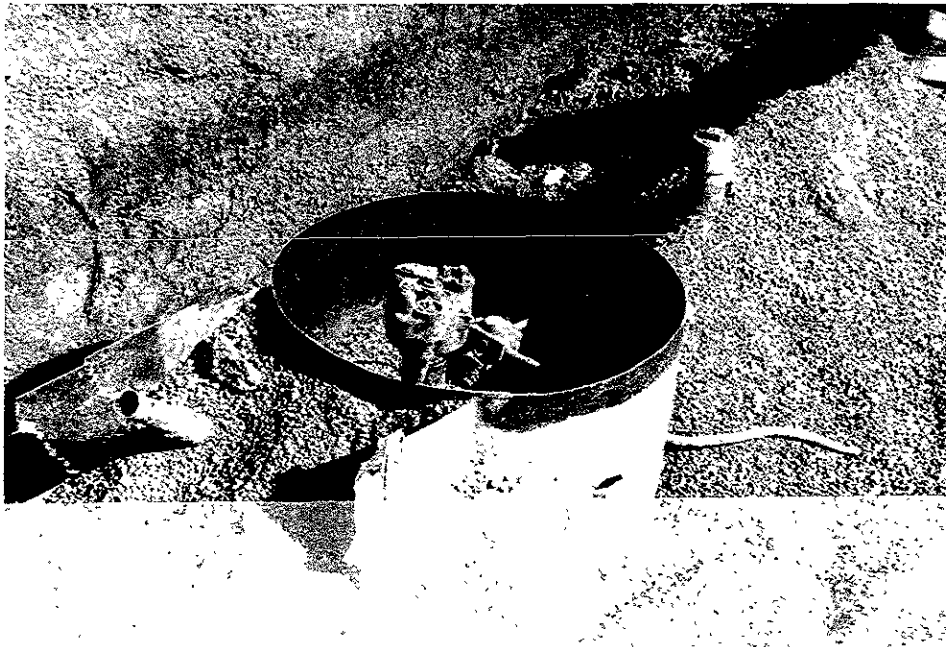
Photograph A2

July 27, 1998 - Tank sump with fibertrench terminated at the sump

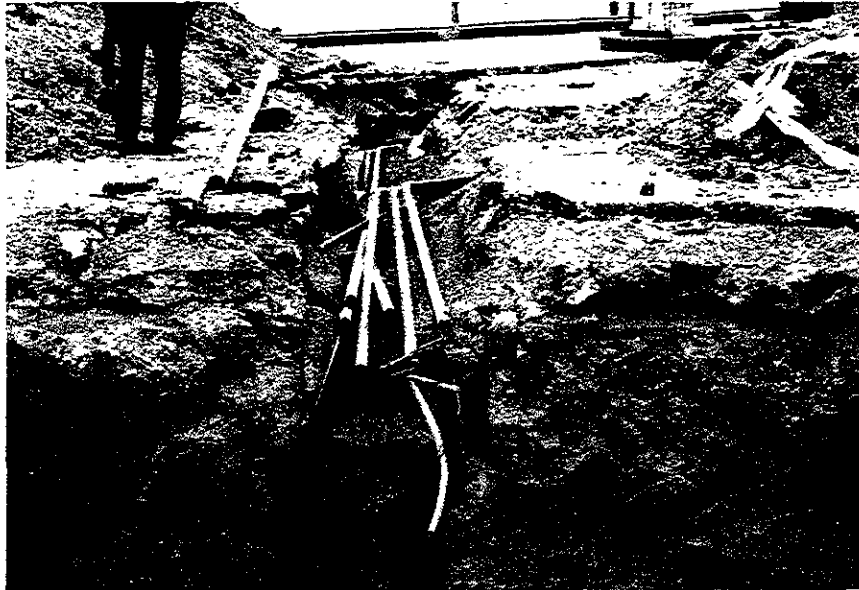
Photograph B1

July 31, 1998 - Looking northeast from the tank cavity, showing fibertrench and product and vent lines.

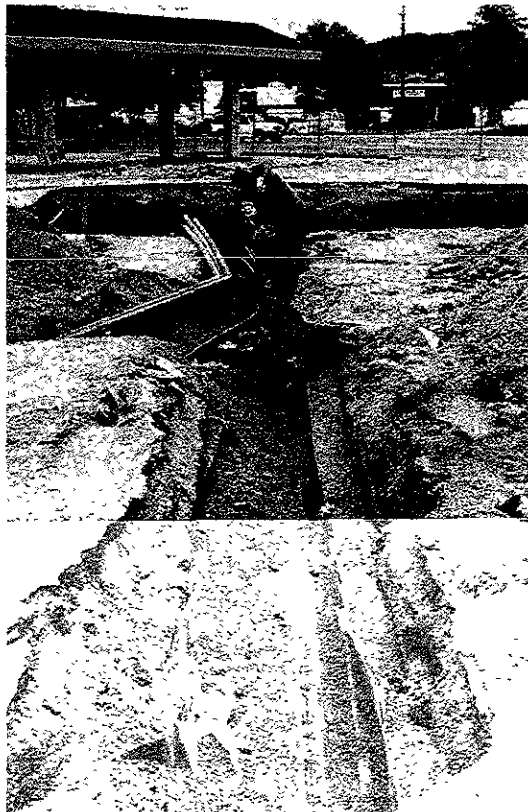
Photograph B2

July 31, 1998 - Looking southwest from the east dispenser island, showing fibertrench, product lines, and vent lines.
