Attn: Mr. Richard Hiett
Re: Remediation at Minami Nursery Site, Hayward, CA

Subject: Remediation Activities Performed to Date at Minami
Nursery Site, Hayward, California

The enclosed report is being transmitted to you at the request of Mr. George Minami, Jr. This report documents remedial activities performed to date at the Minami Nursery site, 600 Shirley Avenue, Hayward, California. Work performed to date includes excavation and removal of two underground fuel storage tanks (UFSTs), legal transport and disposal of the two UFSTs, excavation and on-site stockpiling of the associated contaminated soil and backfilling of the excavations.

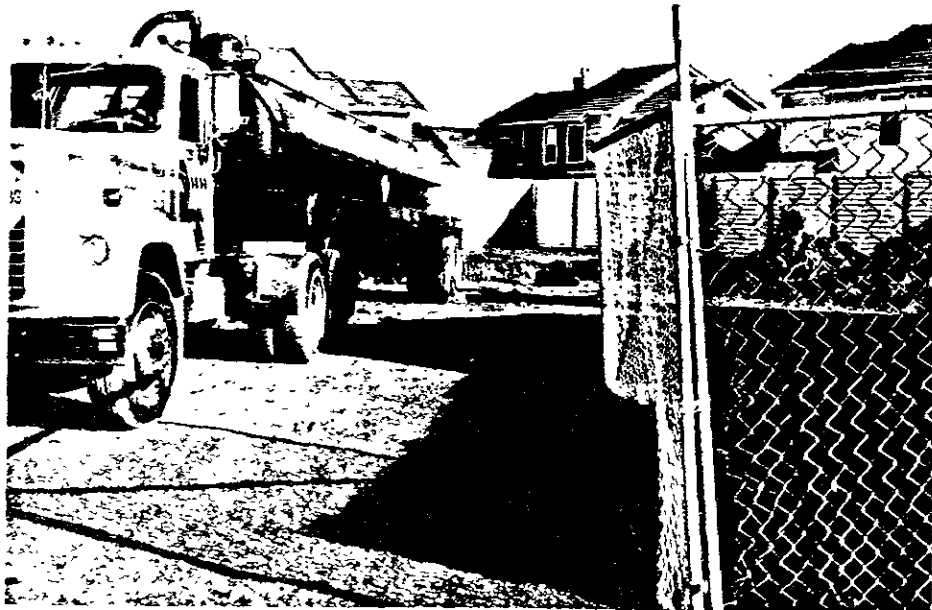
PHOTO 4

**VACUUM TRUCK PUMPING LIQUID
FROM FUEL OIL TANK
NOVEMBER 8, 1989**

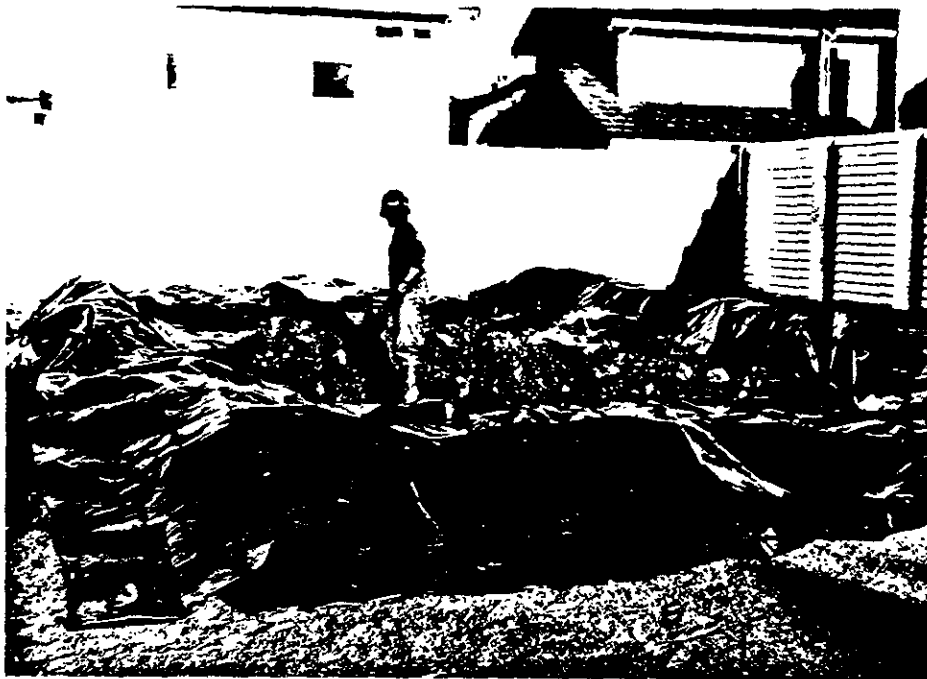
PHOTO 15

Prior to stockpiling any soil, bermed, plastic-lined (10-millimeter thick Visqueen) stockpile areas were constructed (Photo 15; Appendix A). Contaminated soil was stockpiled separately from uncontaminated overburden. After each day's work, the soil stockpiles were covered with plastic sheeting (10-mm thick Visqueen) to prevent release of vapors to the environment and to prevent erosion and leaching due to moisture infiltration and/or runoff.

STOCKPILE AREA FOR SOIL/OILY WATER MIXTURE
FROM FUEL OIL TANK EXCAVATION
NOVEMBER 8, 1989

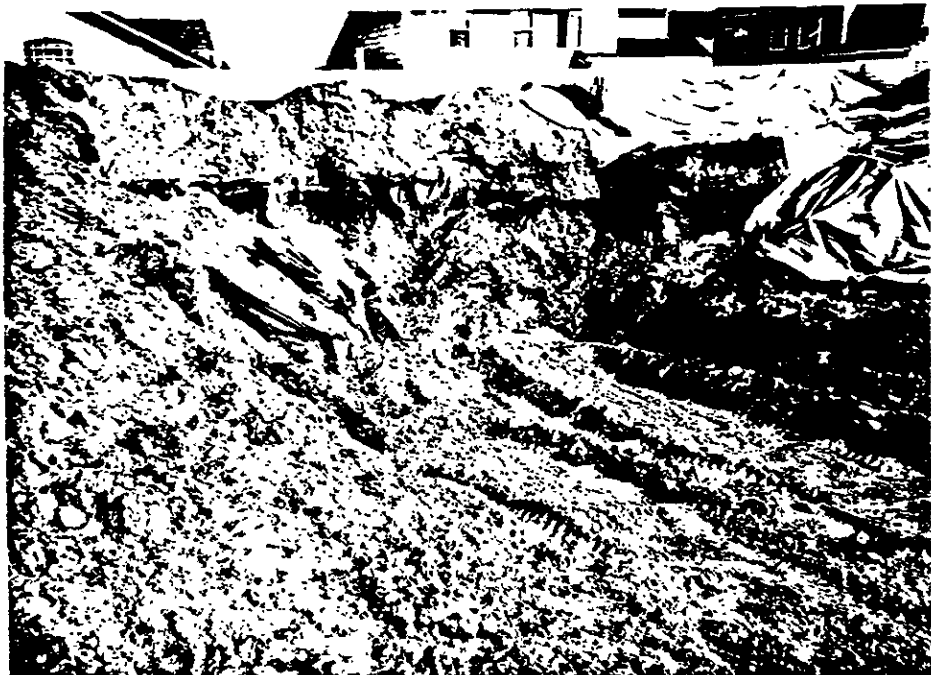
PHOTO 37

The imported fill material was placed in the excavation in uniform lifts not exceeding 12 inches in thickness (Photos 37, 38 and 39; Appendix A). Each layer of fill was compacted individually using a self-propelled tamping foot-roller (BOMAG Model 142) (Photos 38 and 39; Appendix A). In-site compaction was randomly checked using a nuclear density gauge (ASTM Test D2922-71). The locations and depths of the in-situ compaction tests are presented on Figure 2-9.

**INITIAL BACKFILL LAYERS AFTER
BEING SPREAD IN EXCAVATION**

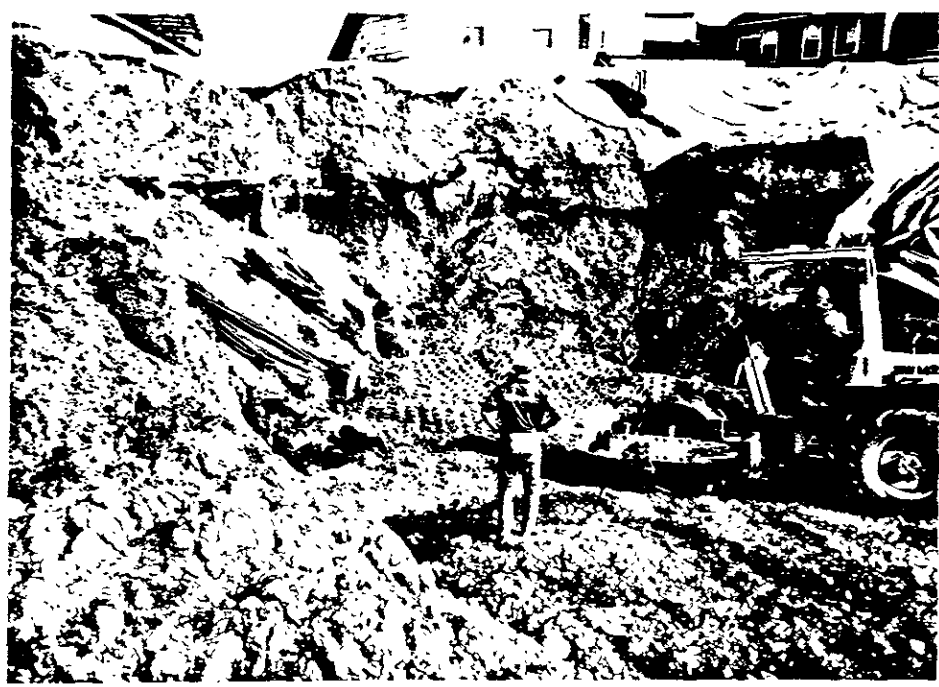
PHOTO 38

SELF-PROPELLED TAMPING FOOT COMPACTOR

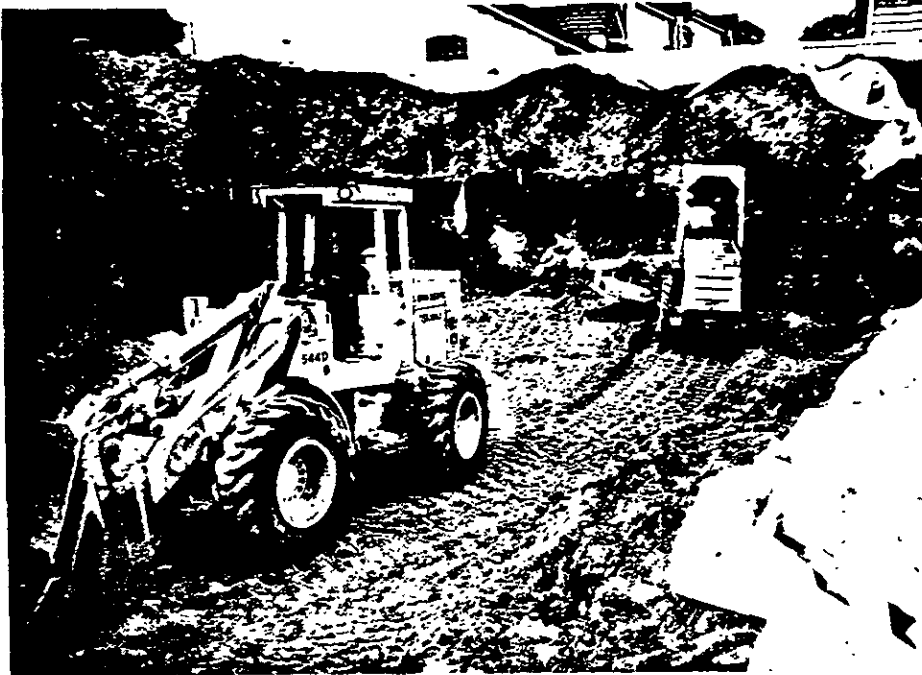
PHOTO 39

FRONT-END LOADER AND
TAMPING FOOT COMPACTOR

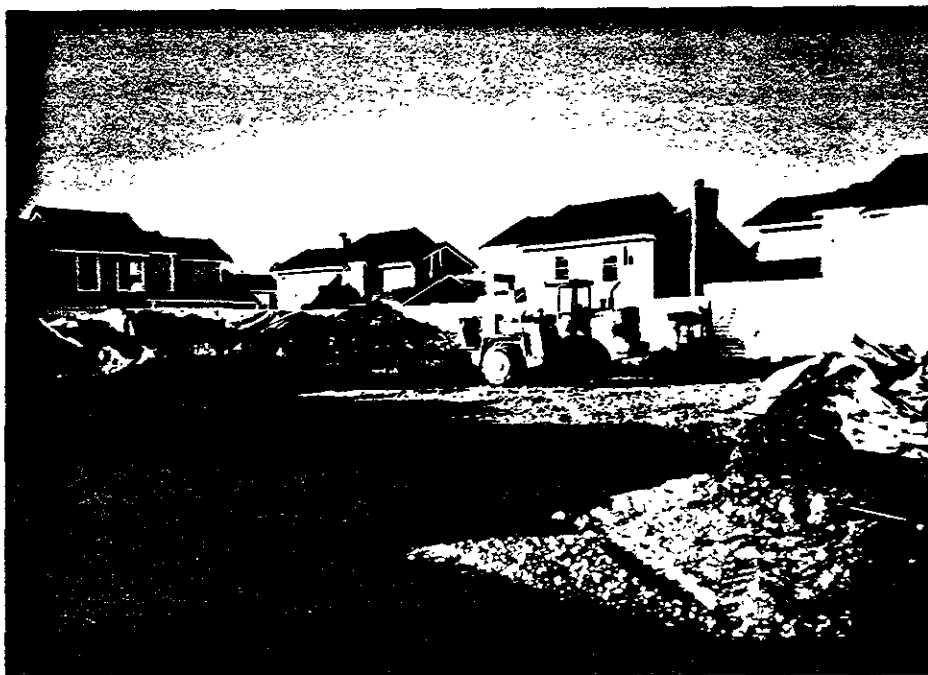
PHOTO 42

Refilling of the fuel oil tank excavation was completed on 21 and 22 March 1990. Imported material was used to backfill the excavation from a depth of 5 feet to ground surface (Photo 42; Appendix A).

**SITE BACKFILL AND COMPACTION
WORK COMPLETED**
