FIRST QUARTER 2010 GROUNDWATER MONITORING AND OXYGEN RELEASE COMPOUND TREATMENT CORRECTIVE ACTION REPORT

REDWOOD REGIONAL PARK SERVICE YARD OAKLAND, CALIFORNIA

EAST BAY REGIONAL PARK DISTRICT OAKLAND, CALIFORNIA

Project No. 2008-02

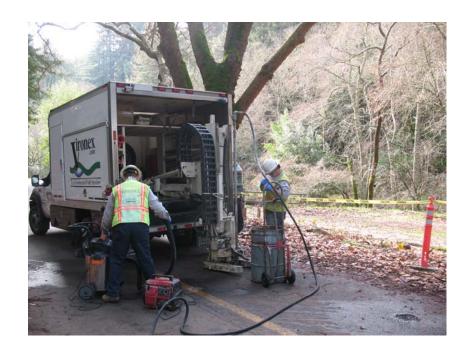
Photographer: H. Pietropaoli Photo No.: 01

Subject: Geopobe drill with rods connected to ORCTM feed hose

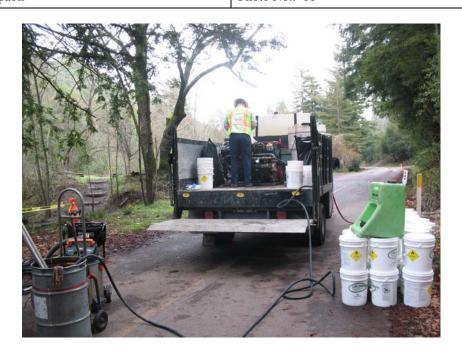
Subject: ORC TM mixing truck in treament zone 3					
Site: Redwood Regional Park Service Yard, Oakland, CA					
Date Taken: February 1, 2010 Project No.: SES 2010-02					
Photographer: H. Pietropaoli Photo No.: 02

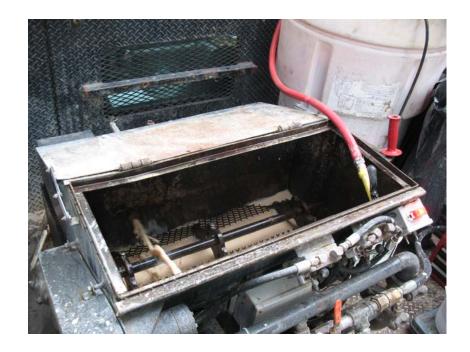
Subject: Inside the ORC TM mixing unit					
Site: Redwood Regional Park Service Yard, Oakland, CA					
Date Taken: February 1, 2010 Project No.: SES 2010-02					
Photographer: H. Pietropaoli Photo No.: 03

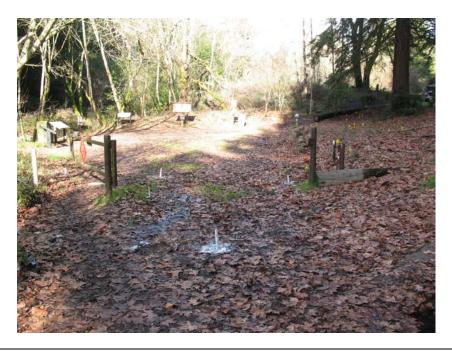
Subject: Injection borehole locations marked for utility clearance in treatment zone 4					
Site: Redwood Regional Park Service Yard, Oakland, CA					
Date Taken: February 1, 2010 Project No.: SES 2010-02					
Photographer: H. Pietropaoli Photo No.: 04

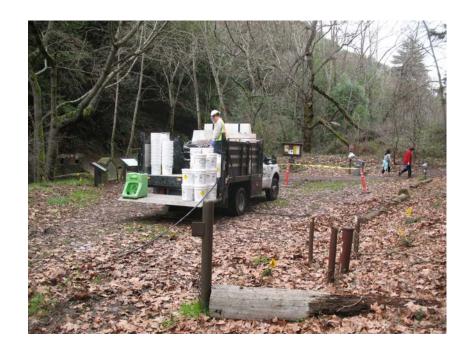
Photographer: H. Pietropaoli Photo No.: 05

Subject: Geopobe mixing truck connected to ORC™ feed hose in lower area

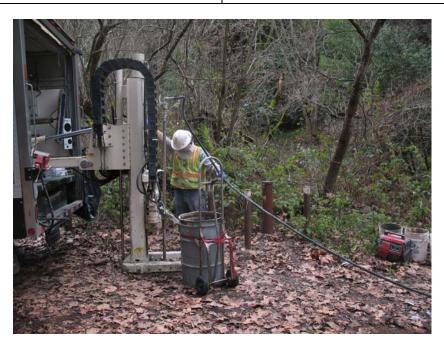
Photographer: H. Pietropaoli Photo No.: 06

Subject: Drill rig injecting in lower zone boerehole

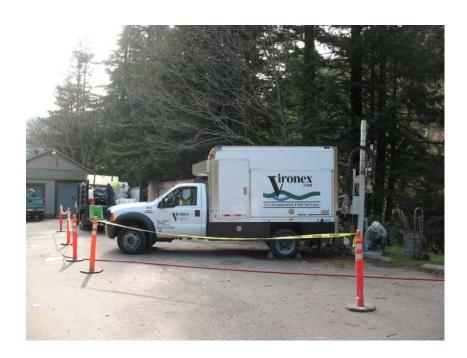
Photographer: H. Pietropaoli Photo No.: 07

Subject: Drill and mixing rigs set up in upper area treatment zone 2

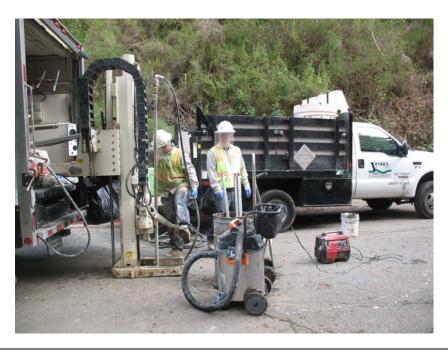
Photographer: H. Pietropaoli Photo No.: 08

Subject: Drill and mixing rigs set up in upper area treatment zone 1

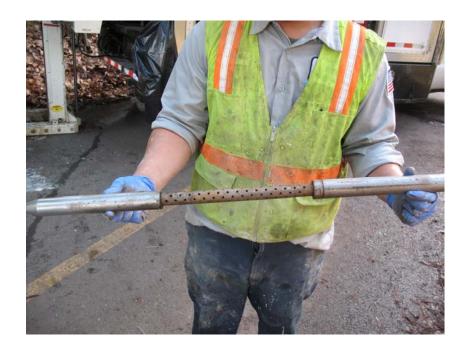
Subject: View of 1-foot injector tip				
Site: Redwood Regional Park Service Yard, Oakland, CA				
Date Taken: February 1, 2010	Project No.: SES 2010-2			
Photographer: H. Pietropaoli	Photo No.: 09

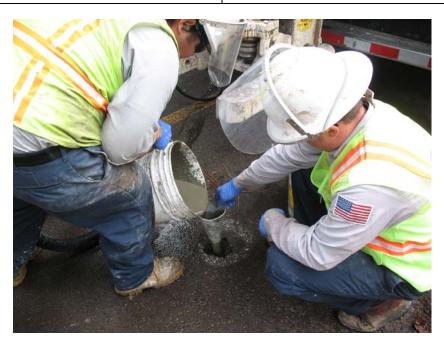
Subject: Grouting of borehole after injection				
Site: Redwood Regional Park Service Yard, Oakland, CA				
Date Taken: February 1, 2010	Project No.: SES 2010-02			
Photographer: H. Pietropaoli	Photo No.: 10
