**FIRST SEMIANNUAL 2016  
GROUNDWATER MONITORING REPORT  
AND PRB EVALUATION**

**REDWOOD REGIONAL PARK  
SERVICE YARD  
OAKLAND, CALIFORNIA**

**EAST BAY REGIONAL PARK DISTRICT  
OAKLAND, CALIFORNIA**

**STELLAR ENVIRONMENTAL SOLUTIONS, INC.  
2198 SIXTH STREET  
BERKELEY, CALIFORNIA 94710**

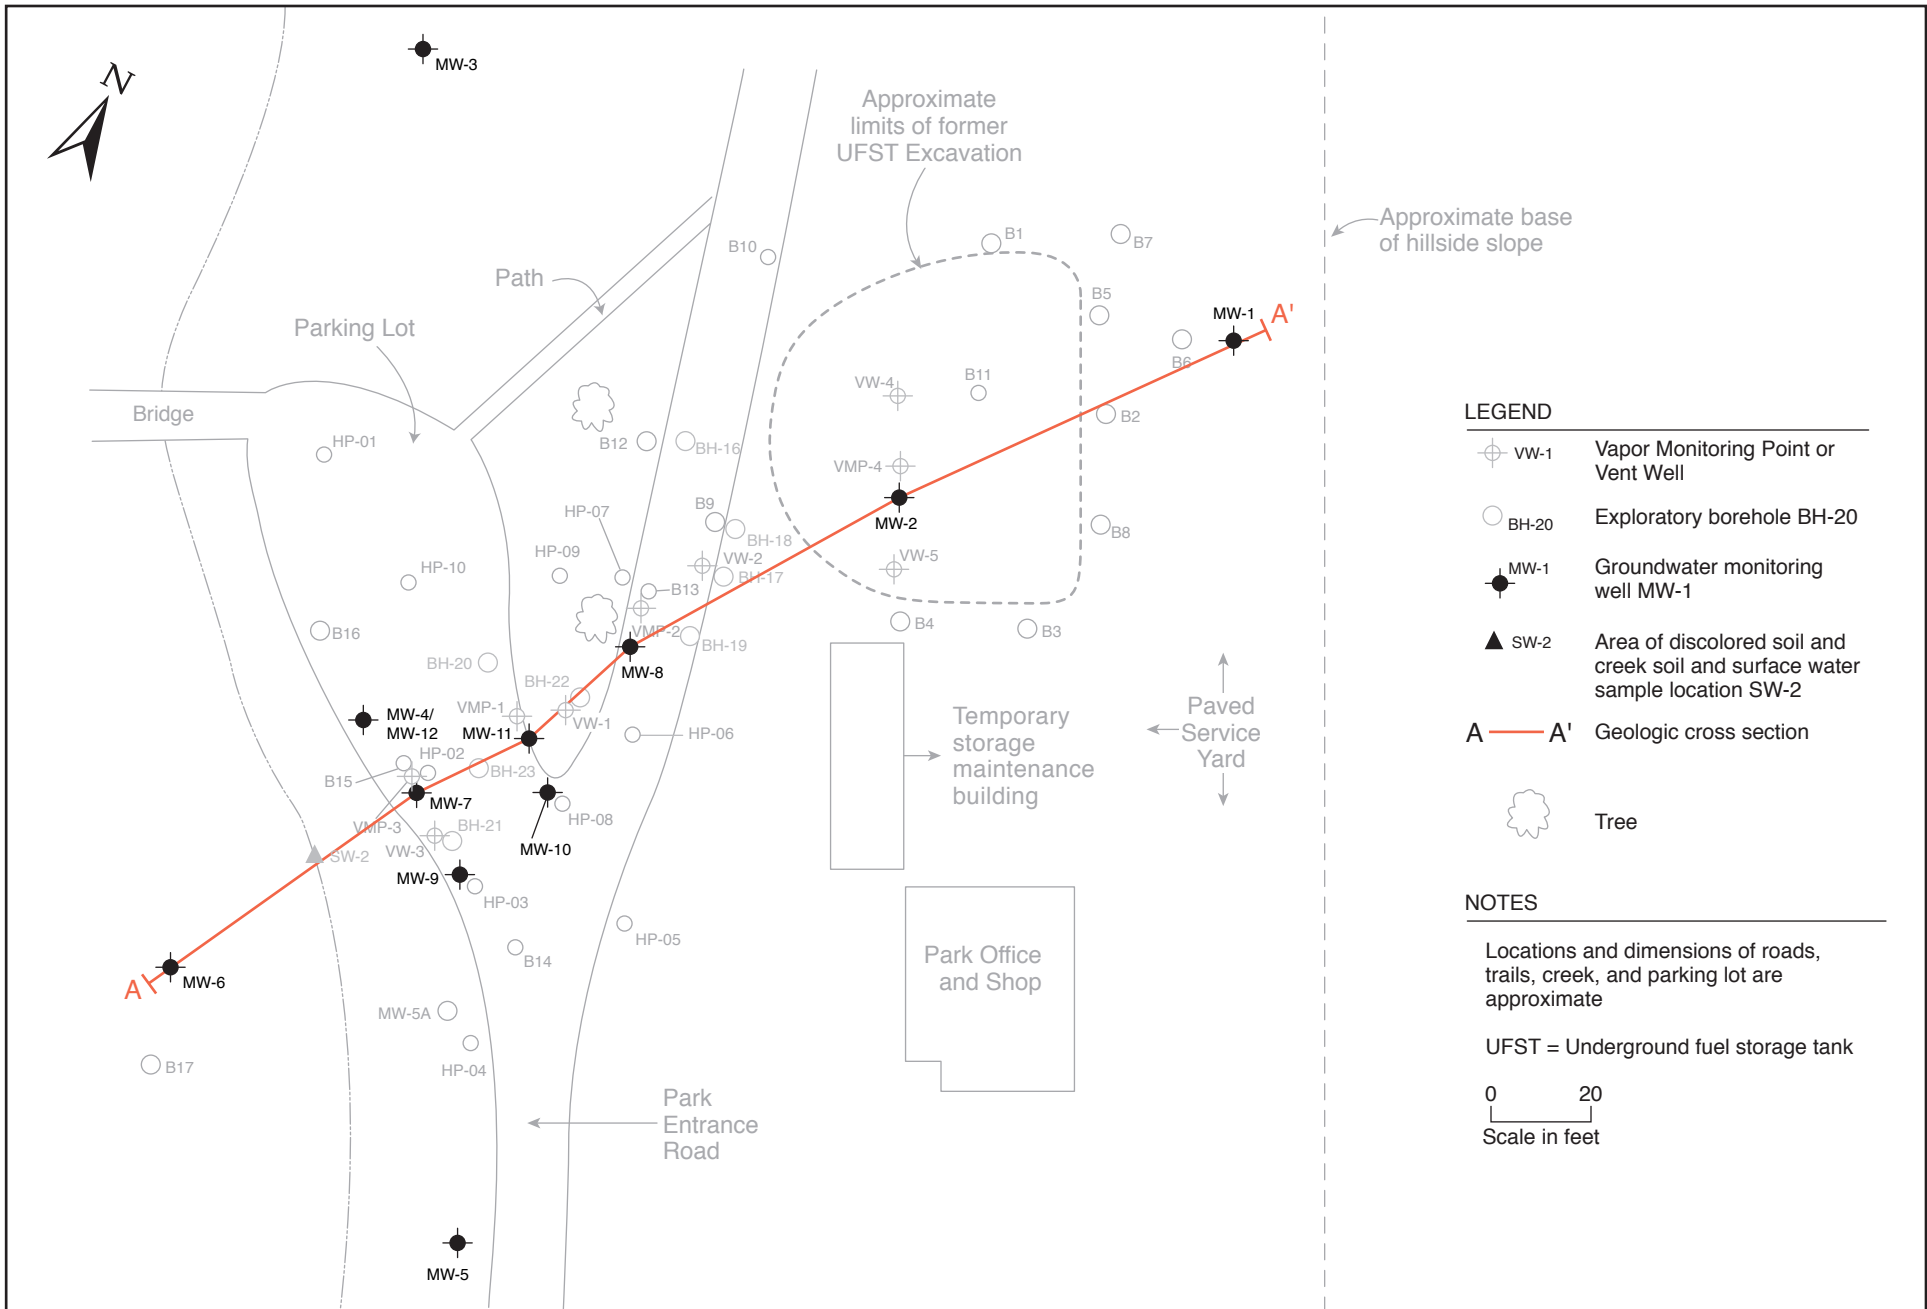
**Figure 2**  
 by: MJC      APRIL 2015

**SITE PLAN SHOWING HISTORICAL BORINGS, WELLS AND GEOLOGIC CROSS-SECTION LOCATIONS**  
**Redwood Regional Park Service Yard, Oakland, CA**

Figure 1 shows the location of the project site. Figure 2 presents the site plan.
