| SUBJECT: REDWOOD REGIONAL PARK FUEL LEAK SITE<br>FUEL LEAK CASE NO. RO0000246 | | | |
| THE FOLLOWING: BIOVENTING SYSTEM INSTALLATION AND STARTUP REPORT<br>(DATED FEBRUARY 21, 2006) | | | |

Subject: Bioventing Installation and Startup Report  
Redwood Regional Park Service Yard Site – Oakland, California

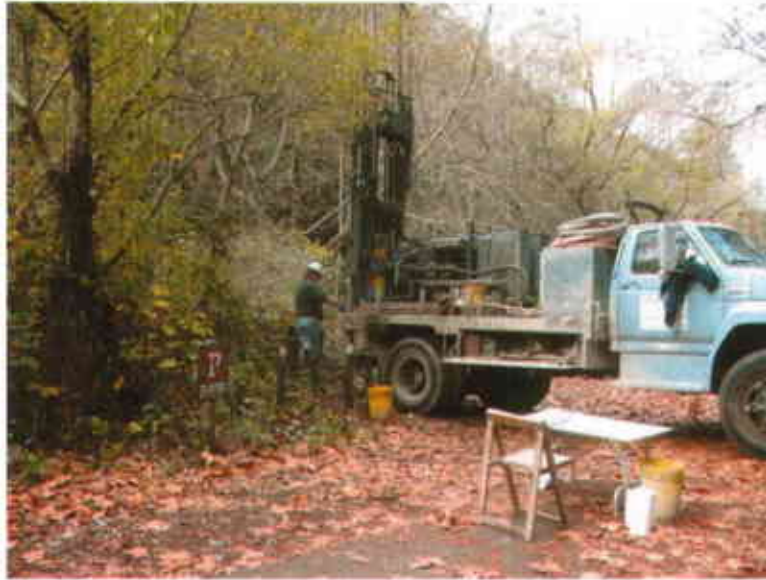
Photo No.: 01

Subject: Drilling borehole for vent well VW-3, looking to the northwest from the park service road.

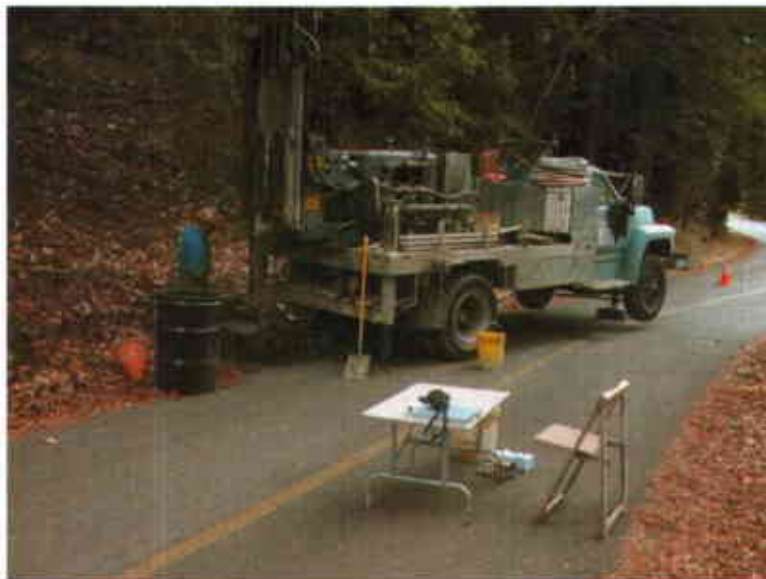
Photo No.: 02

Subject: Drilling borehole for vent well VW-2, looking to the south, down the park entrance road.

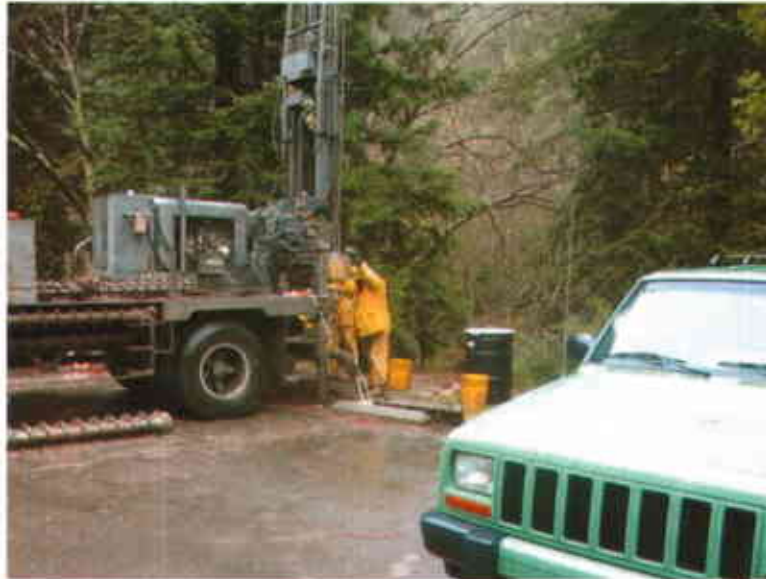
Photo No.: 03

Subject: Drilling borehole for vapor monitoring point VMP-4, looking to the west from the service yard parking lot.

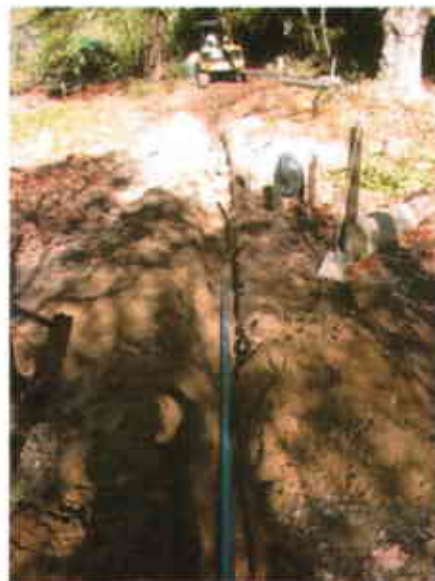
Photo No.: 04

Subject: Trenching for bioventing underground piping, looking to the north from VW-3.

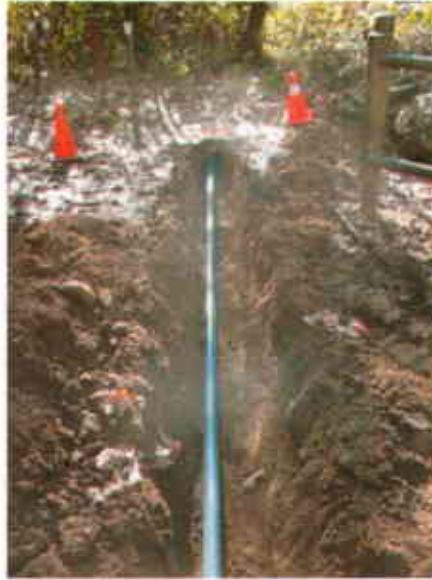
Photo No.: 05

Subject: Below-grade piping connected to VW-3 (before backfilling), looking to the north.

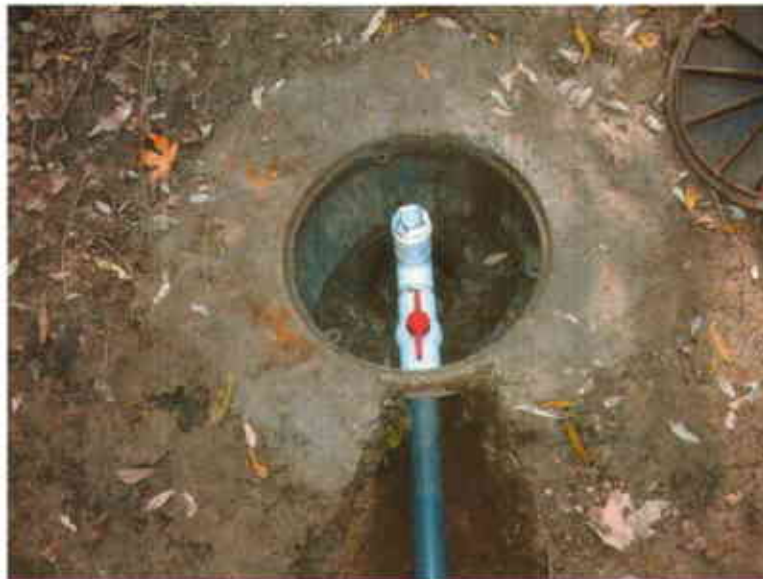
Photo No.: 06

Subject: Surface completion at vent well VW-3 showing ball valve (red handle) and sampling port (top of well).

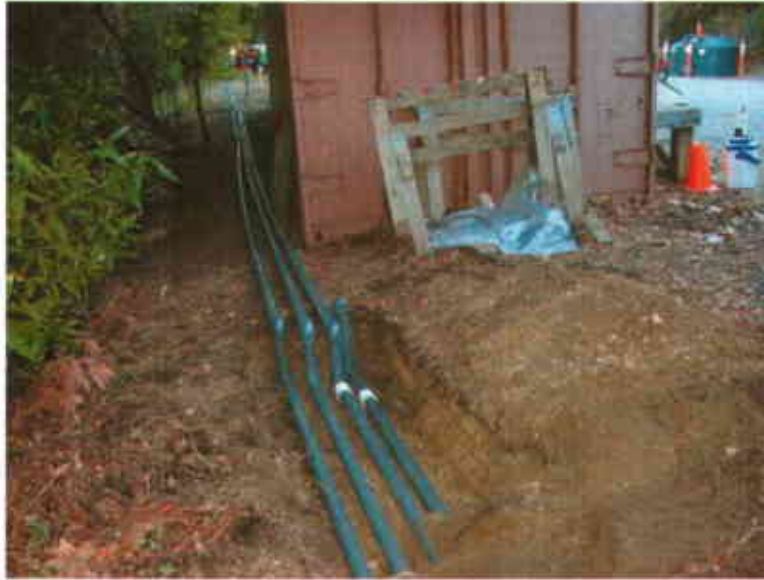
Photo No.: 07

Subject: Bioventing piping going underground (before backfilling), looking to the north.

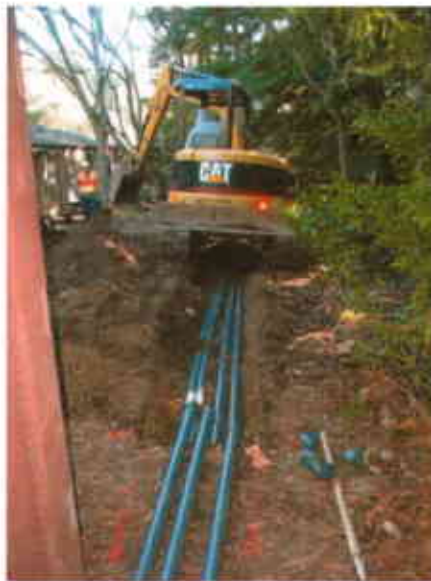
Photo No.: 08

Subject: Bioventing piping going underground (before backfilling), looking to the south.

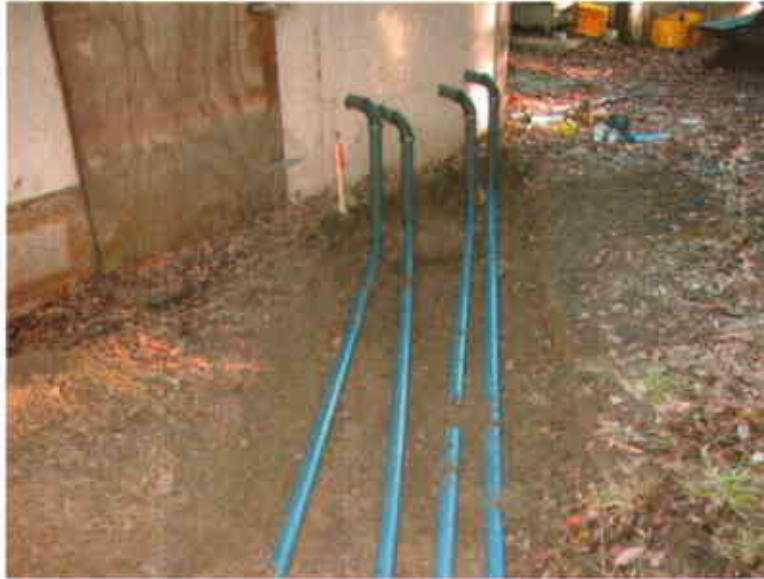
Photo No.: 09

Subject: Bioventing piping coming from blower shed (before backfilling), looking to the southeast.

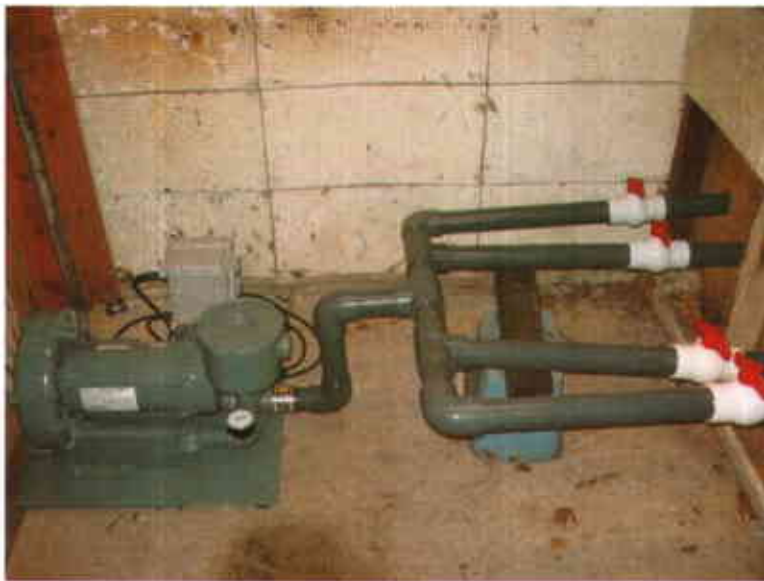
Subject: Bioventing blower (left) and piping manifold (right) in the blower shed (before installing flow measurement ports on the manifold).
