Underground Fuel Storage Tank Locations

Owens-Brockway Glass Container Facility - Oakland, CA

DATA COMPILATION AND CLOSURE REPORT UNDERGROUND FUEL STORAGE TANK LOCATIONS OWENS-BROCKWAY GLASS CONTAINER FACILITY OAKLAND, CALIFORNIA

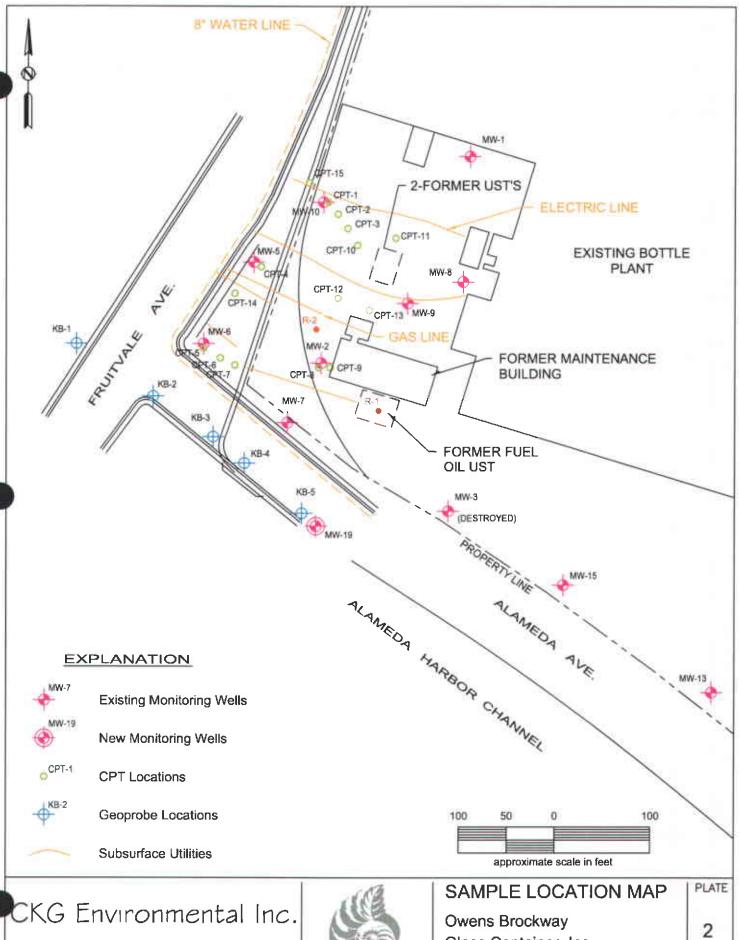
Onsite facilities include the operating glass manufacturing plant, warehouses, offices and two former underground fuel storage tank areas, (Plate 2).

On May 28 through 29, 2003, Cone Penetration Test (CPT) probes were advanced at a total of 15 locations as shown on Plate 2. The CPT investigation was completed under the direction of Christina J. Kennedy, R.G. of CKG. Borings were advanced to depths of 18 - 25 feet below ground surface (bgs) depending on the depth of groundwater or on whether or not there was a response from the UVIF detector. CPT logs are presented in Appendix B.

The following describes the results of the CPT investigation and well installation at the Owens-Brockway Glass Container facility in Oakland, California. Analytical laboratory reports are included in Appendix E. Sample locations are presented on Plate 2.

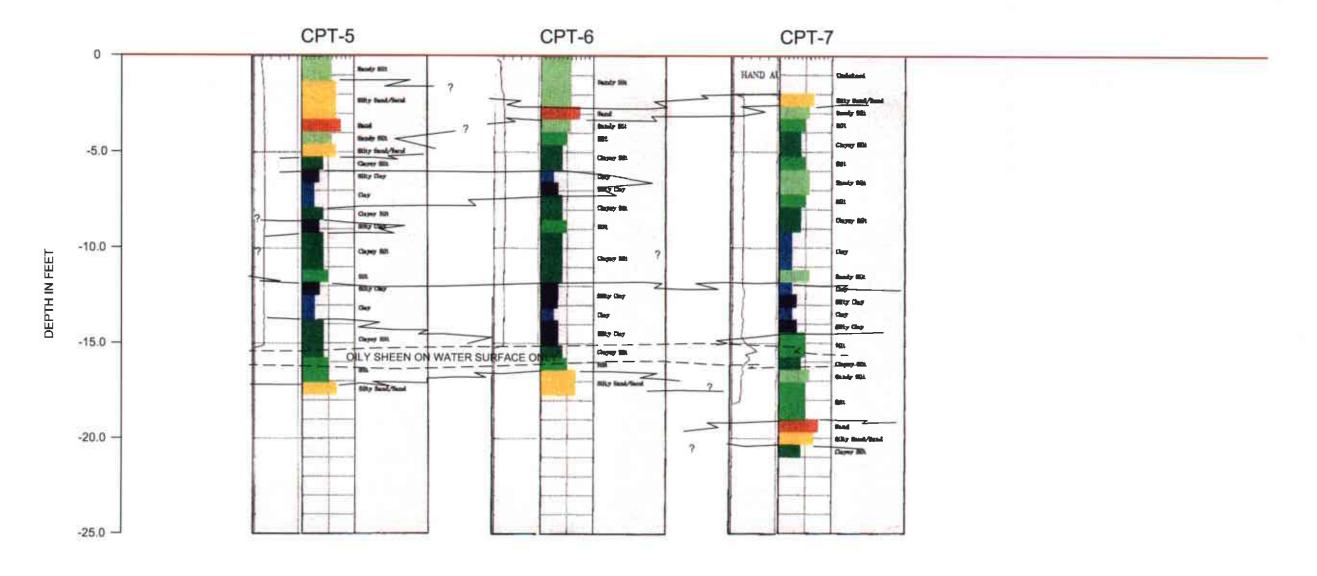
4C

The UV/IF response shown on Plates 4A – 4D shows that the fuel oil has spread out laterally from each former UST location within the soil column for a distance of 10-15 feet, although in some areas sandier material allowed the fuel to spread further. Once the fuel oil reached groundwater then it spread to its present configuration. The subsurface utilities are rarely deeper

than 5 or 6 feet below ground surface so it appears that they may not have had a significant effect in distributing the fuel oil except to a lesser extent along the UST piping.
