**SITE CHARACTERIZATION REPORT
and
WORK PLAN**

**PACO PUMPS INC.
9201 San Leandro Street
Oakland, California**

October 16, 1992

Jonas & Associates Inc. Job No. PCO-220-01-SAII

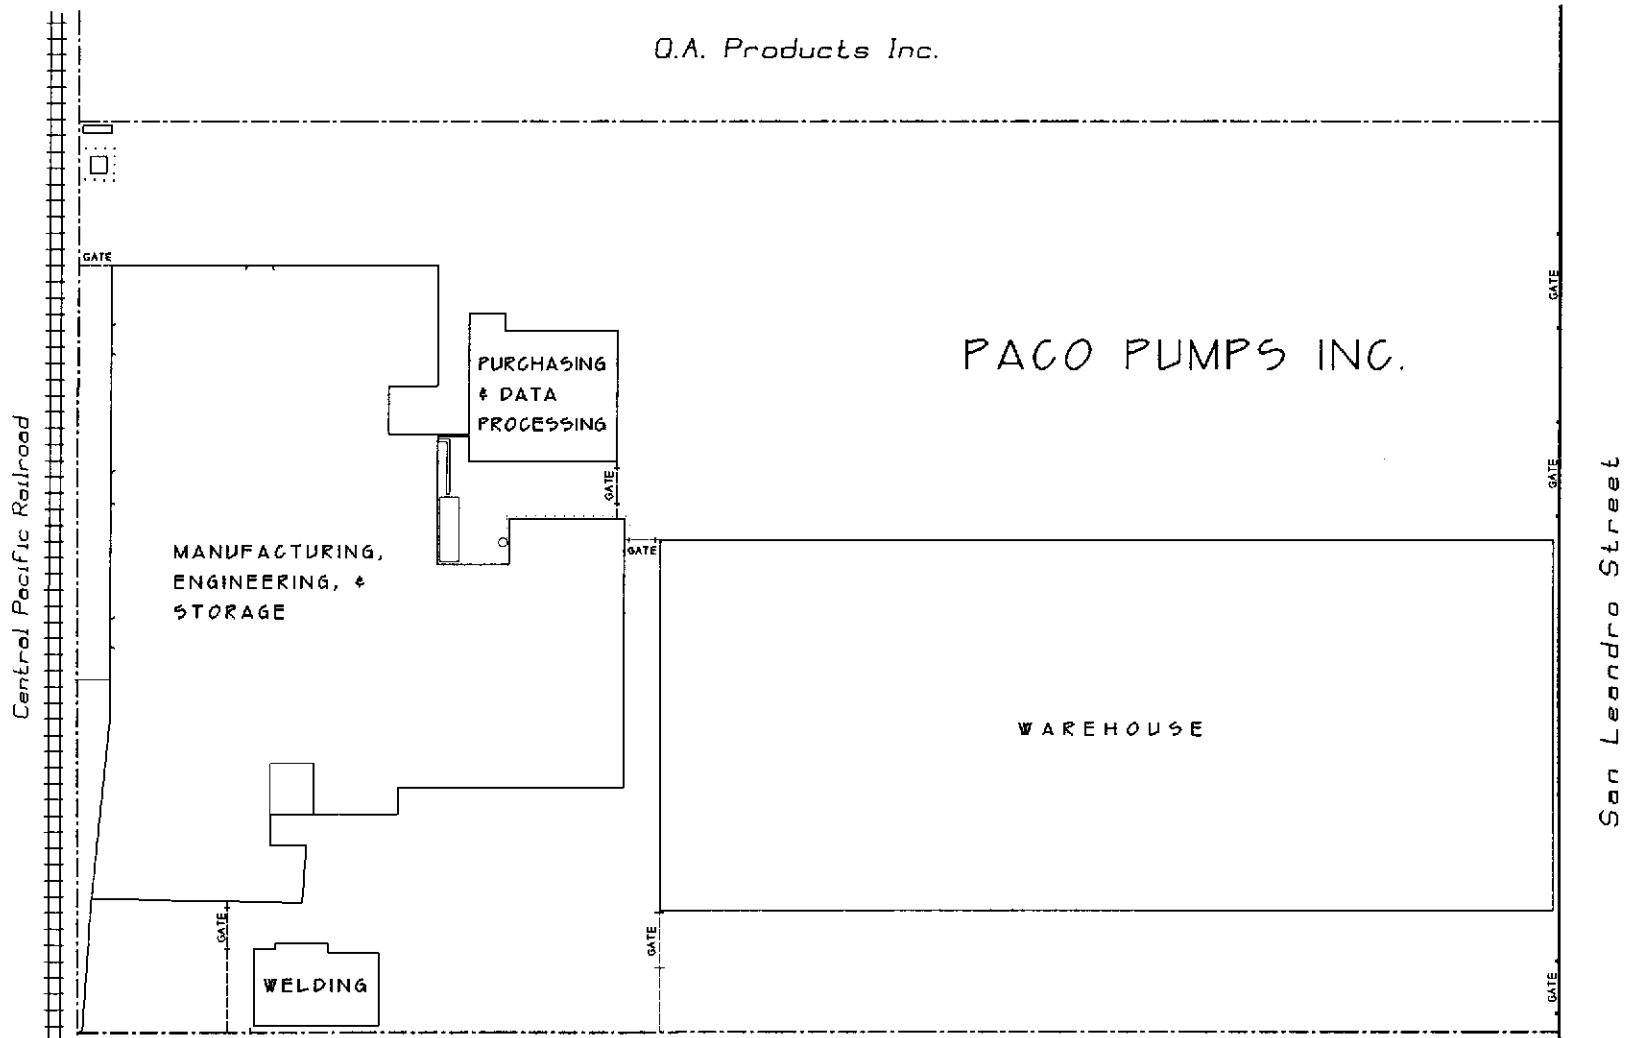
Drawn by A.J. 5-29-1992
 Checked by Approved by
 Drawing Number PC0220-5/92:FI-2
 Figure 1-2

Facility Map
 PACO Pumps
 9201 San Leandro Street
 Oakland, California
 Prepared by
JONAS & ASSOCIATES INC.

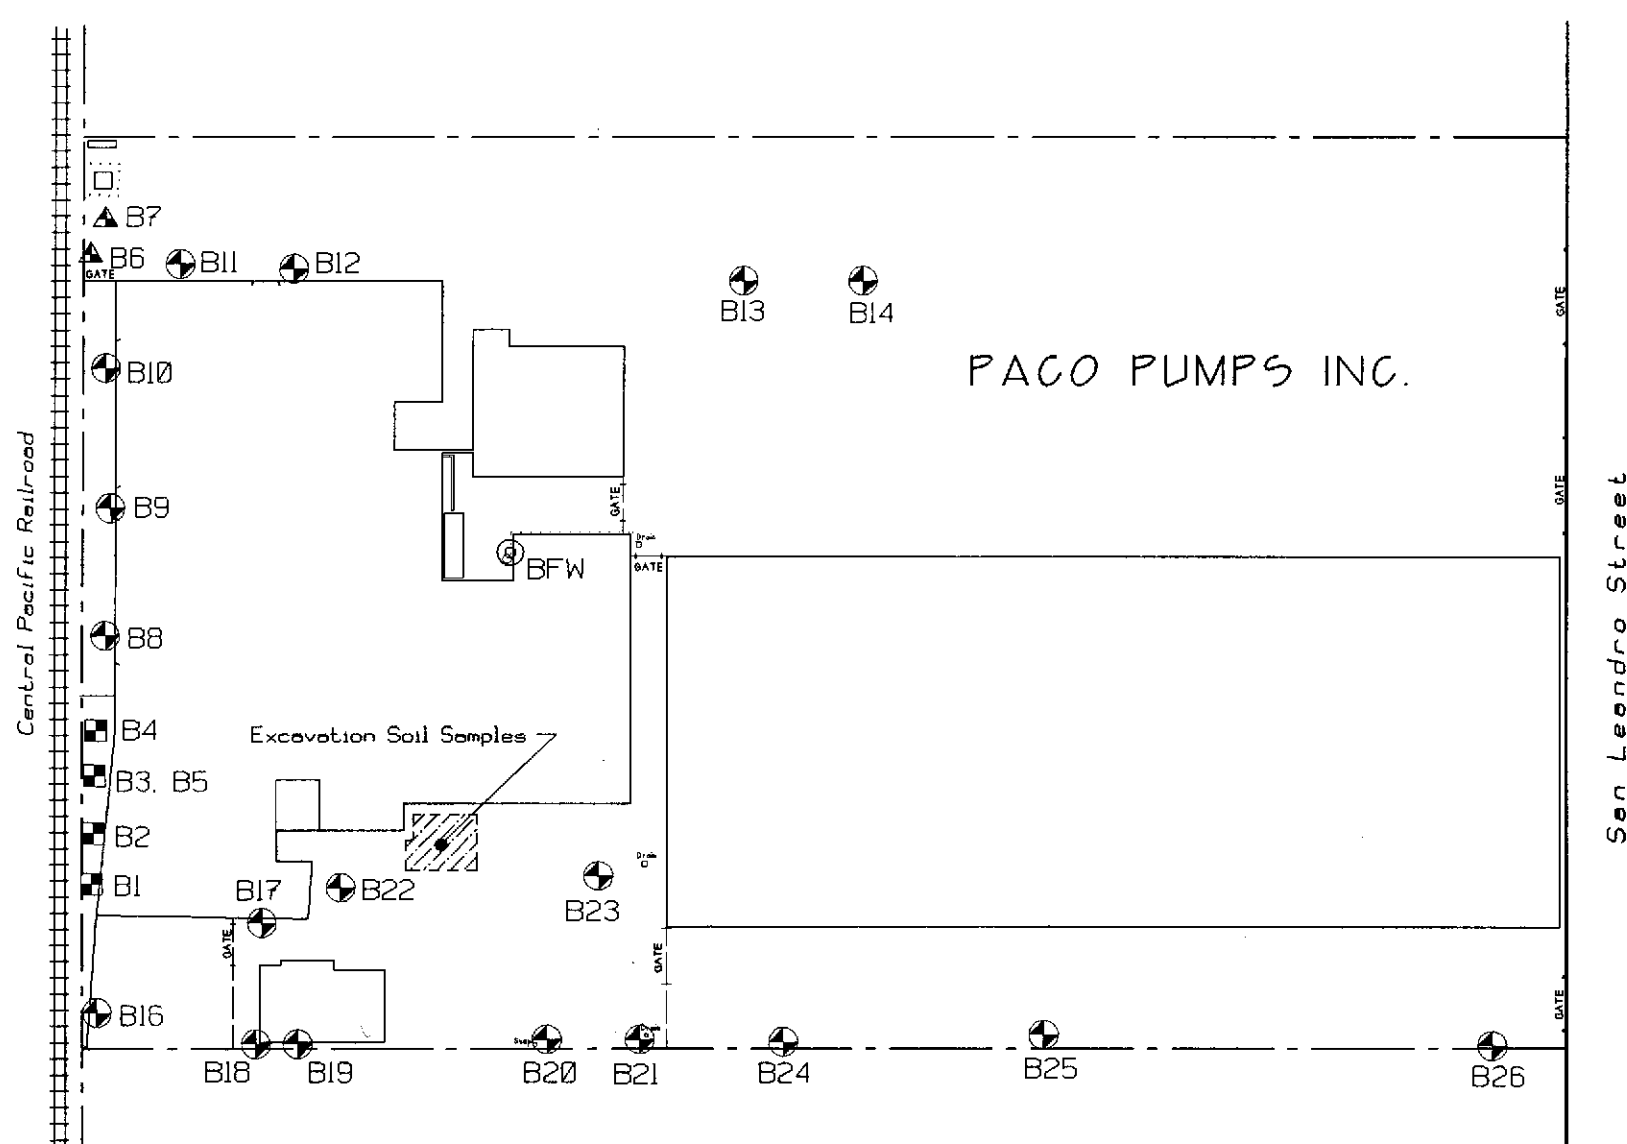
Drawn by A.J. 5-8-1992 Checked by Approved by Drawing Number PC0220-5/92:F4-1 Figure 4-1

- Legend:**
- Composite Soil Sample 0-0.5' & 1.0'-1.5'
 - Discrete Soil Sample 3.0'-3.5'
 - Discrete Soil Sample 0-0.5'
 - Water Sample

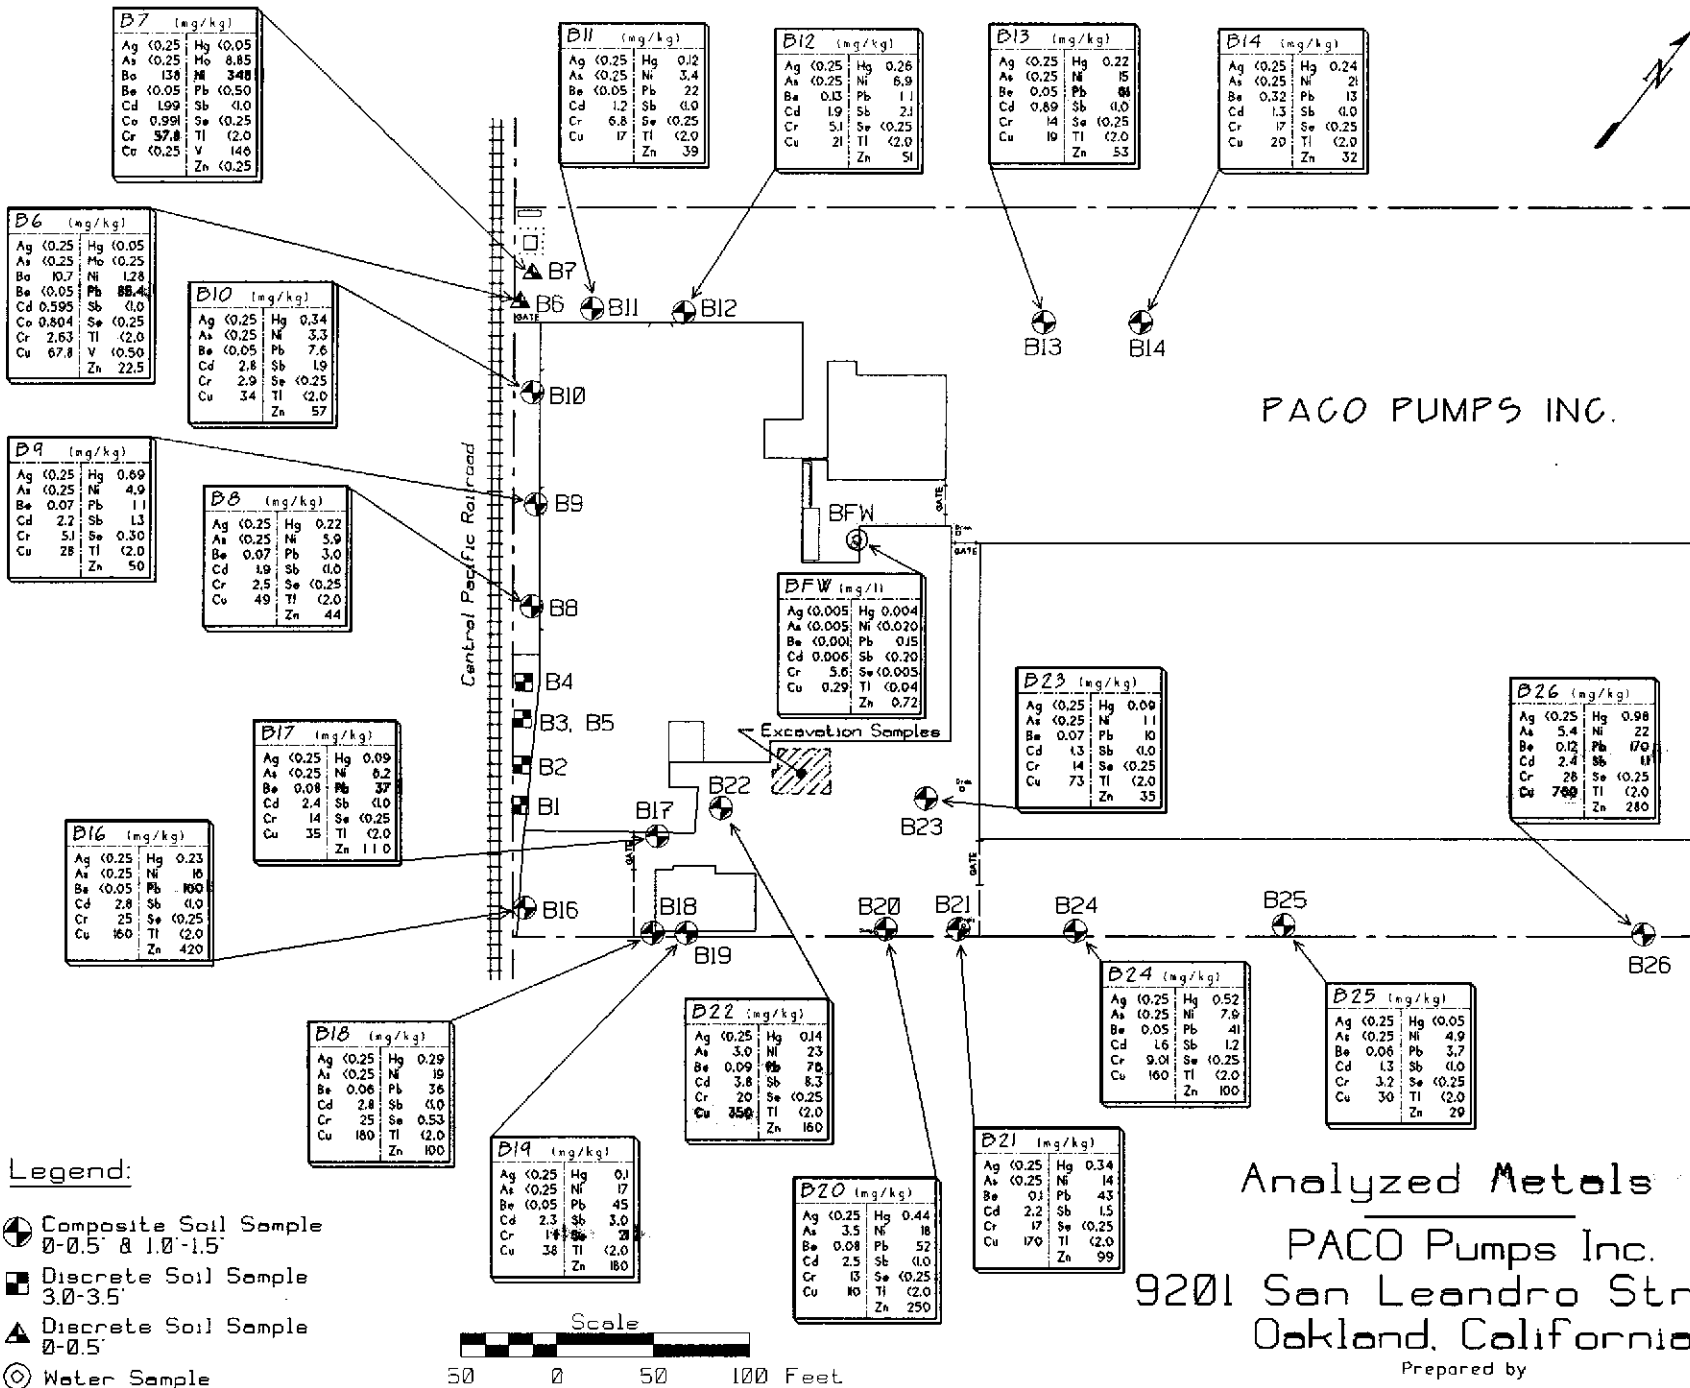
Drawn by A.J. Checked by Approved by
 6-8-1992
 Drawing Number PC0220-6/92:F4-2
 Figure 4-2

B7 (mg/kg)

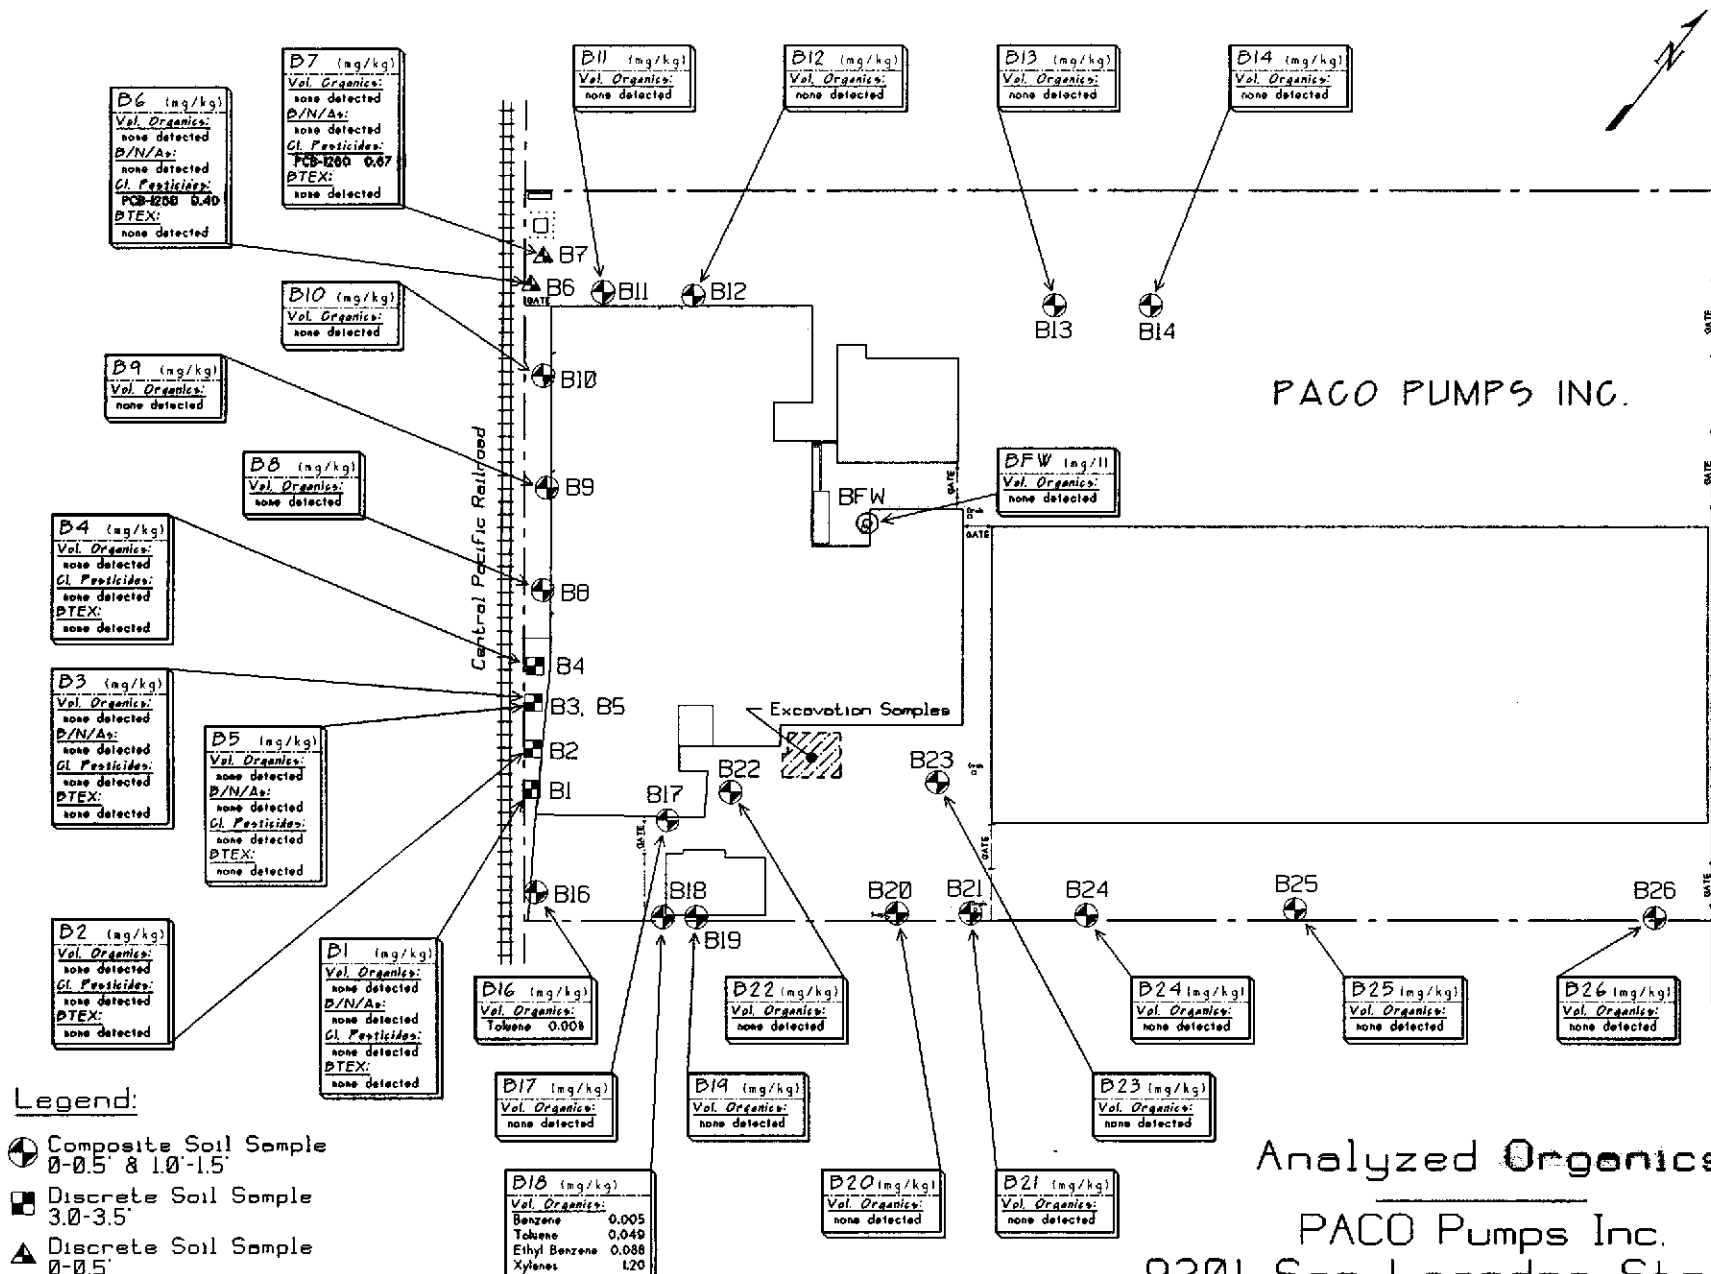
Drawn by A.J. Checked by Approved by
 6-8-1992
 Drawing Number PC0220-6/92/F4-3
 Figure 4-3

Vol. Organics = Volatile Organics: soil(B240); water(B24)
 BNAs = Base/Neutral/Acid Extractables: soil(B270)
 Cl. Pesticides = Chlorinated Pesticides: soil(B080)
 BTEX = Benzene, Toluene, Ethyl Benzene, Total Xylenes (B010)

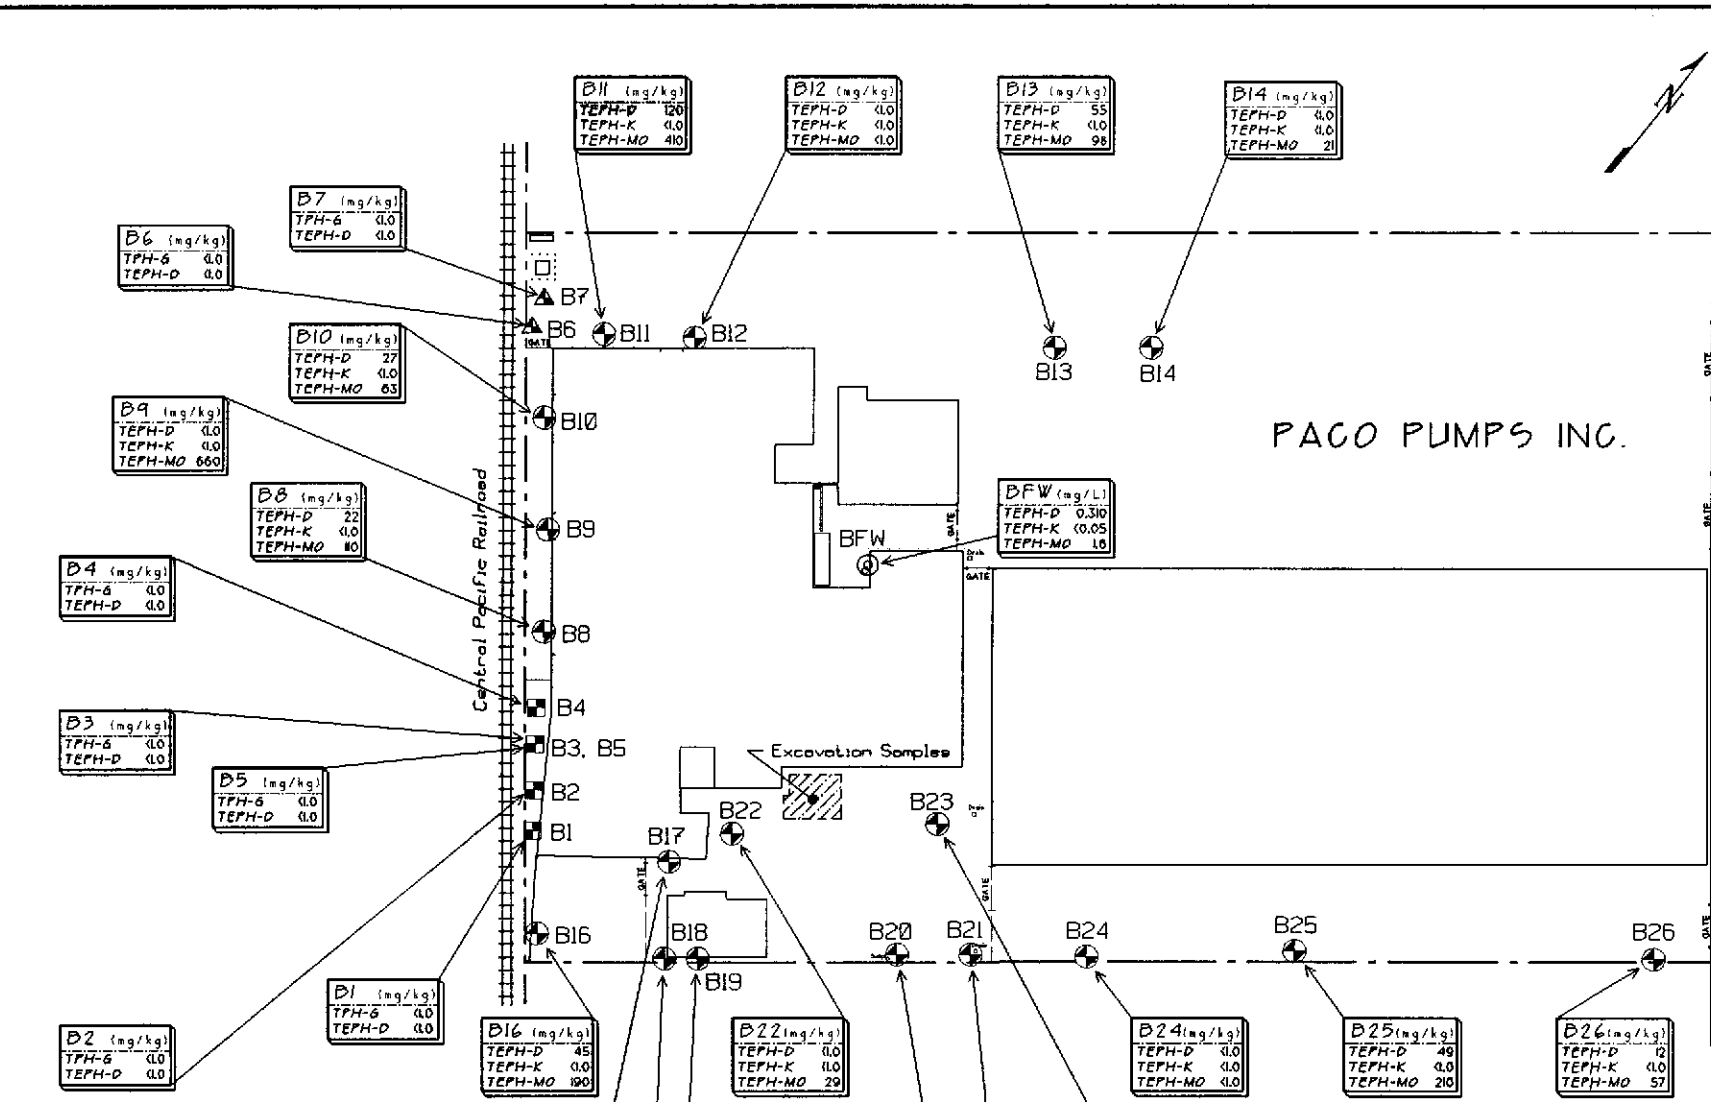
Drawn by A.J. 6-8-1992 Checked by Approved by
 Drawing Number PC0220-6/92:F4-4
 Figure 4-4

Analyzed
Petroleum Hydrocarbons
 PACO Pumps Inc.
 9201 San Leandro Street
 Oakland, California
 Prepared by
JONAS & ASSOCIATES INC.

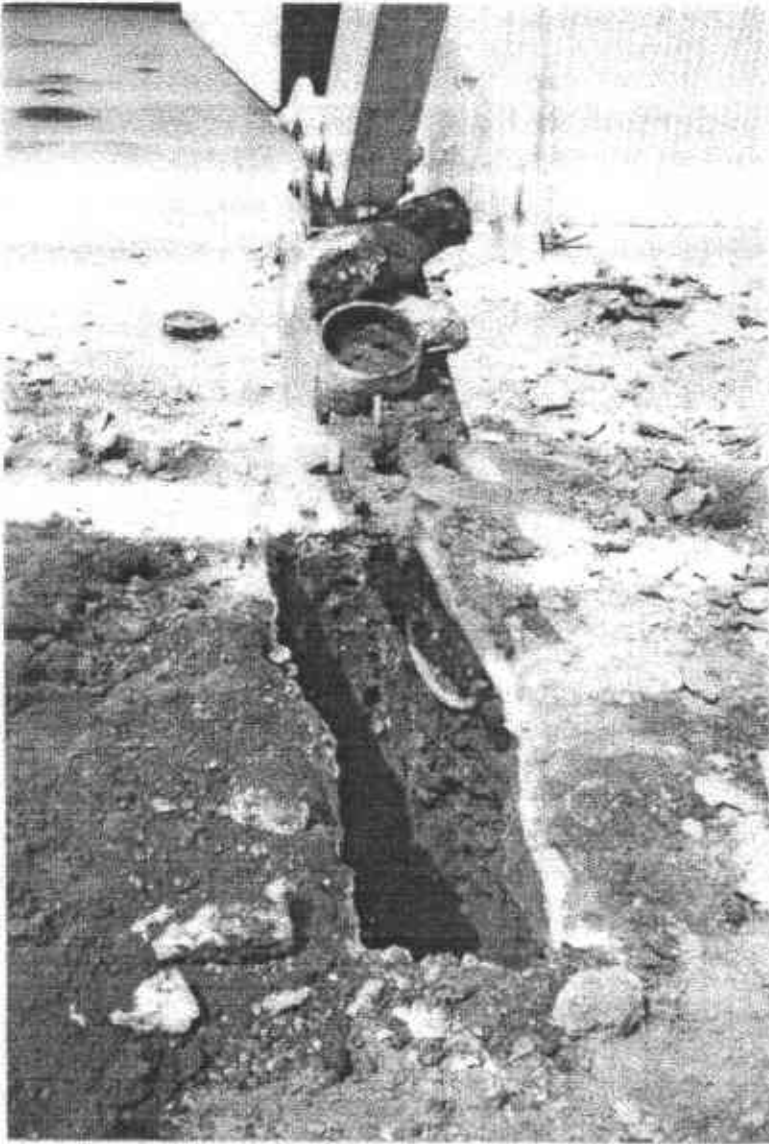
Picture 3:
Backhoe removing debris found in excavation.
June 29, 1992

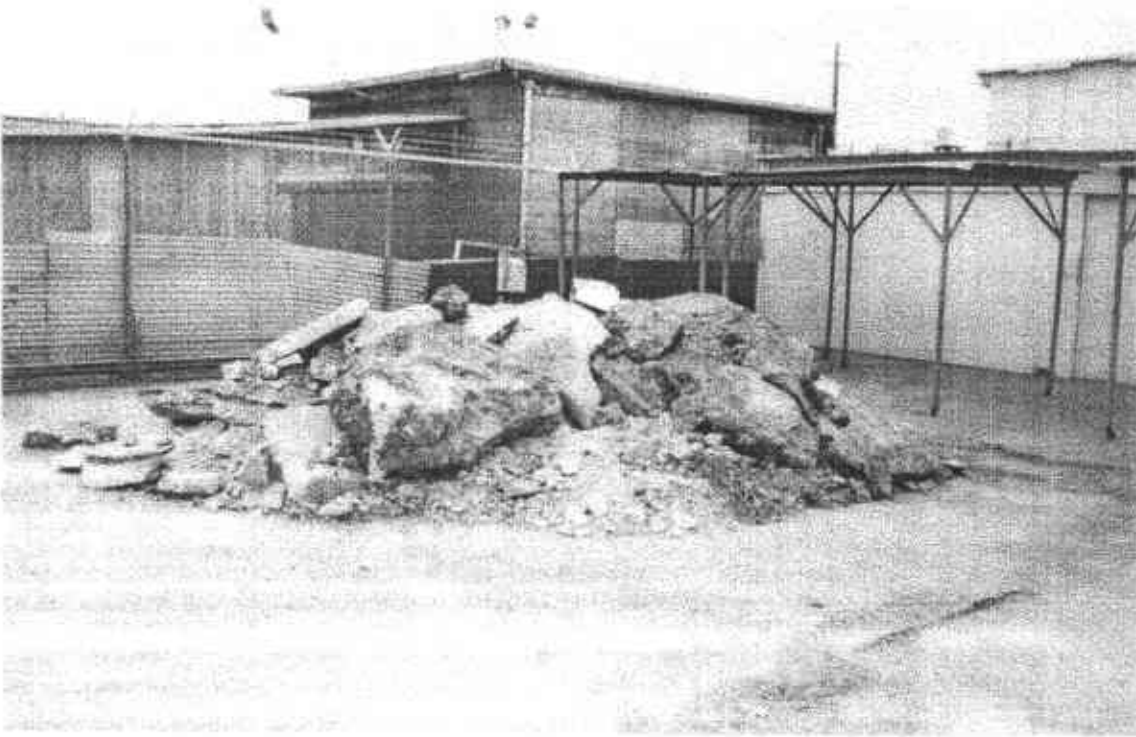
Picture 11:
Pile of concrete and
asphalt. Previously used
as a surfacing material
above the excavation.
August 3, 1992
