This Phase I Environmental Site Assessment (ESA) was performed to identify, to the extent feasible, recognized environmental conditions in connection with the subject site (cited hereinafter as the "Property"). We declare that, to the best of our professional knowledge and belief, we meet the definition of Environmental Professional as defined in §312.10 of this part. We have the specific qualifications based on education, training, and experience to assess a property of the nature, history, and setting of the subject property. We have developed and performed the all appropriate inquiries in conformance with the standards and practices set forth in 40 CFR Part 312. The protocol utilized for this assessment is in general accordance with the requirements of ASTM Standard E 1527-05.

**5239 TELEGRAPH AVE, OAKLAND CA 94609**

5239 TELEGRAPH AVE  
OAKLAND, CA

ERAS PROJECT #  
07039

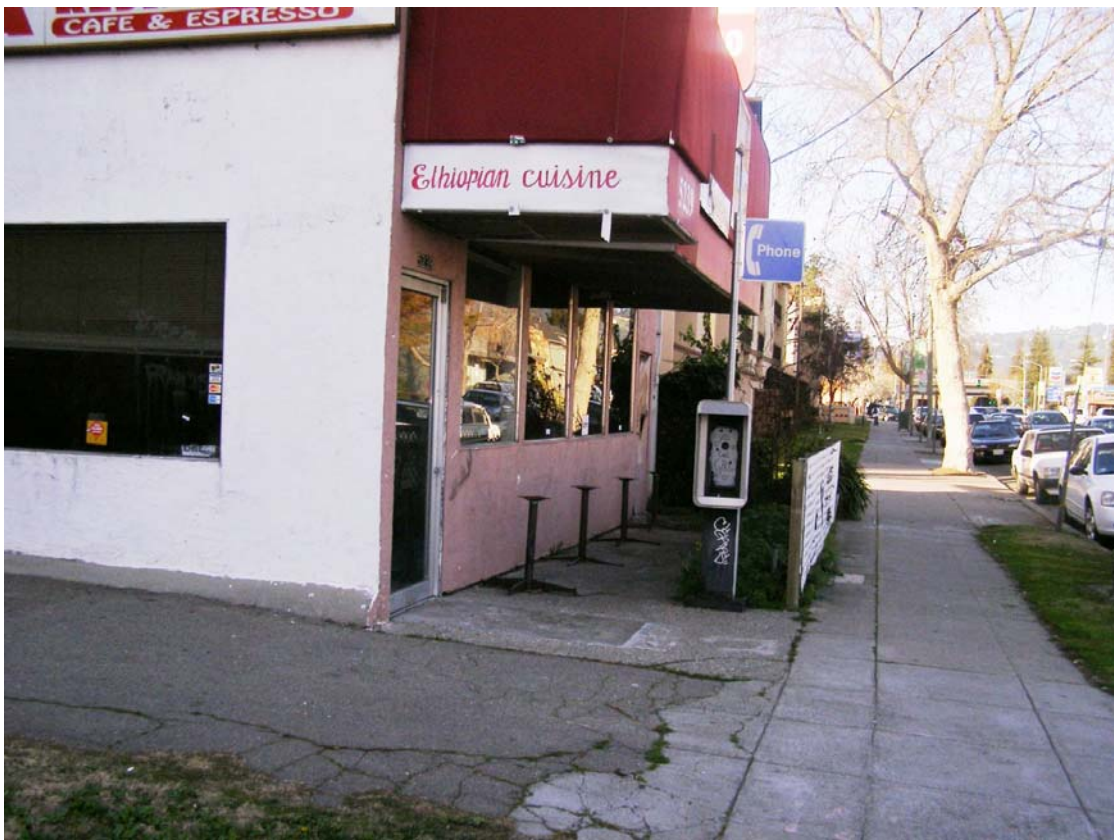
Photograph 1 - View front of the building from the south

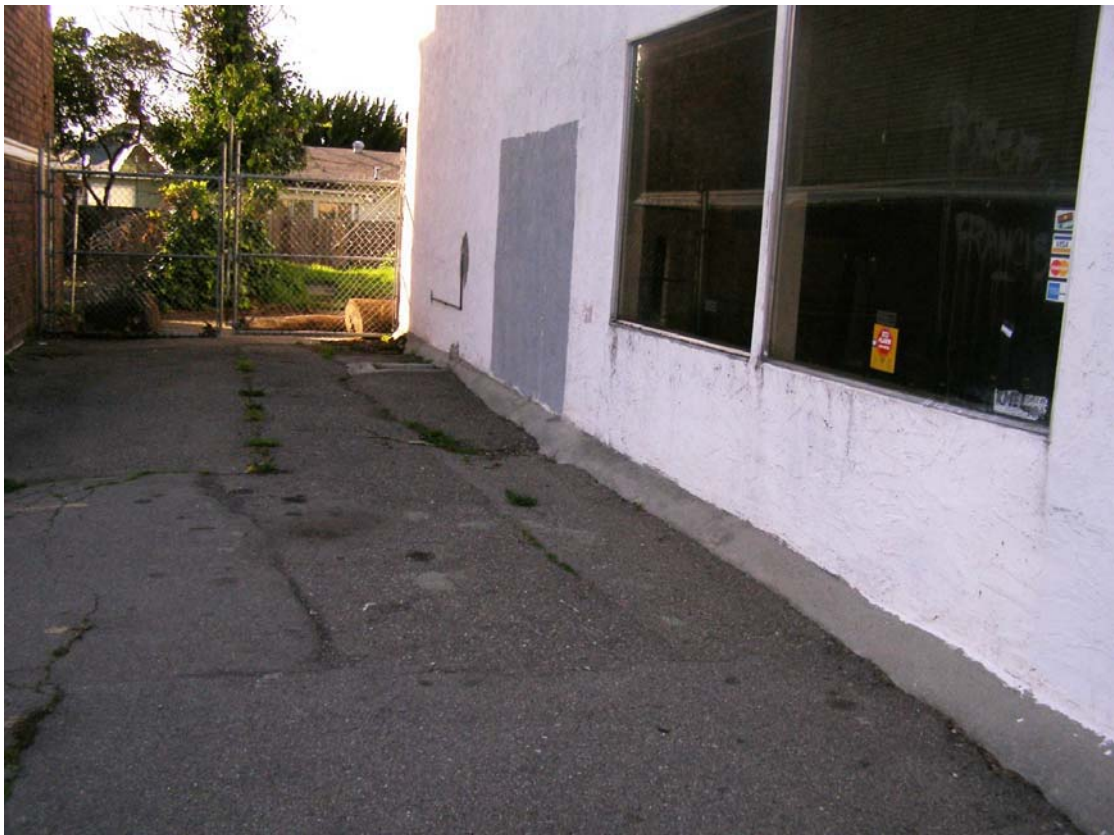
Photograph 2 - View of the south side of the building and driveway

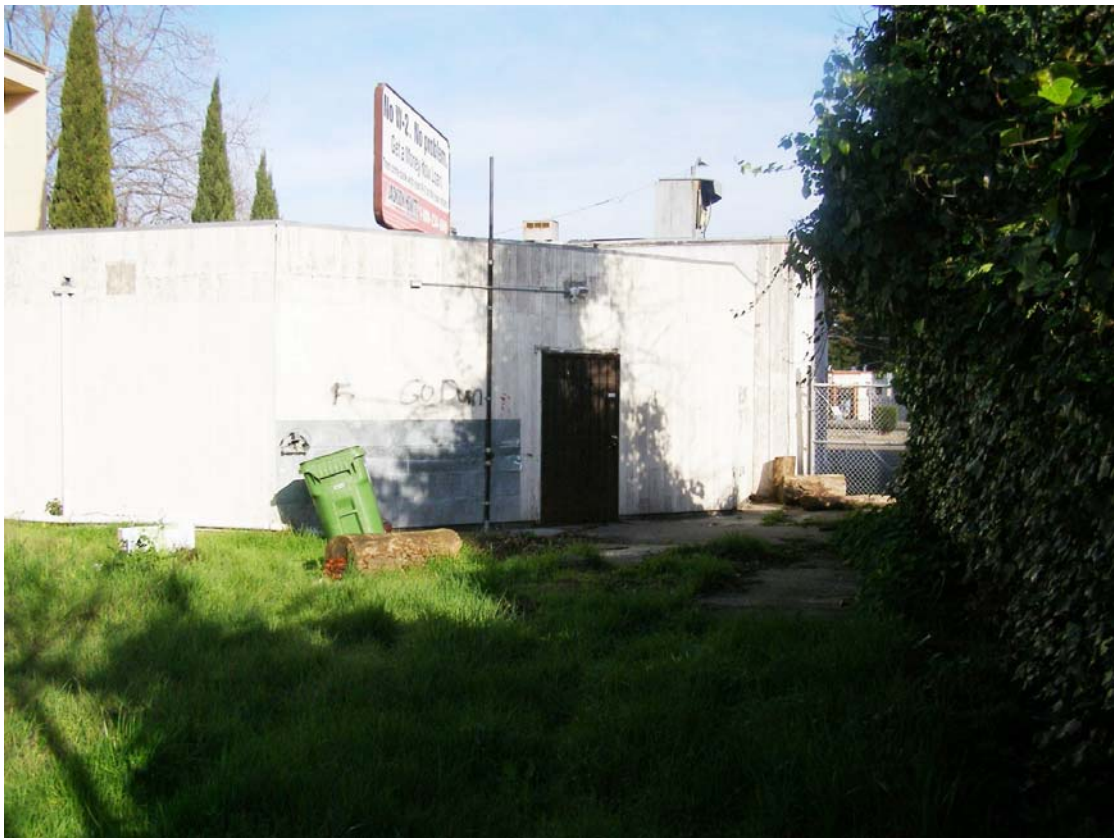
Photograph 3 - View to the east of the rear of the building and yard

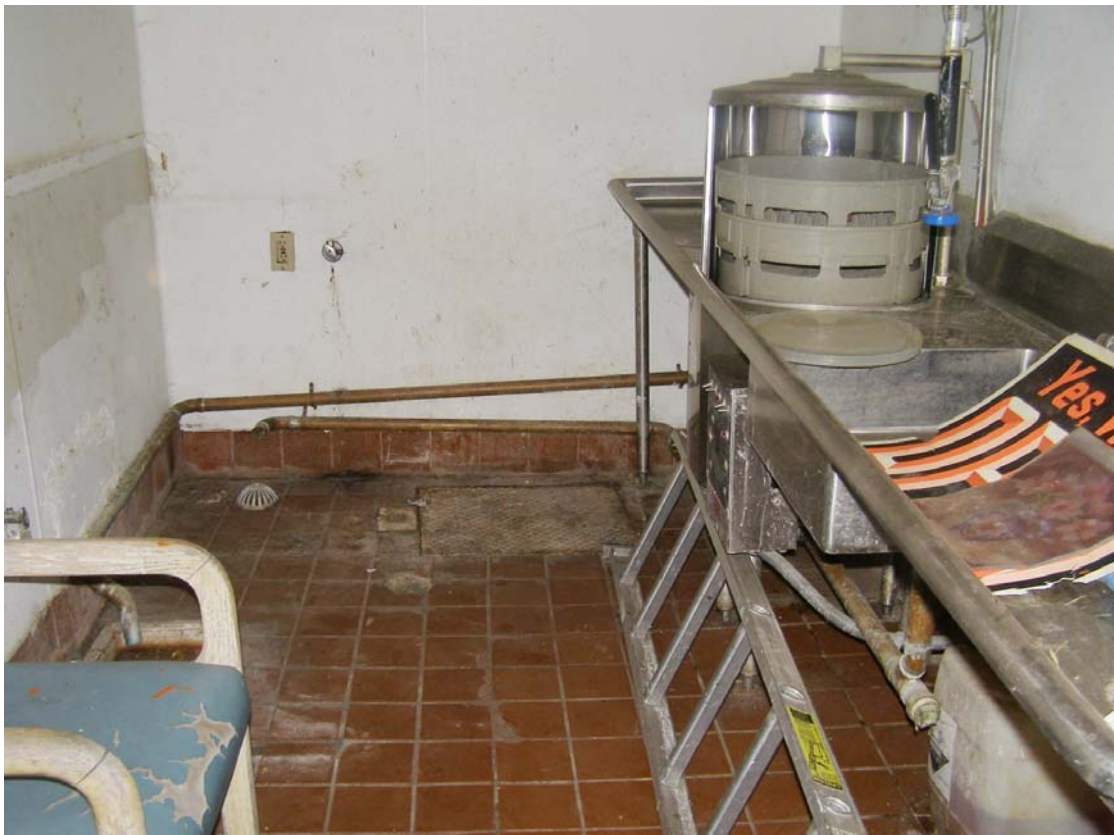
Chemicals used and stored on the Property included only one five gallon capacity plastic container of concentrated dishwashing detergent. No indication of leaks or spills was noted in these areas.

Photograph 4 - View of the dishwashing area with detergent container

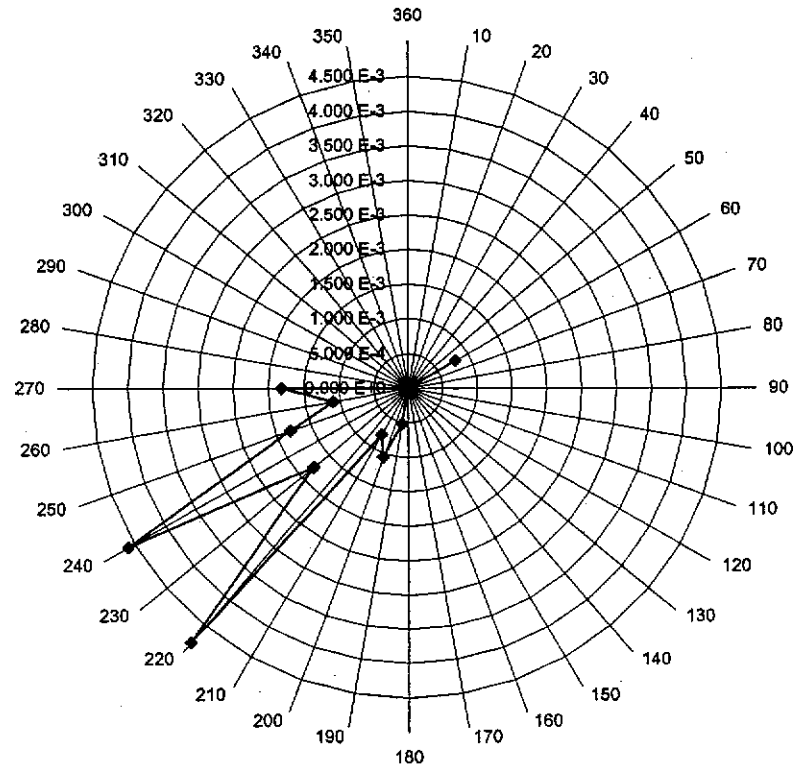
**Autopro Facility  
Water Direction Gradient  
April 1994 through December 2004**

Explanation  
This graph shows the gradient magnitude for each particular flow direction. Average magnitude shown when more than one event is in a particular flow direction.

Rose Diagram  
Groundwater Direction Gradient  
Autopro Facility  
Oakland, California
