Subject: Fuel Leak Case#RO0000346  
Site Location: 3519 Castro Valley Boulevard, Castro Valley

**Soil Gas Investigation Report  
and Updated Site Conceptual Model**

**3519 Castro Valley Boulevard  
Castro Valley, California 94546**

**Project 2762**

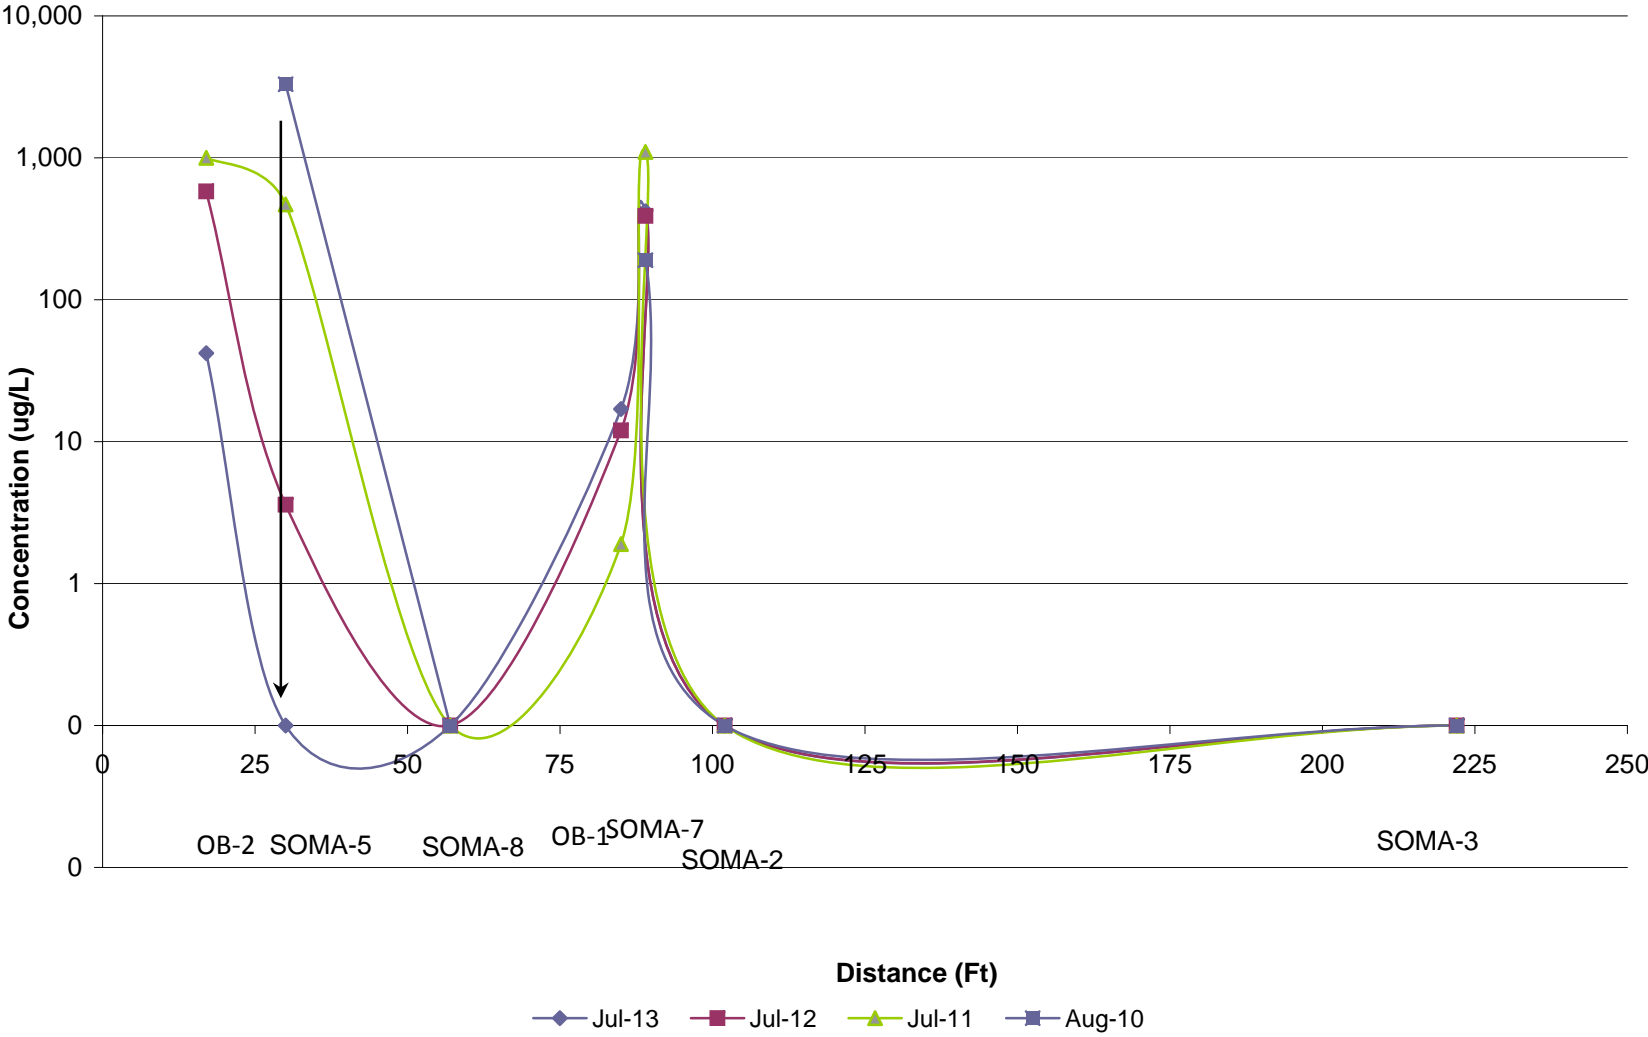
Figure 18: MtBE Conc vs. Distance from Former USTs

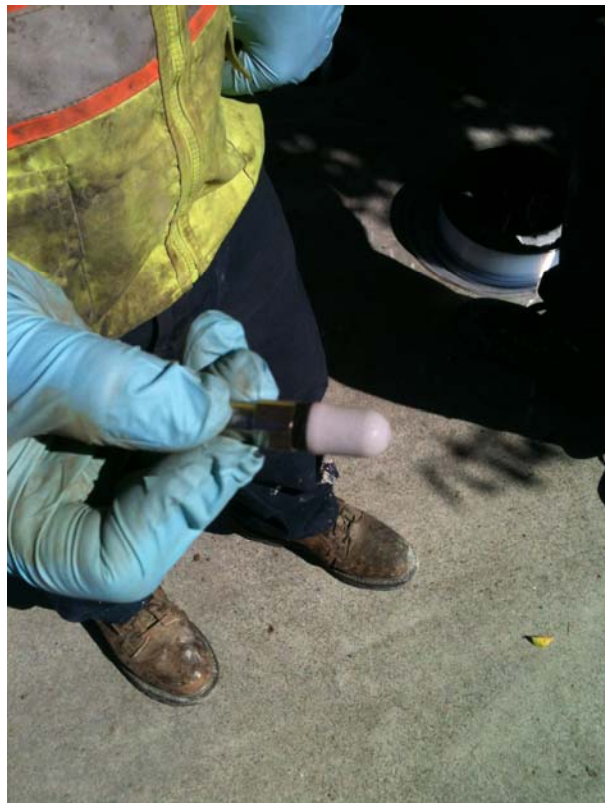
**Plate 6.** Vapor sampling tip used to construct vapor points

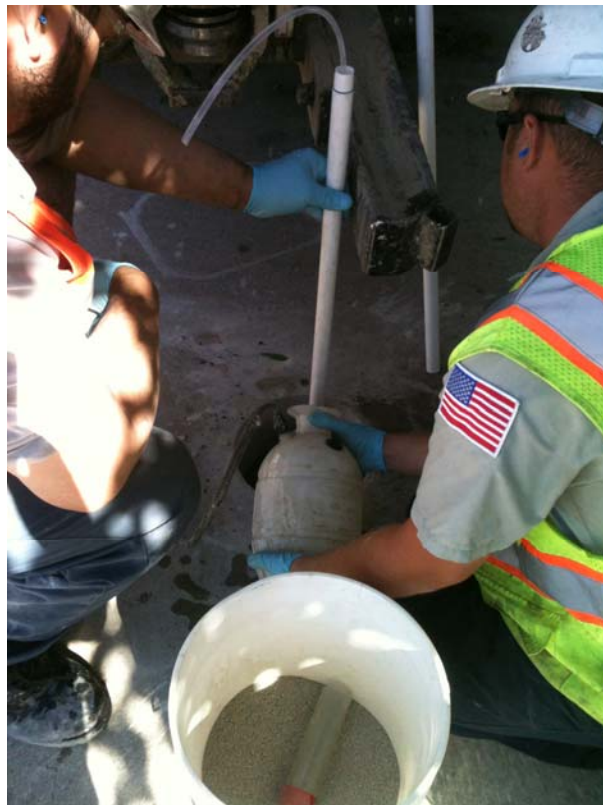
**Plate 8.** Adding water to hydrate bentonite for vapor point seal

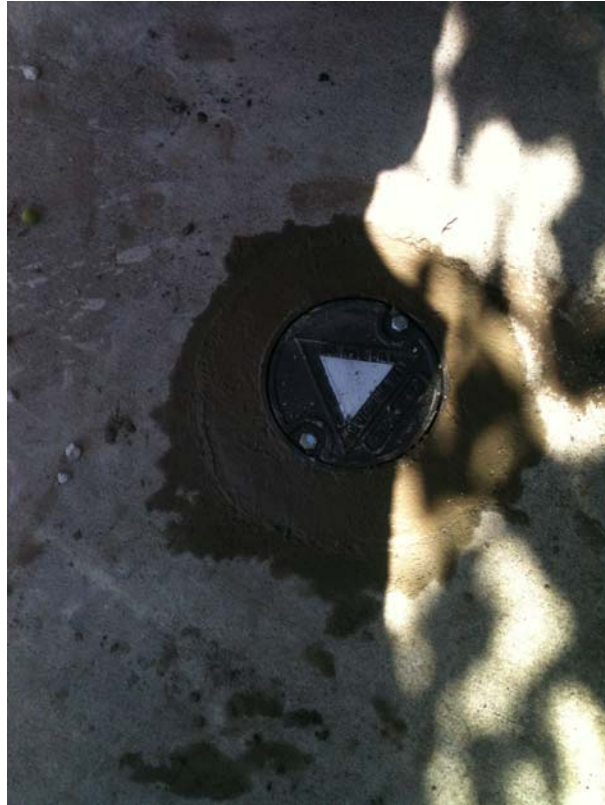
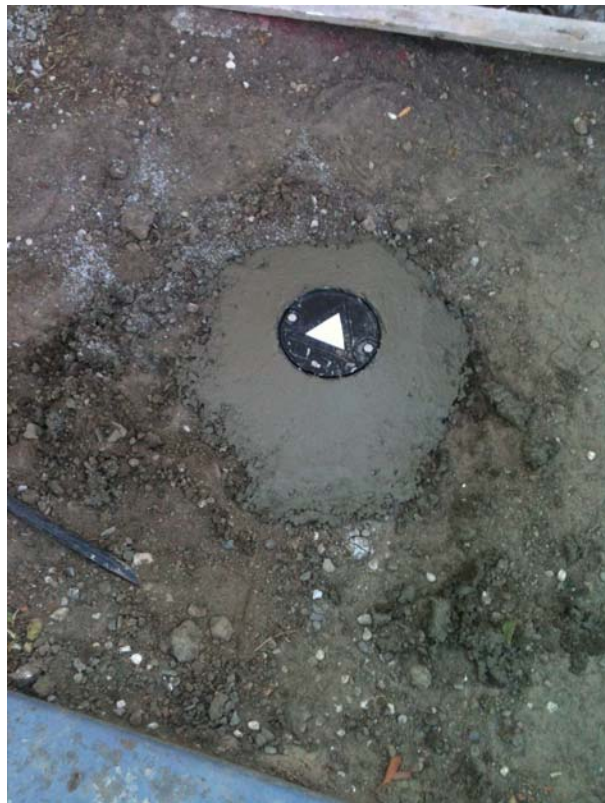
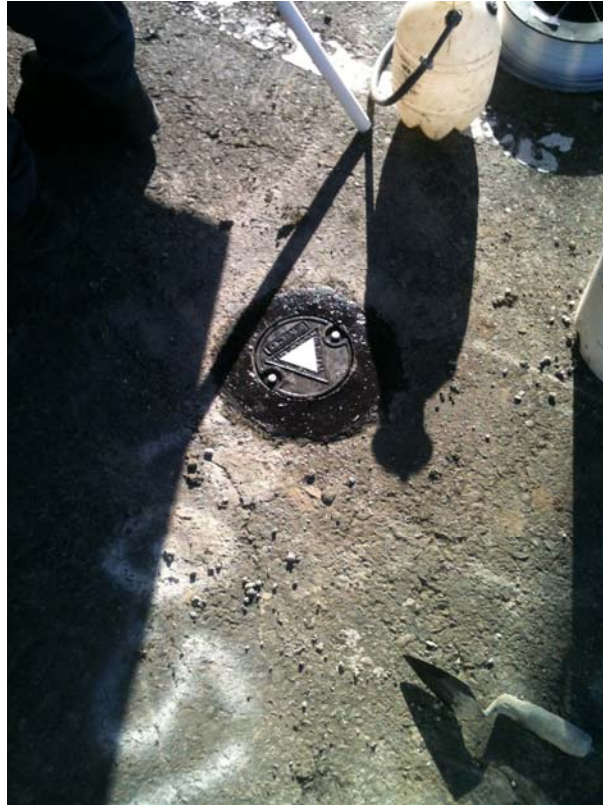
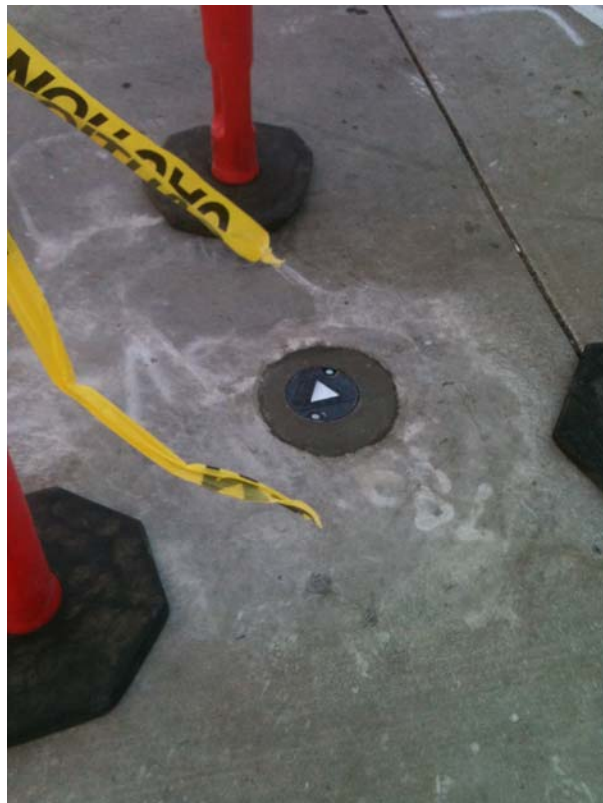
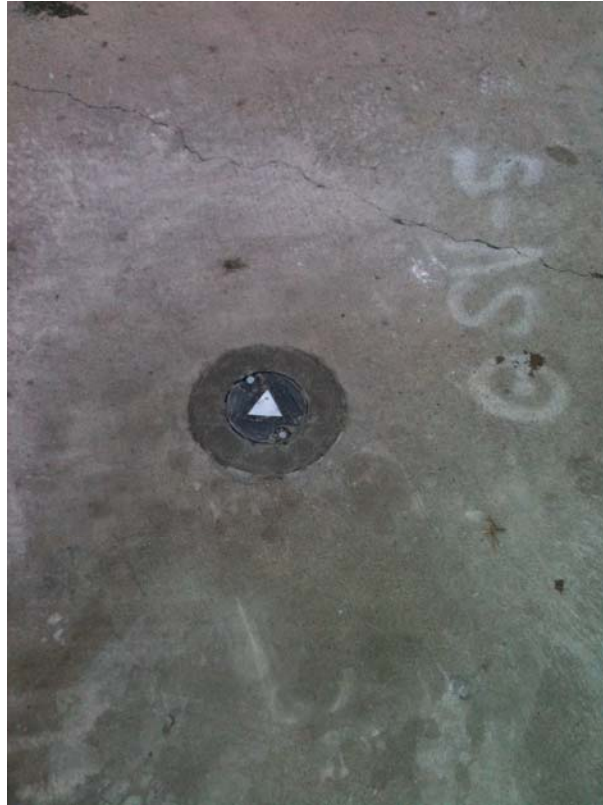
**Plate 15.** Soil vapor sampling point set with small well box

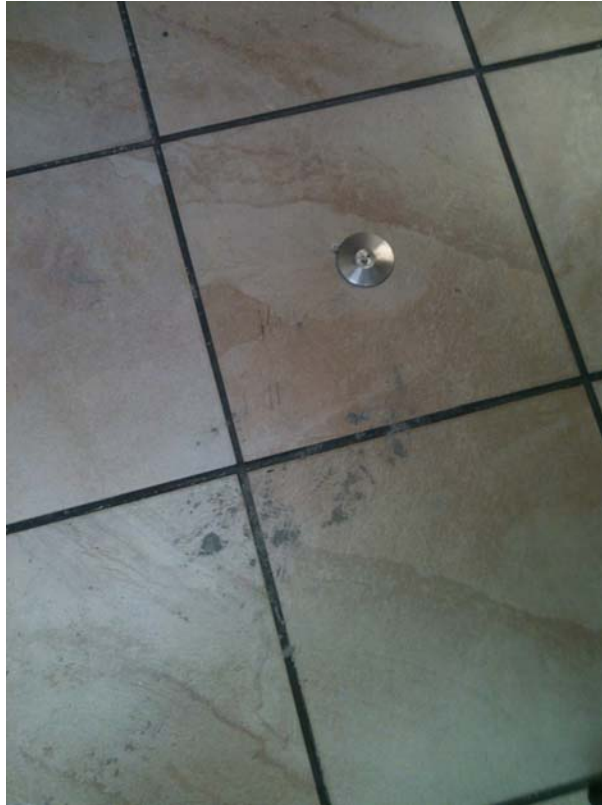
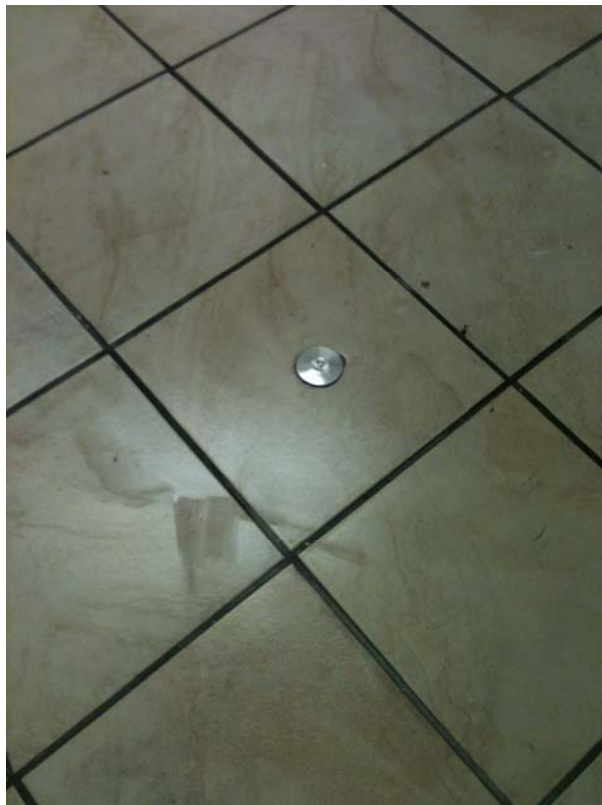
**Plate 23.** Soil vapor sampling pin installed through tile

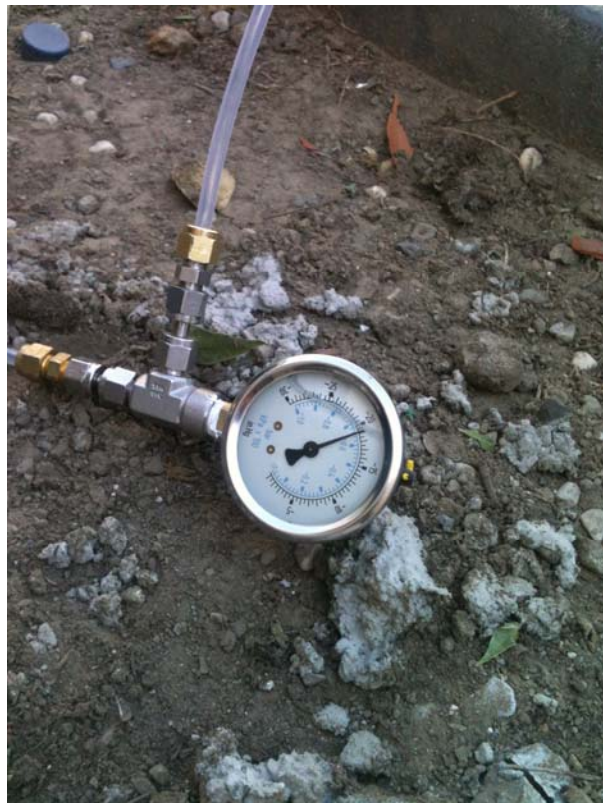
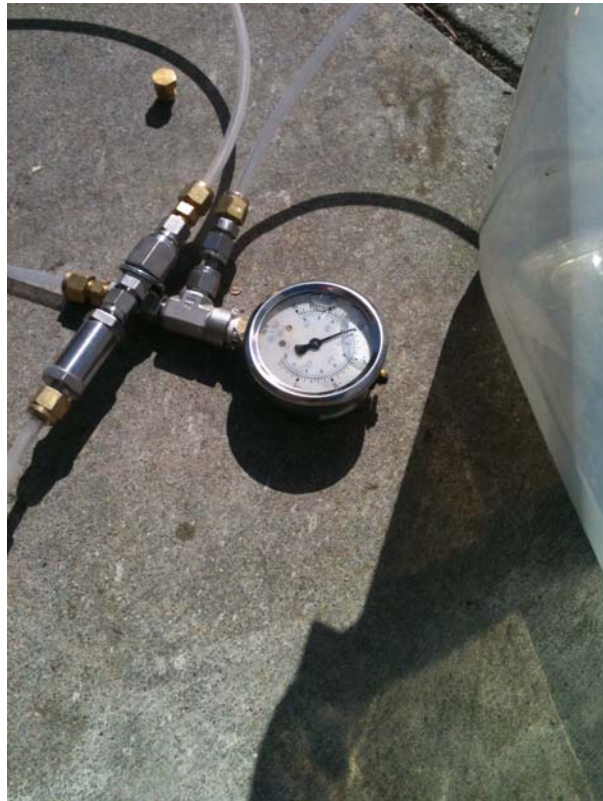
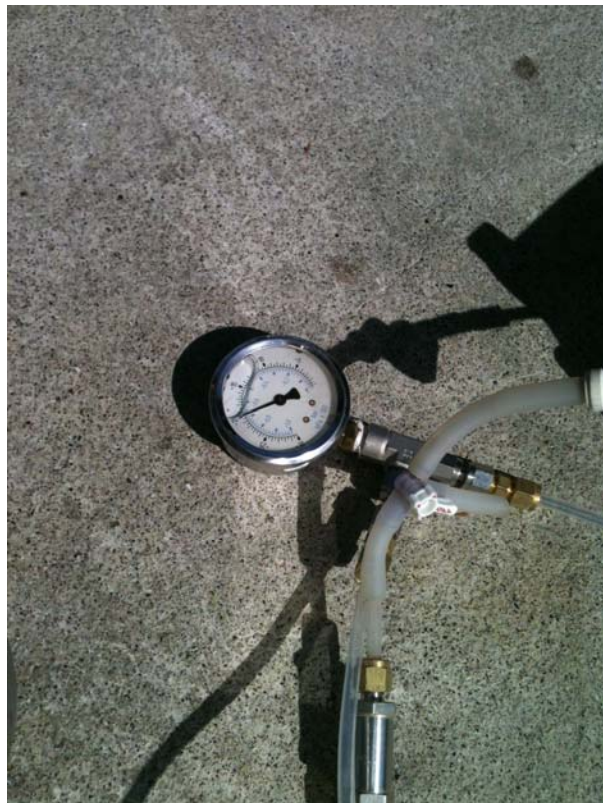
**Plate 26.** Shut-in test showing continuous vacuum held for two minutes

Soil vapor samples were collected on October 10, 2013. Prior to soil vapor sampling a shut-in test was conducted at each sampling location to check for a possible leak in the above ground sampling system. To conduct a shut-in test, the above ground valves, lines and fittings down-stream from the top of the probe were assembled. The test was conducted while the connection to the purge pump was in closed position. While the system was under negative pressure, the pressure gauge was observed and any possible vacuum drop was noted and any fittings would be tightened. During the shut in tests there were no leaks causing pressure drops detected. To ensure that stagnant air was removed from the sampling system and that samples are representative of the subsurface conditions, each sampling location was purged of approximately three purge volumes prior to sampling.

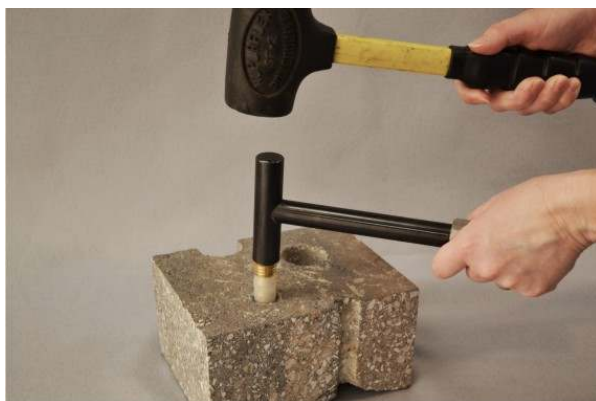
**Figure 2.** Installing the Vapor Pin™.

dead blow hammer (Figure 2). Make sure the extraction/installation tool is aligned parallel to the Vapor Pin™ to avoid damaging the barb fitting.

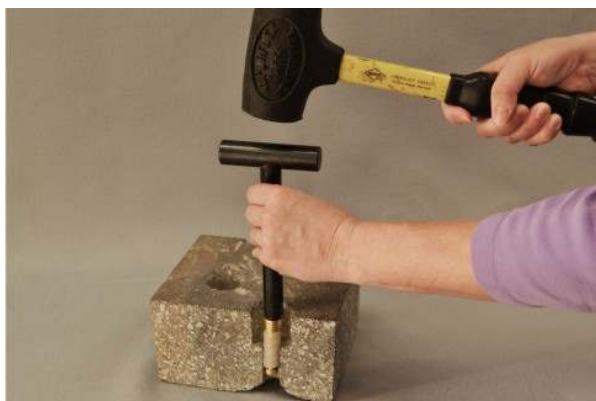
**Figure 3.** Flush-mount installation.

For flush mount installations, unscrew the threaded coupling from the installation/extraction handle and use the hole in the end of the tool to assist with the installation (Figure 3).

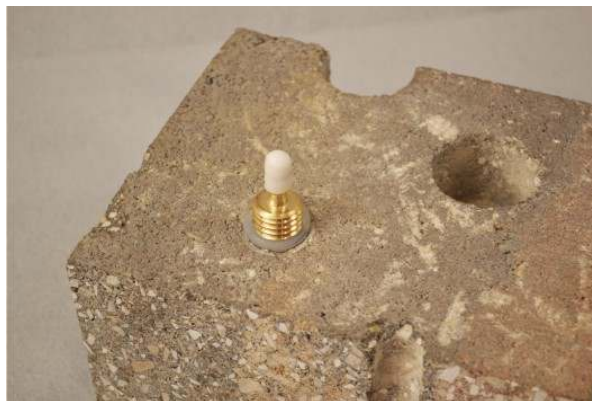
**Figure 4.** Installed Vapor Pin™.

During installation, the silicone sleeve will form a slight bulge between the slab and the Vapor Pin™ shoulder. Place the protective cap on Vapor Pin™ to prevent vapor loss prior to sampling (Figure 4).

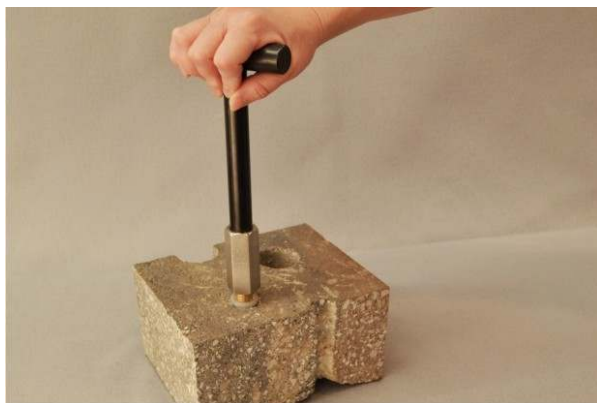
**Figure 7.** Removing the Vapor Pin™.

1) Remove the protective cap, and thread the installation/extraction tool onto the barrel of the Vapor Pin™ (Figure 7). Continue

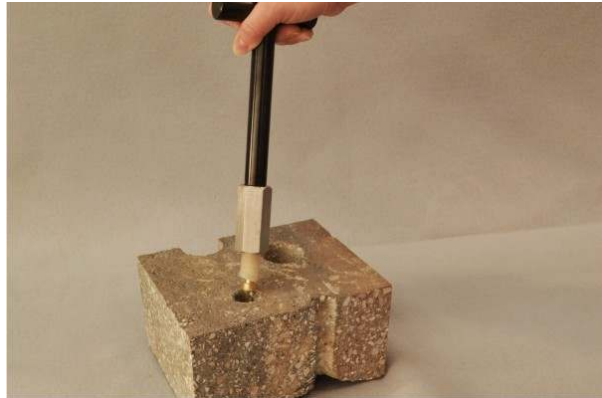
**Figure 8.** Extracted Vapor Pin™.

turning the tool to assist in extraction, then pull the Vapor Pin™ from the hole (Figure 8).
