**Baseline Vapor and Air Monitoring
Report for Building 300**

Former Pacific Electric Motors Site
1009 66th Avenue
Oakland, California
(Fuel Leak Case Number RO0000411)

**Baseline Vapor and
Air Monitoring Report
for Building 300**

Former Pacific Electric Motors
Site, 1009 66th Avenue, Oakland,
California
(Fuel Leak Case Number
RO0000411)

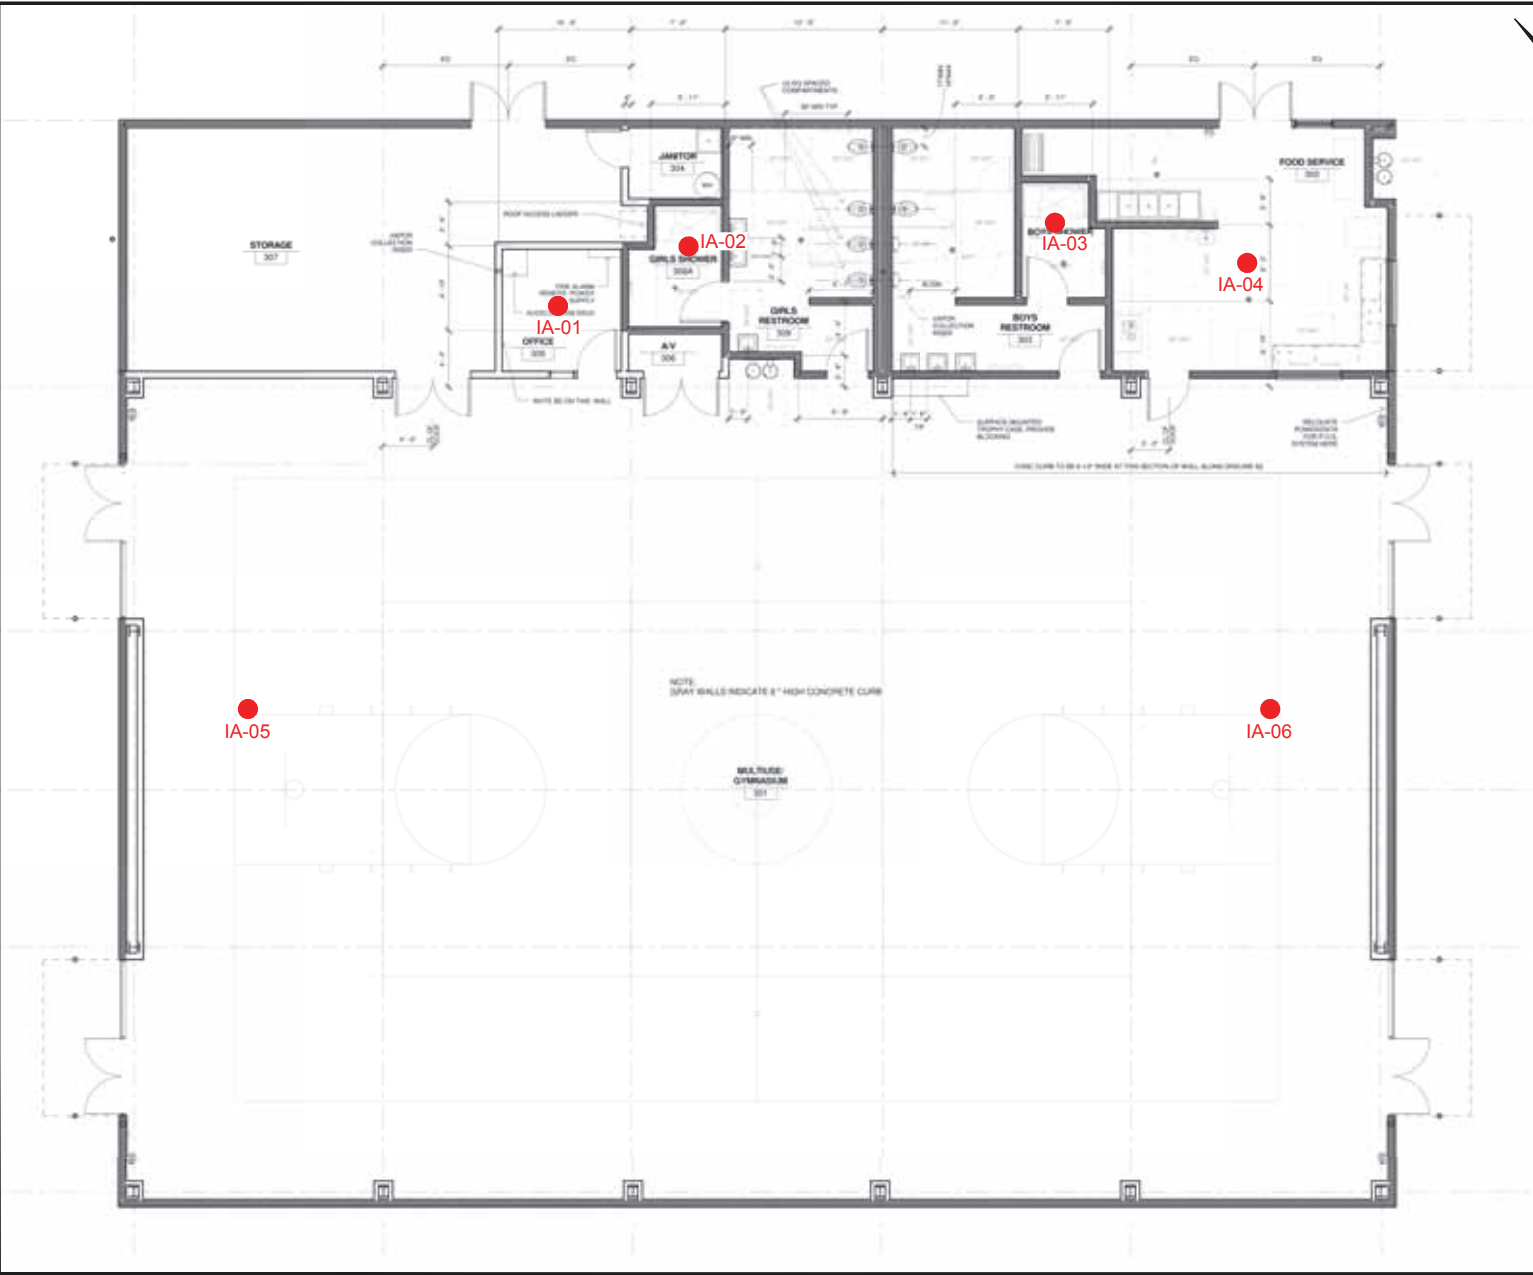
Figure 3 – Revised Proposed Indoor Air Sample Locations

IA-01 ● PROPOSED INDOOR AIR SAMPLE LOCATION

- NOTES:
1. SOURCE: K2A ARCHITECTURE
 2. PROPOSED INDOOR AIR SAMPLE LOCATIONS ARE APPROXIMATE AND WILL VARY BASED ON ACTUAL FIELD CONDITIONS.

On March 20, 2015 ARCADIS submitted to ACEH the Building 300 Vapor and Indoor Air Monitoring Plan that described procedures to establish baseline conditions in Building 300 following construction of the VIM system (Air Monitoring Plan; ARCADIS 2015). This plan is a supplement to the Air Monitoring Plan and provides detailed procedures to obtain grab air sampling from the riser pipes of the VIM system. The grab air samples will be used to compare with the indoor air samples collected as described in the Air Monitoring Plan (ARCADIS 2015) and to evaluate the effectiveness of the VIM system. Shortly after the submission of the March 20, 2015 Air Monitoring Plan, the floor plan of Building 300 was changed to accommodate the sanitary sewer. To accommodate the revised floor plan, the proposed indoor air sample locations were also changed. A revised figure is included as Figure 3.
